## Client Details

Gosforth Parish Council  
c/o Jacqueline Williams  
Clerk to Gosforth Parish Council  
2 Wells Cottages  
Ravenglass  
Cumbria CA18 1SP

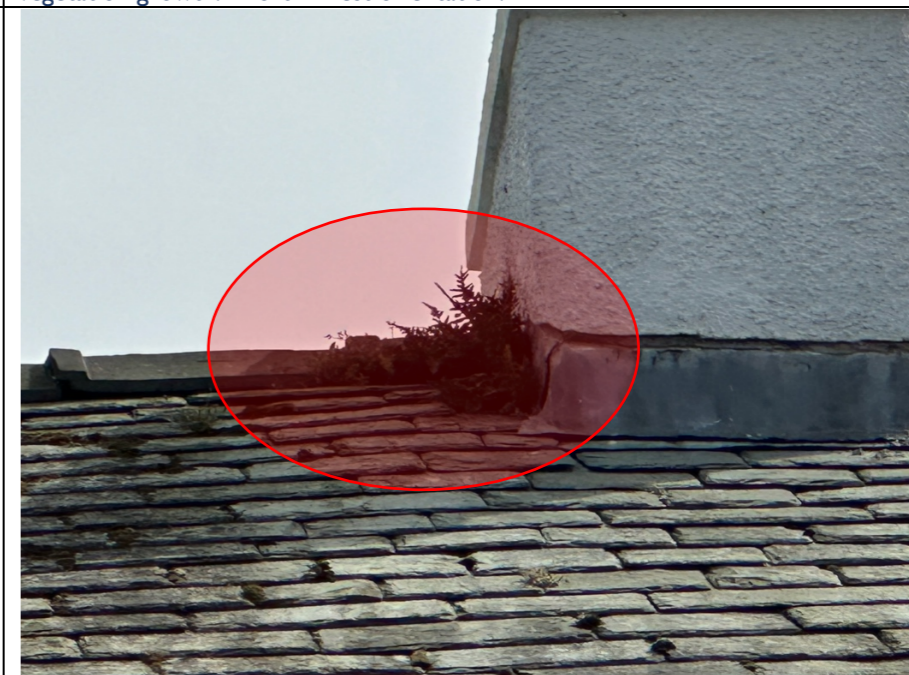
006 – During the survey we were advised that remedial works had been carried out to the external chimney stack to the South West facing wall of the traditional building. Whilst there is evidence to suggest that cement pointing repairs took place, it is clear the junction of the roof slate with the chimney stack is still holding water as proved by the vegetation growth at the junction.

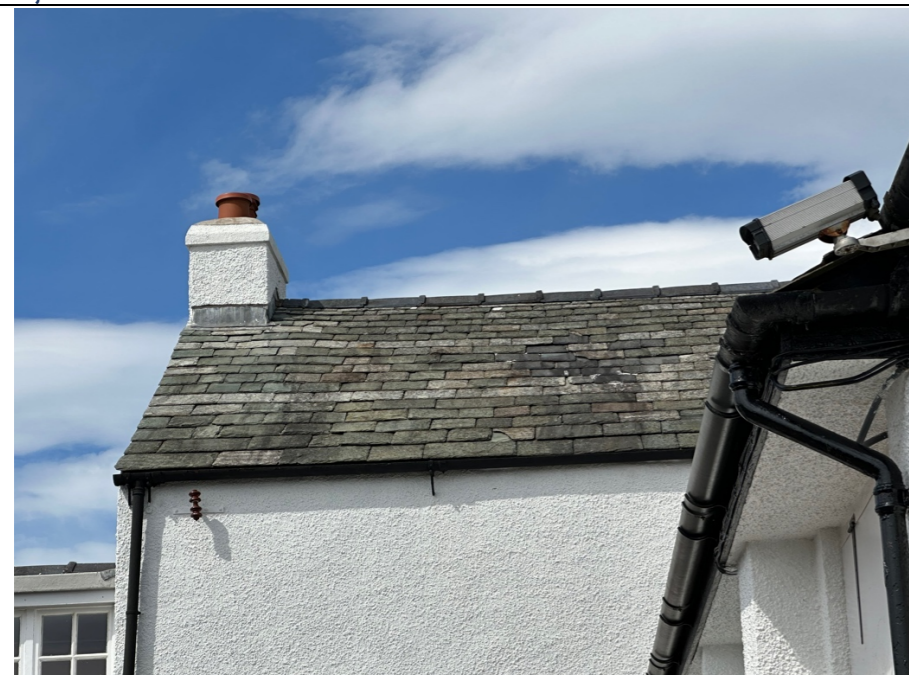
007 – South East facing slated pitched roof slope of the traditional Grade II Listed building.

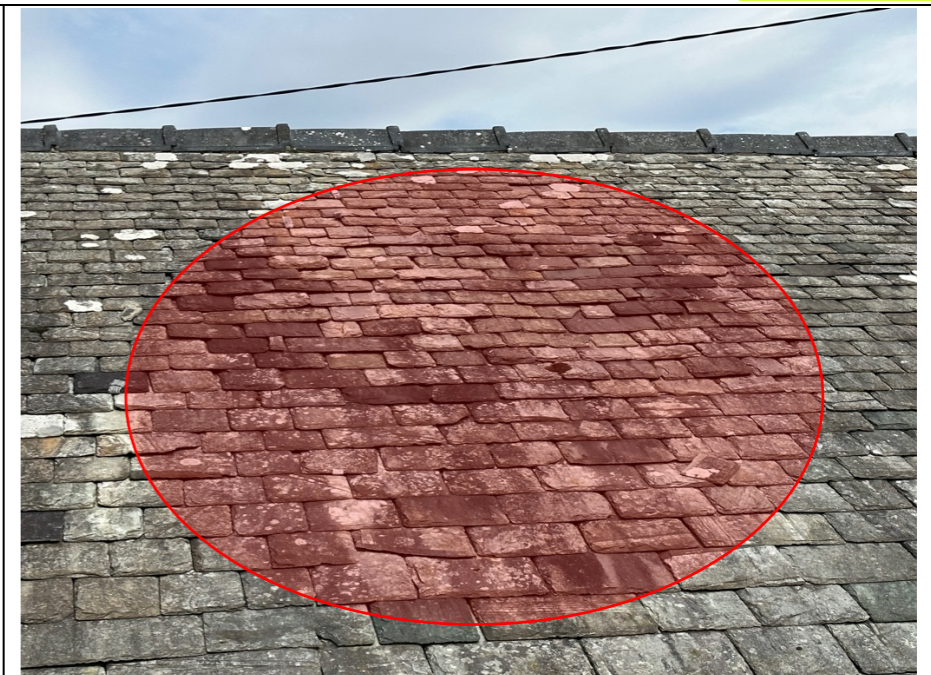
009 – General gapping of joints to the slate roof covering and within the 'red zone' the slates are showing signs of deterioration, including – gapping, broken & missing slates.

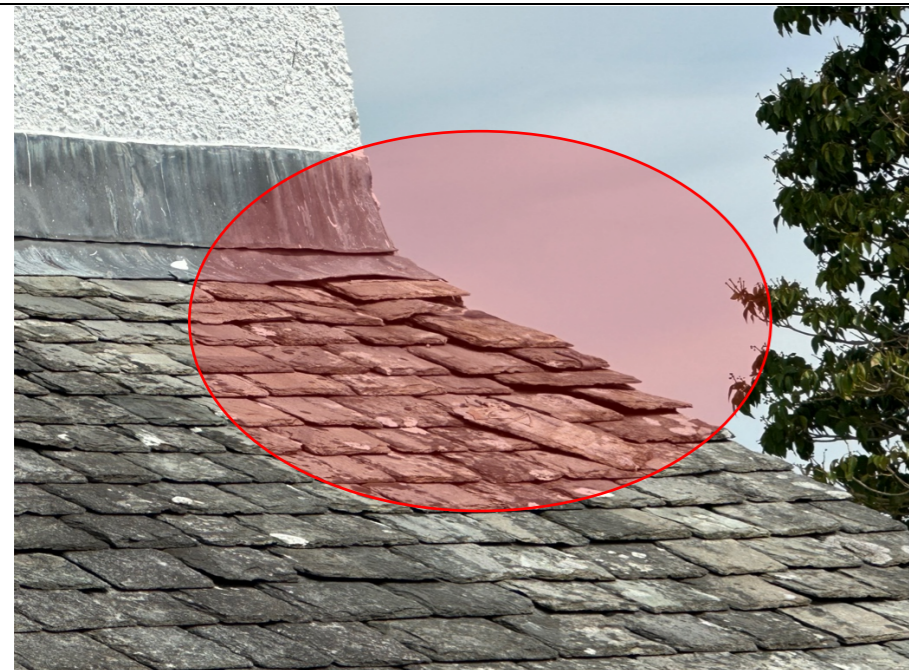
010 – Slating to verge on the North East gable elevation (SE facing roof slope). Slates are lifted and misaligned. There is evidence to suggest that the loose slate resting on the slope has in the past been stuck down with some form of mastic sealant.

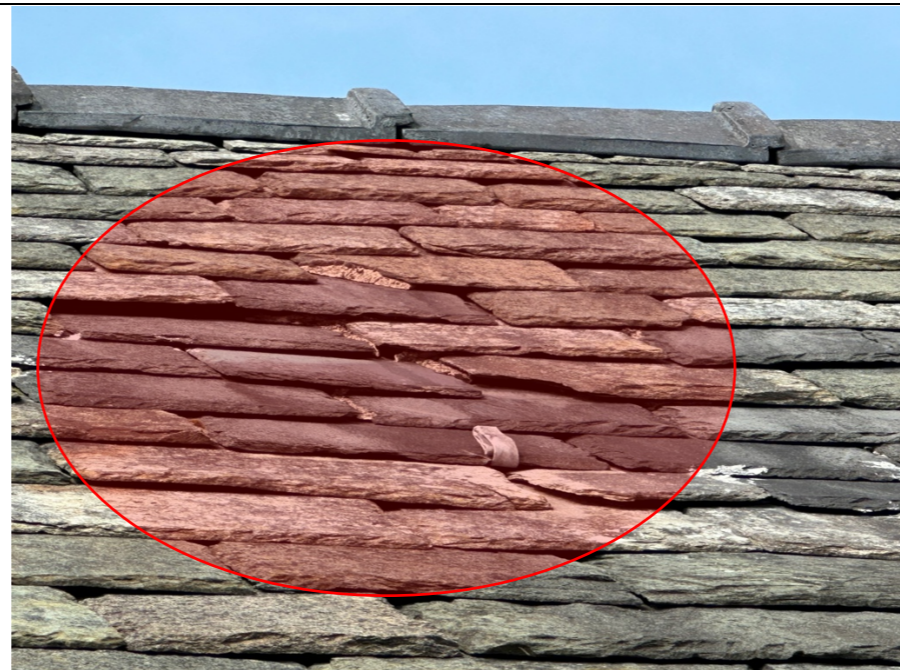
011 – South East facing roof slope, clear signs of lifting and gapping roof slate, broken slates and the use of lead tangles / tags to secure loose slates in place.

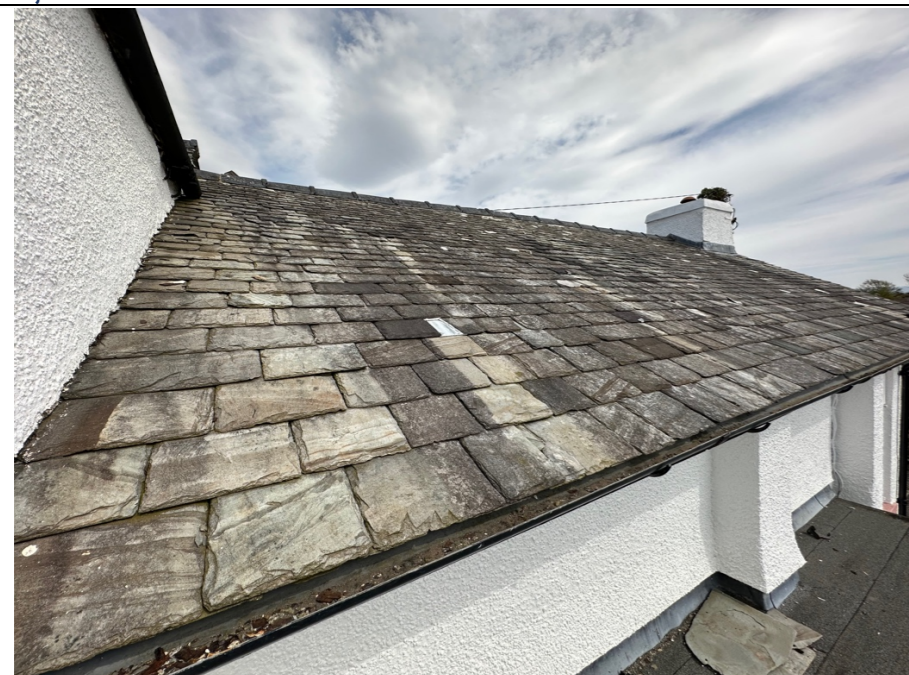
012 – General view of the South West facing slated roof slope to the rear addition of the traditional building. Note: The North East facing roof slope of the addition could not be viewed or surveyed due to access restrictions and difficulties getting a clear line of sight across the roof slope.

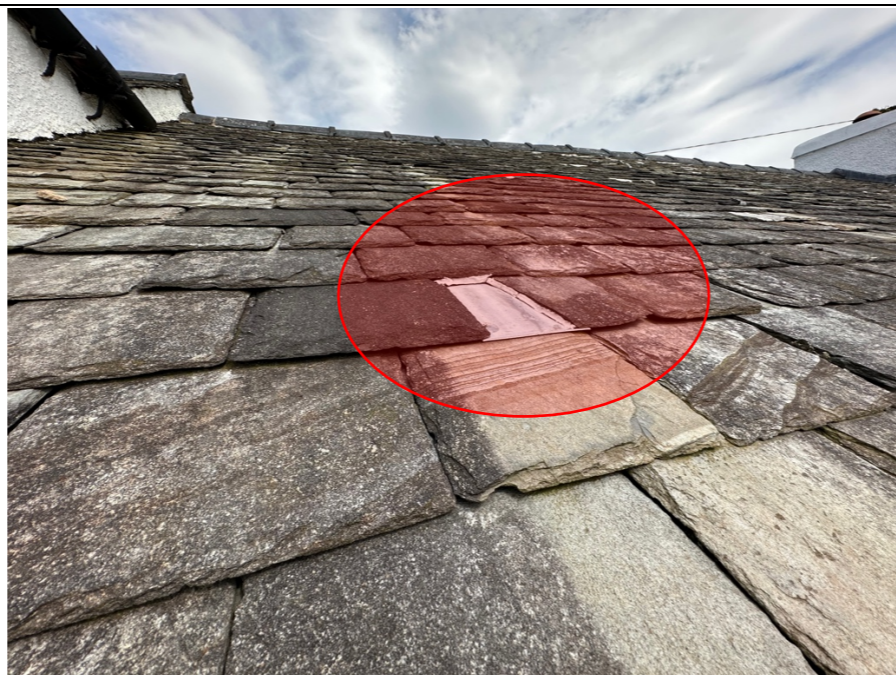
013 – Evidence of a non-typical slate repair to the rear addition roof covering.

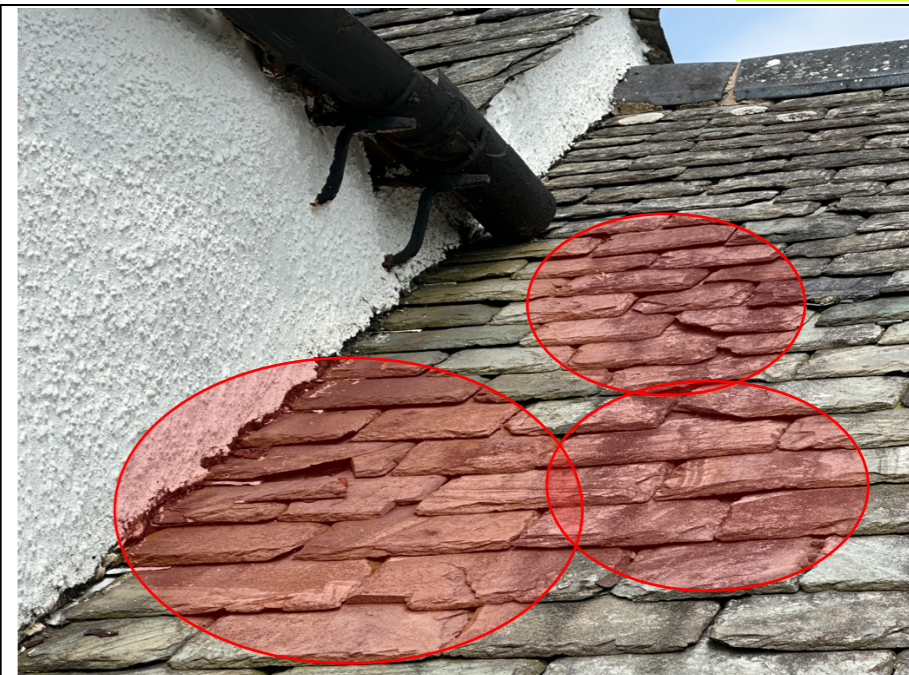
014 – Image taken of the rear addition slate roof area adjacent to the abutment with the Grade III Listed structure. Numerous examples of broken and damaged slates.

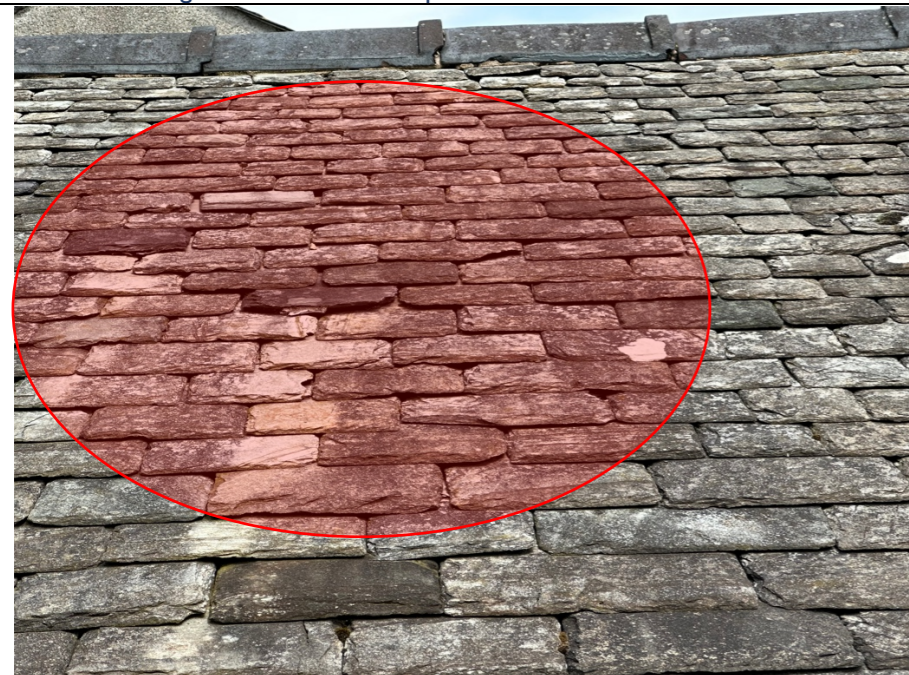
015 - Image taken of the rear addition slate roof area in a more central area of the roof slope. In addition to a number of damaged slates, note the uneven bedding / laying of the roof slate and also the gapping between slates within the highlighted area. Possibly an area where repairs have been previously undertaken.

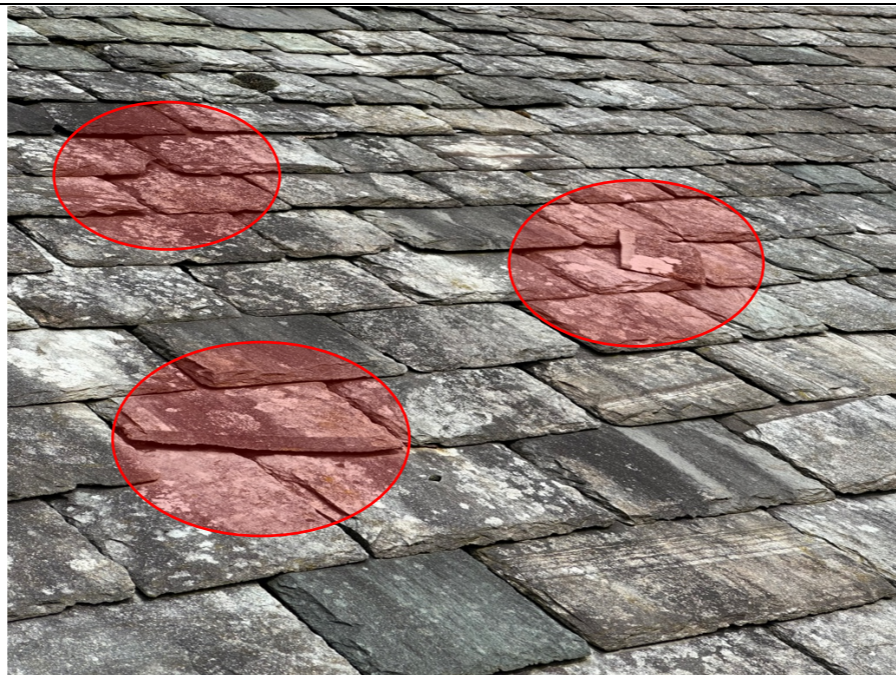
016 – Image of additional broken roof slates to the rear addition roof slope.

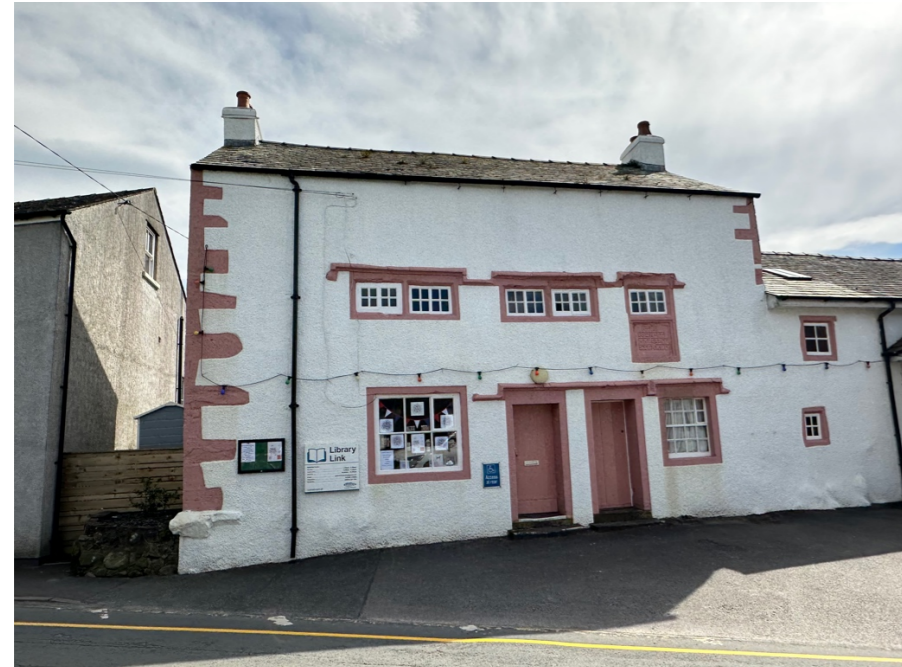
017 - General elevation of the traditional older building, all under a dual pitched natural slate roof covering, small timber framed windows, rendered walls and painted stone detailing. North West orientation.

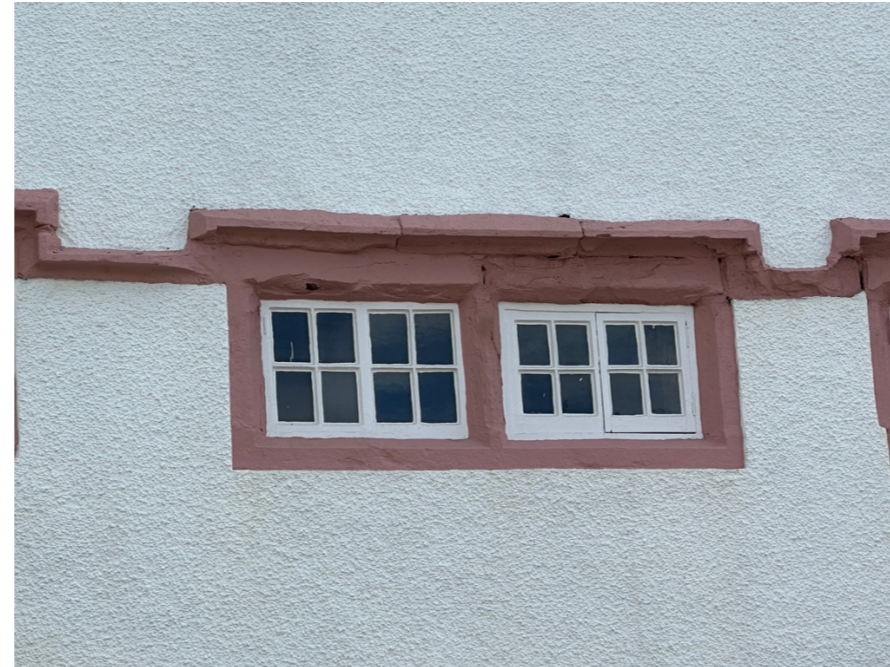
018 – Central pair of timber windows with 1 No. opening light at first floor level, divided by a natural stone mullion. Detailing generally includes projecting natural stone corbelling linking the 3 No. window positions at this level and a projecting cloak moulding above the actual window openings to cast rain water away from the structure.

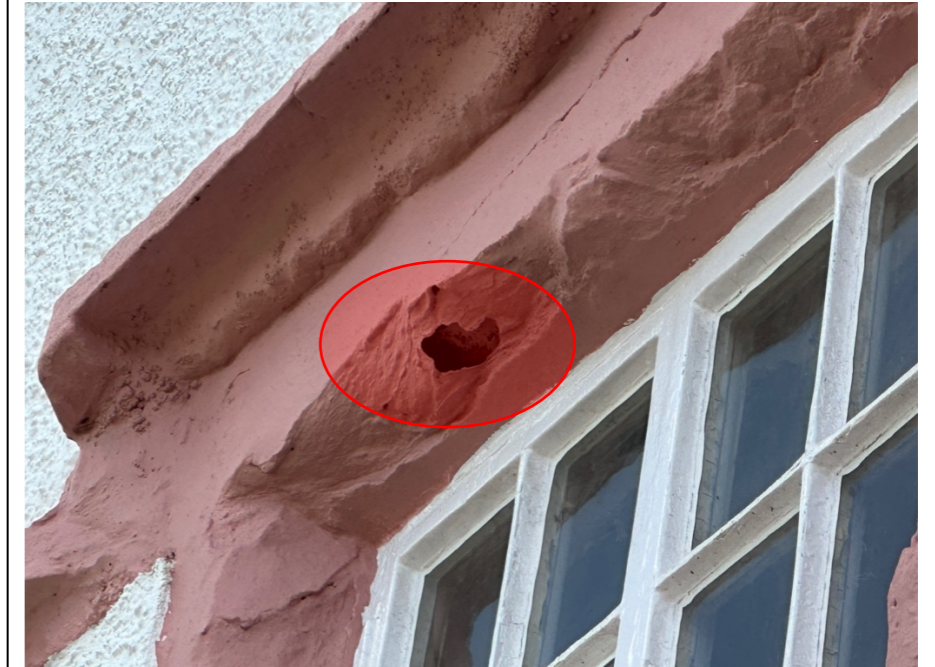
019 – The presence of the cement render will be contributing to the clear deterioration and general degradation of the natural stone mouldings to the elevation (typically sandstone). Despite being painted the stone detailing will be holding water which will be tracking through the stone, which consequentially will be causing the lamination of the stone and the break down of the painted surface finish.

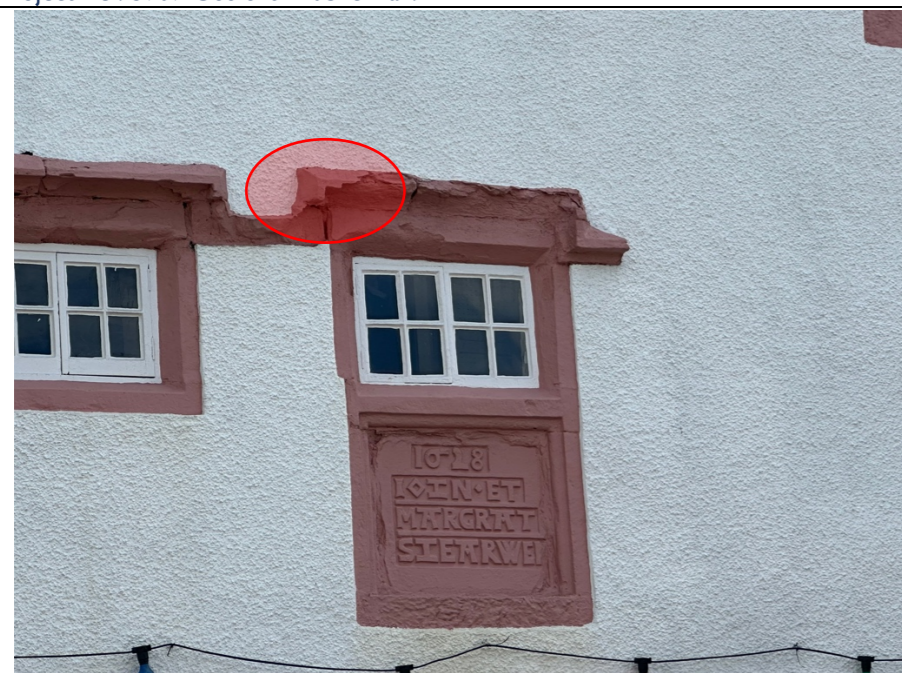
020 – Extensive deterioration of the natural stone cloak moulding to the end window and date stone combination. Further evidence of discoloured render around the opening also. Refer to photo's 021 and 022.

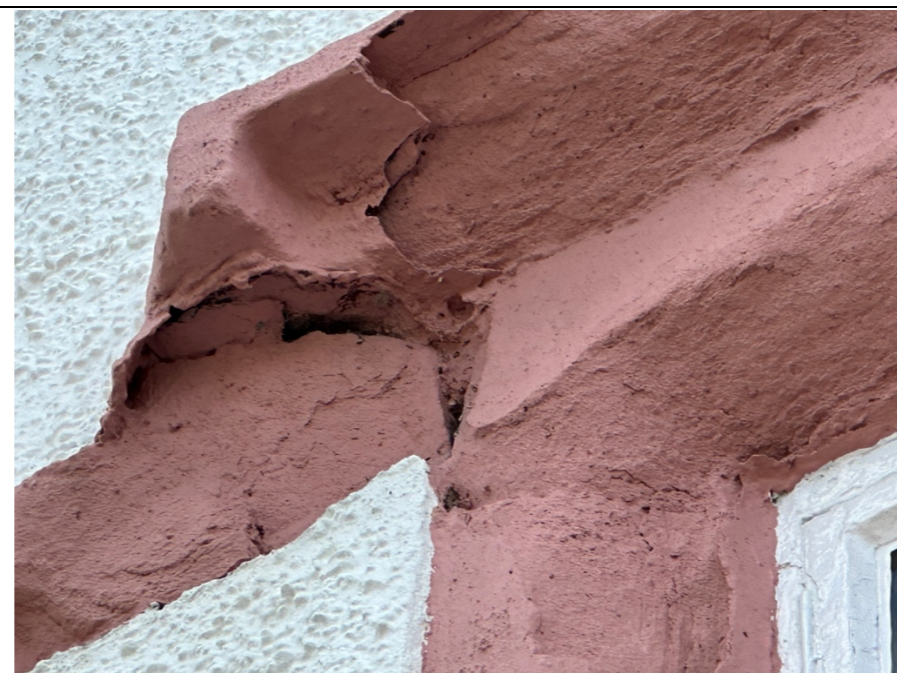
021 – The extent of deterioration to the natural stone moulding is believed to be beyond repair, as too much of the material has been lost. Repair would always be the first option to consider when dealing with Listed and historical buildings as the premiss is always wherever possible to conserve the original fabric of the building.

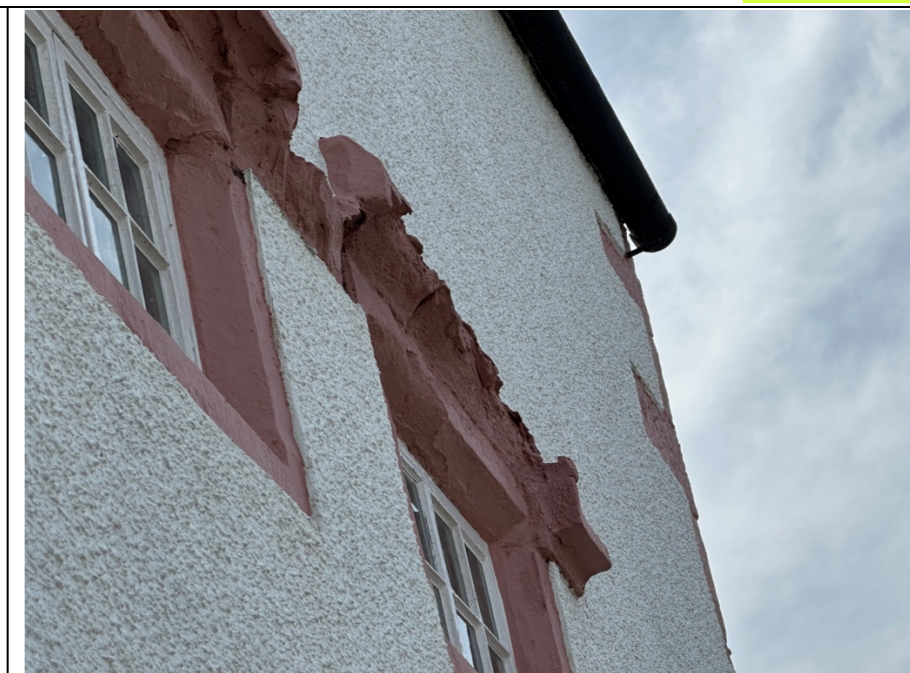
022 – Image of the window opening and detailing identified in image 020, it is clear that more than 50% of the original fabric of the cloaked moulding has been lost and that which remains is in a deteriorating and friable condition.

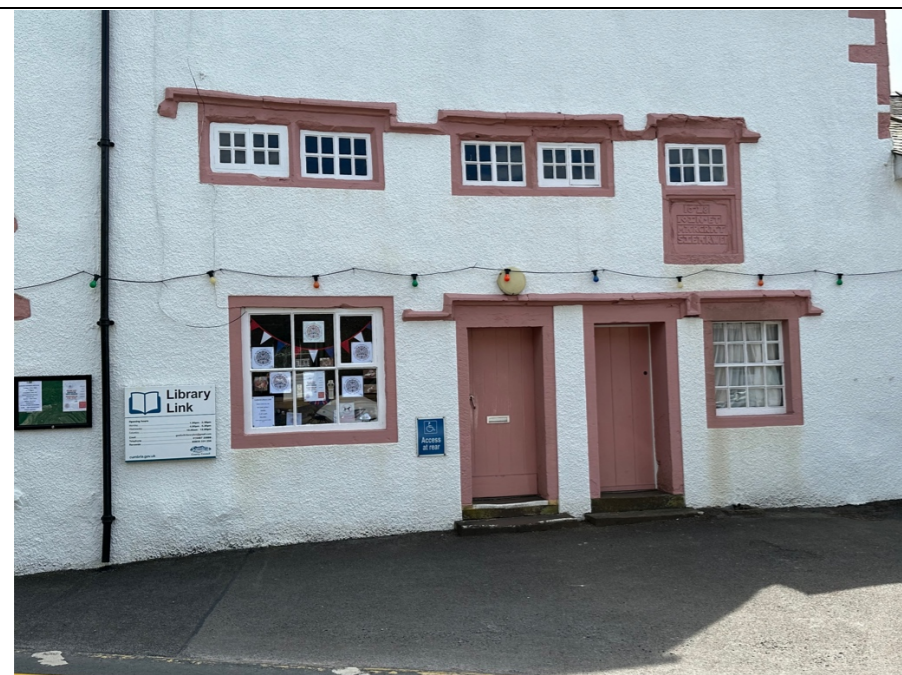
023 – General photo of the front elevation with clearer imagery of the areas of discoloured render associated with trapped moisture and water ingress behind the rendered surface.

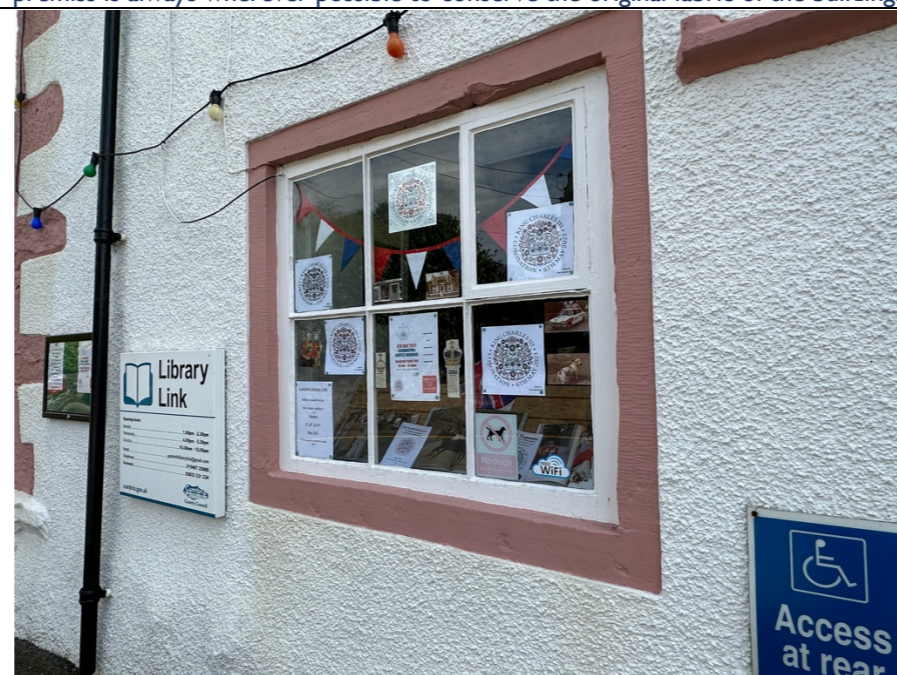
024 – Example of where the rough cast render finish has been built / up and applied to stand proud of the original sandstone detailing.

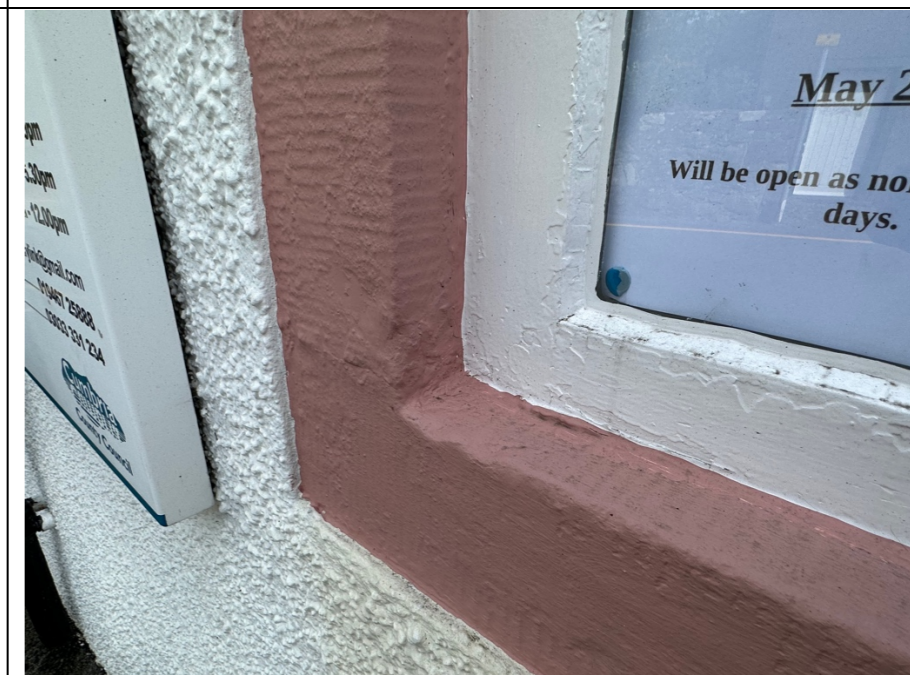
025 – Enlarged / close up image of the window opening and rendered finish identified in image 024.

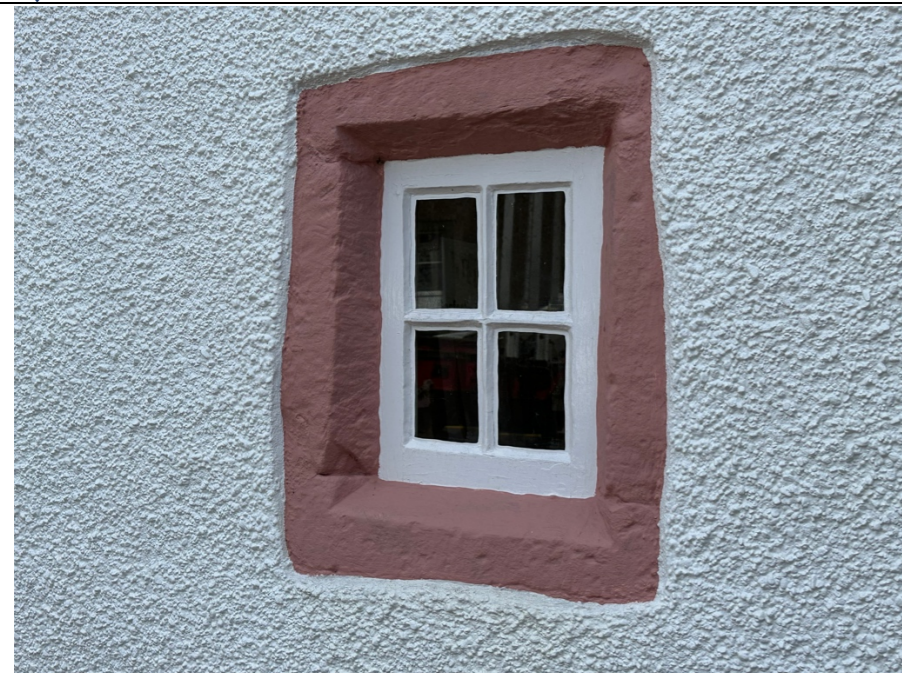
026 – Further example of the rough cast render finish to the Listed building having been brought forward of the natural stone detailing.

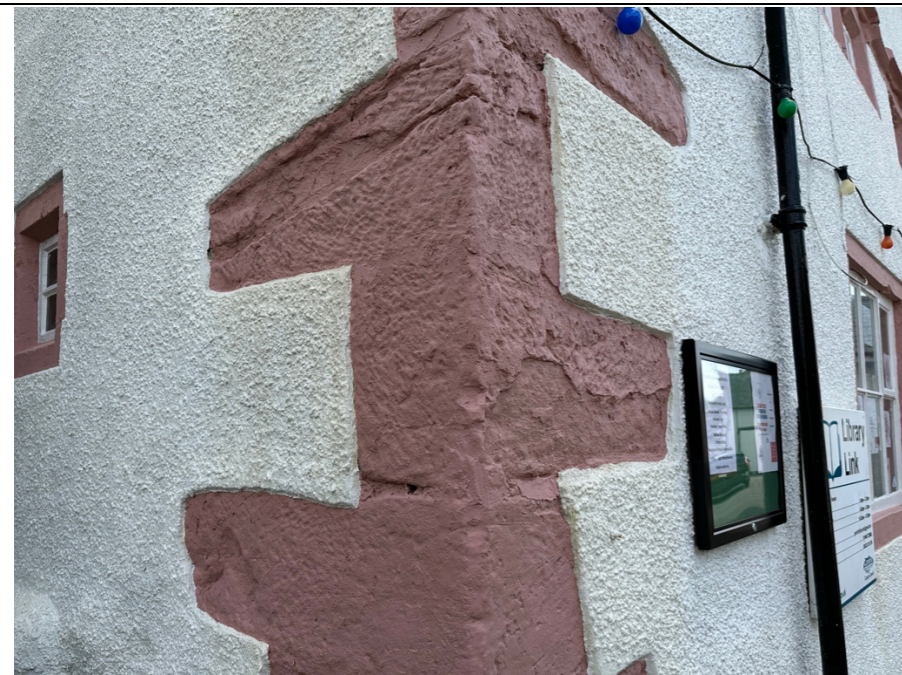
029 – As with the natural sandstone detailing external opening surrounds and the associated moulding details, the rough cast render finish has been applied / brought significantly forward of the natural stone.

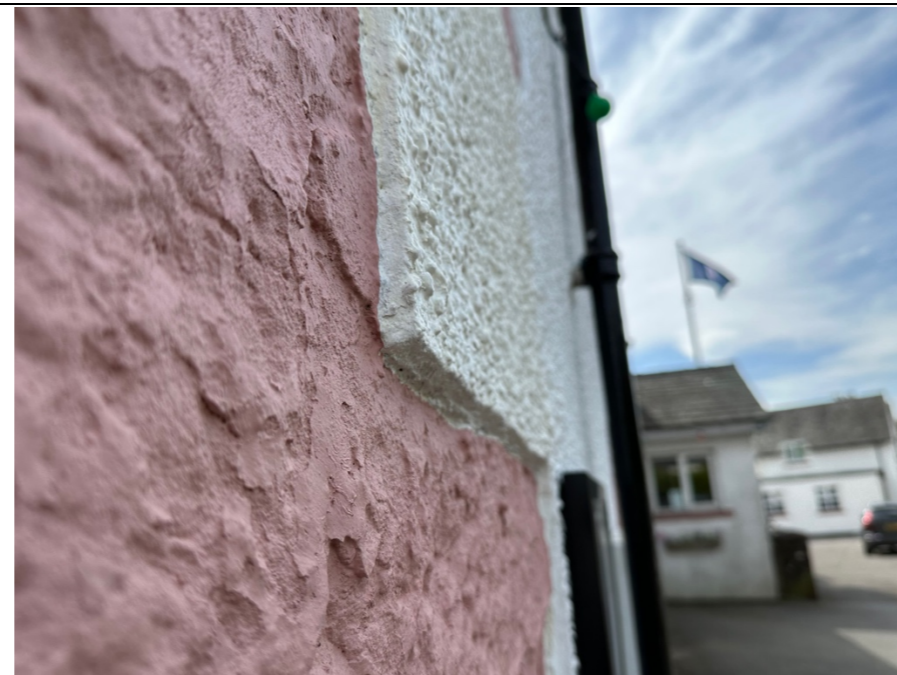
030 – A clear example of the incorrectly applied cement based rough cast render finish, which stands as much as 15mm in front of the original natural stone detailing.

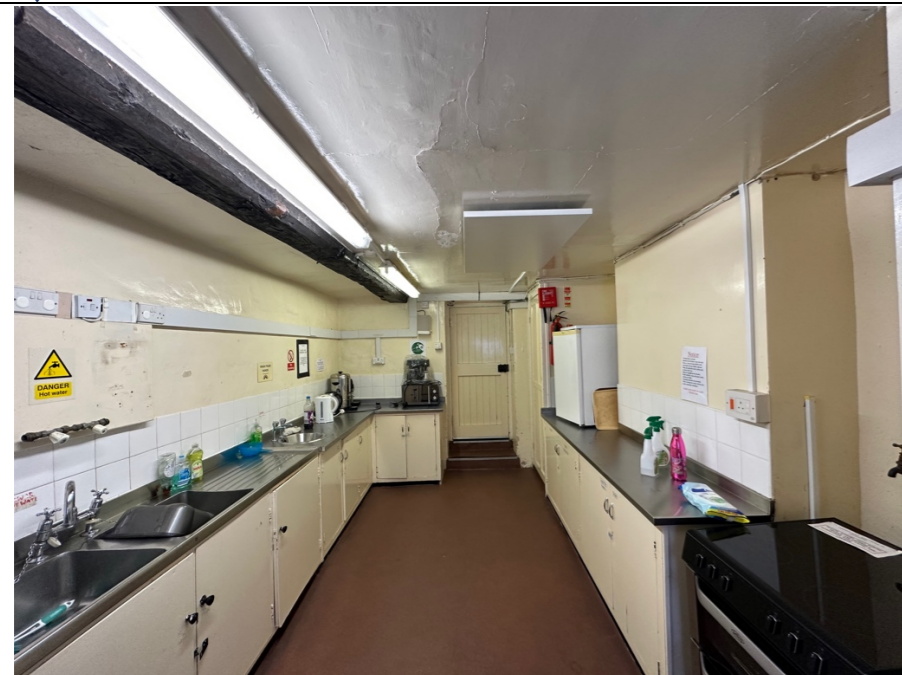
031 – Internal image of the kitchen area within the traditional Listed building, looking back toward the rear corridor which provides access to the Library area, toilets and the main hall.

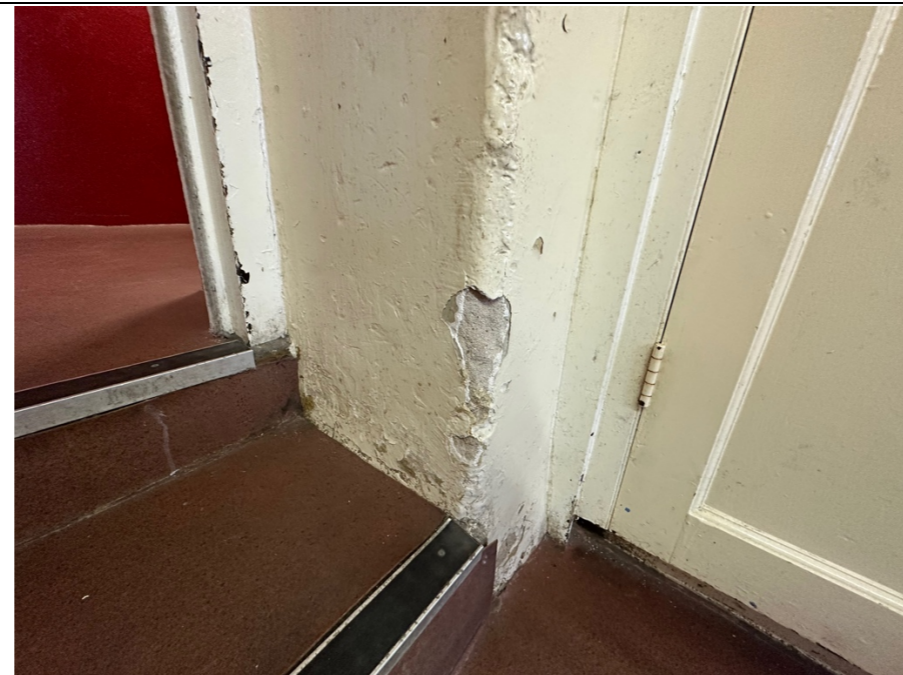
032 – Image of the door reveal between the rear corridor and the kitchen, illustrating the changes in level between the two areas.

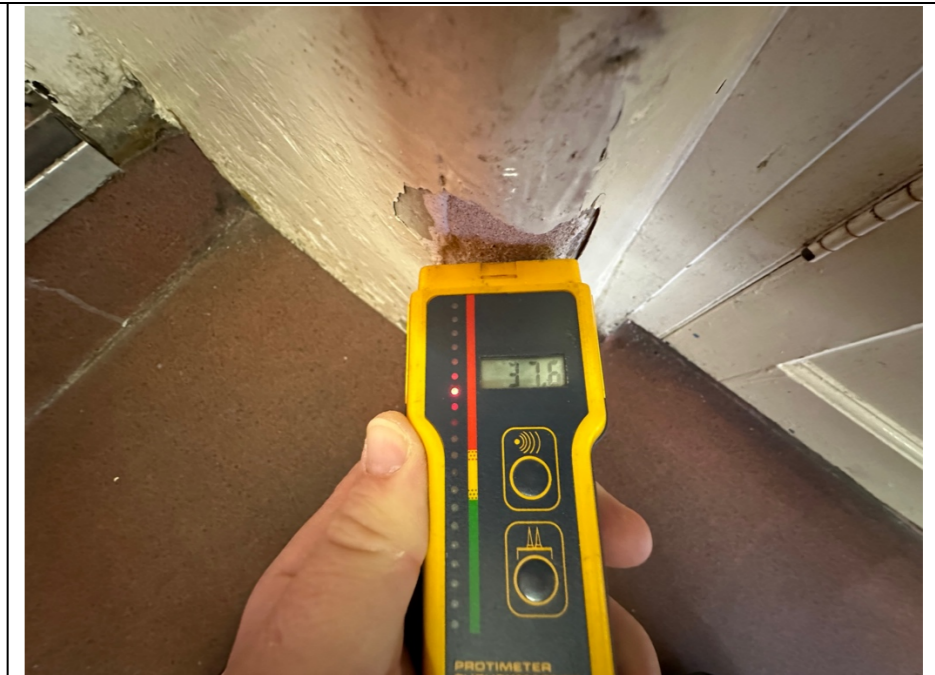
033 – Around the building a Protimeter was used to record the condition of walls and partitions in respect of moisture / damp. Readings were taken using the two pins of the Protimeter penetrating the surface of the wall / partition.

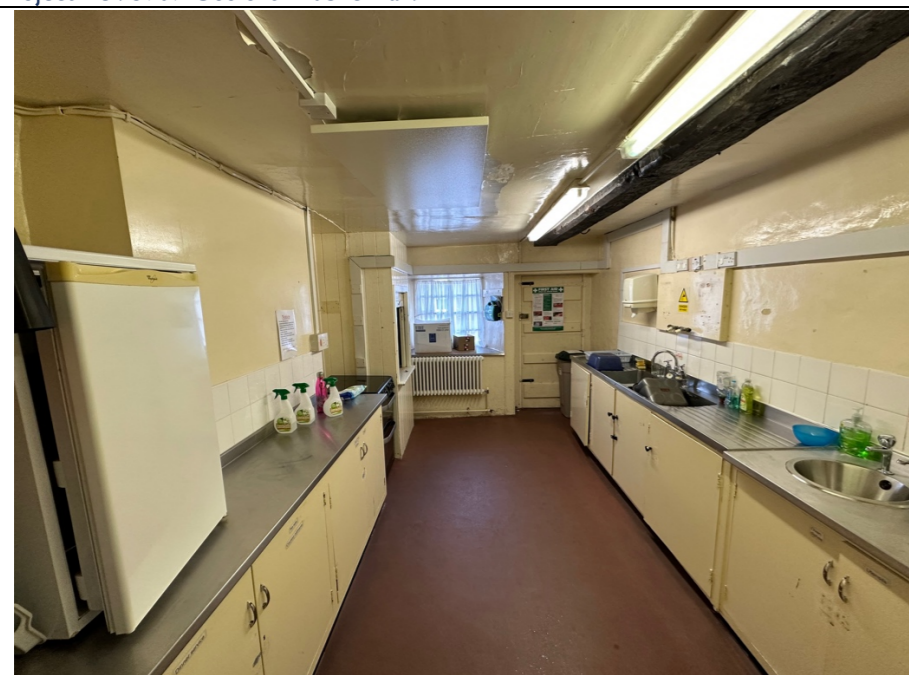
034 - Internal image of the kitchen area within the traditional Listed building, looking forward toward the front and principal elevation of the building.

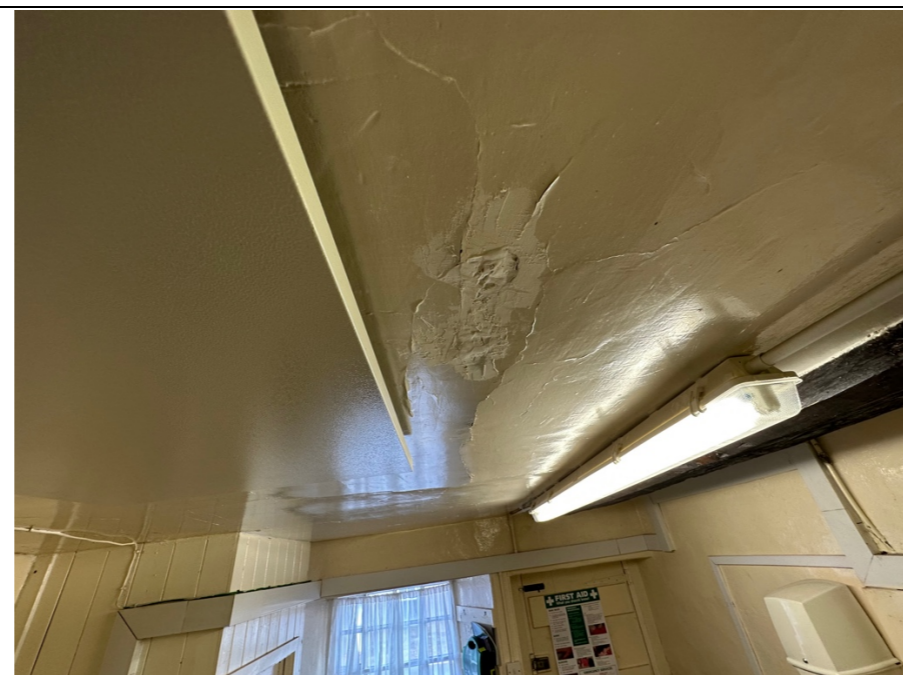
035 – Evidence of untidy and relatively unsuccessful previous repair attempts to the deteriorating kitchen lathe and plaster ceiling.

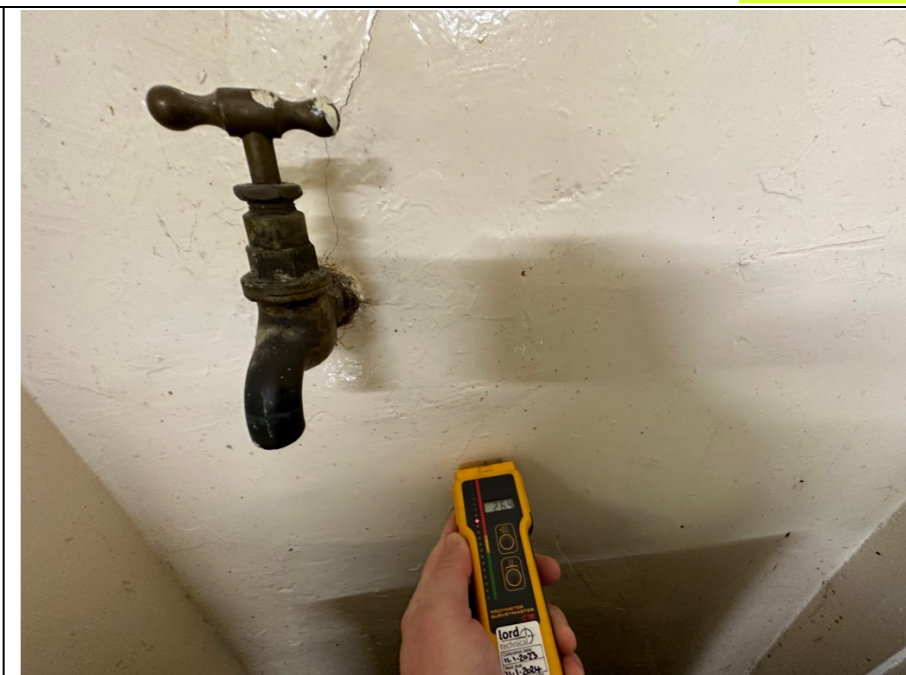
036 - In this location (adjacent to the tap) the Protimeter presented moisture levels of 26.4%. Which indicates there are issues with rising damp to the lower areas of the wall in this location.

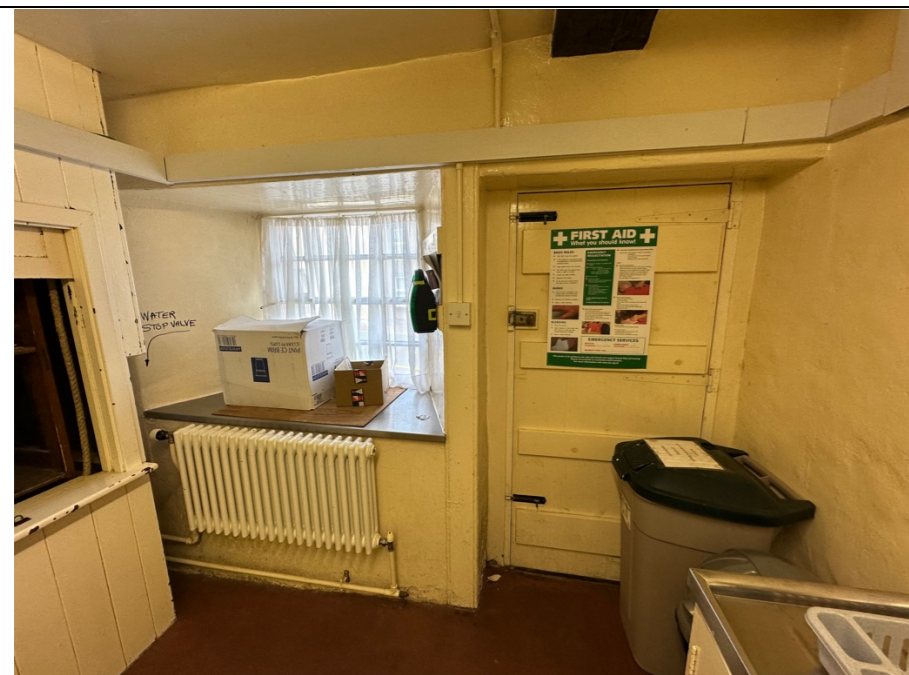
037 – View of the principal front wall of the Listed building.

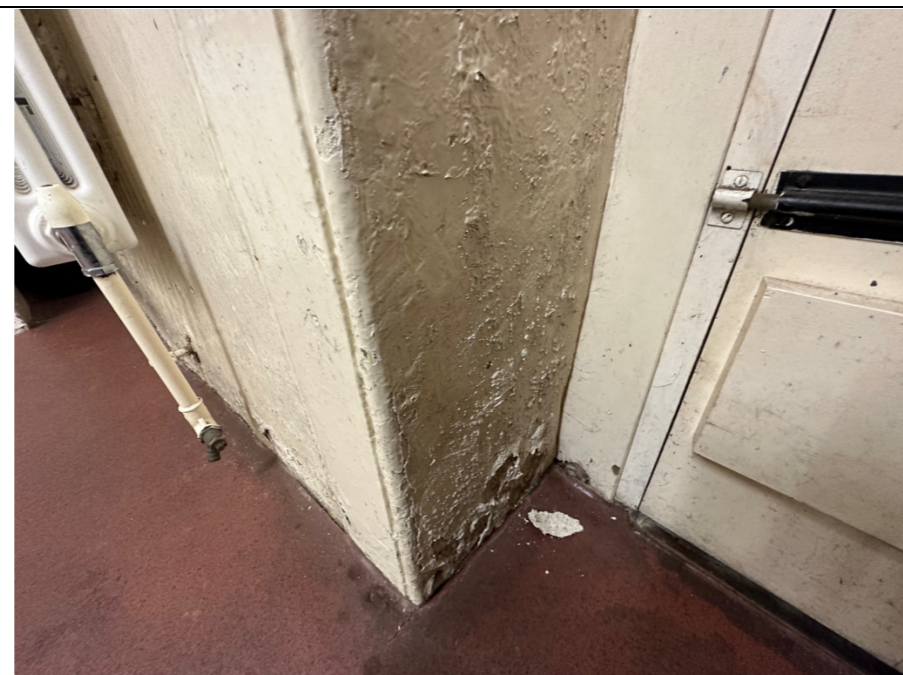
038 – Deteriorating painted (decorated) finishes to the internal wall surfaces to the front wall of the structure. Location, internal reveal to the external kitchen front door. Refer to photo 038.

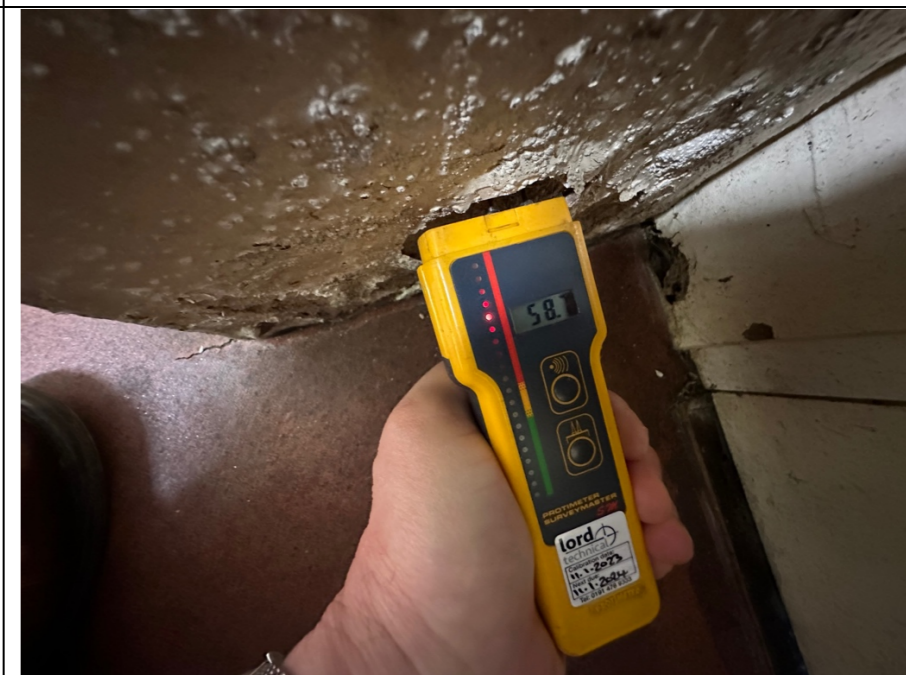
039 - In this location (adjacent to the external door) the Protimeter presented moisture levels of 58.7%. Which indicates there are issues with rising damp to the lower areas of the wall in this location and equally are possibly associated with the external render issues identified earlier..

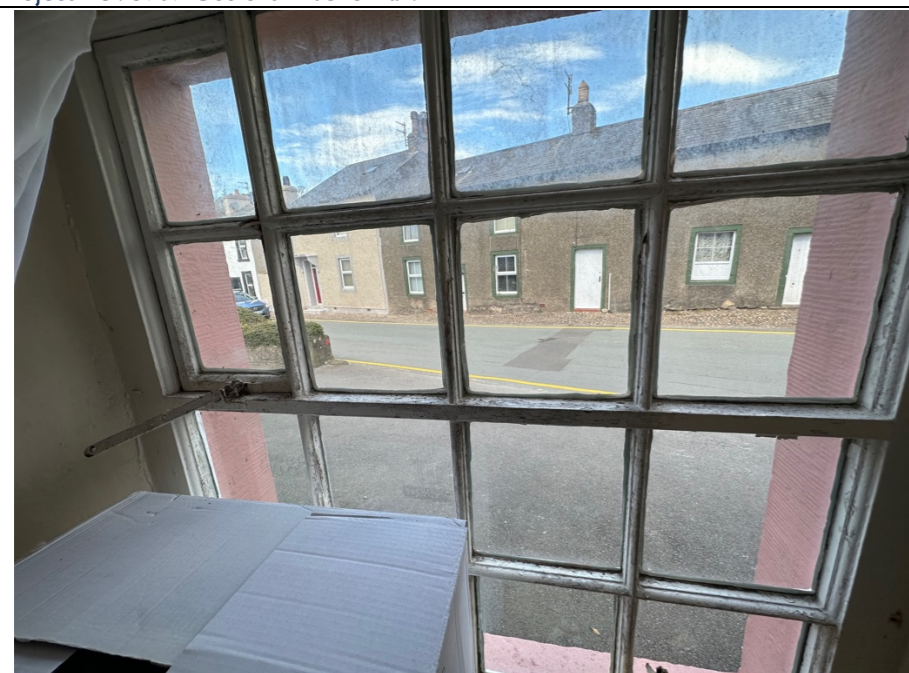
040 – Kitchen window within the principal elevation external wall. Whilst decorated externally, the internal condition of the decorations to the timber joinery is in a deteriorating condition.

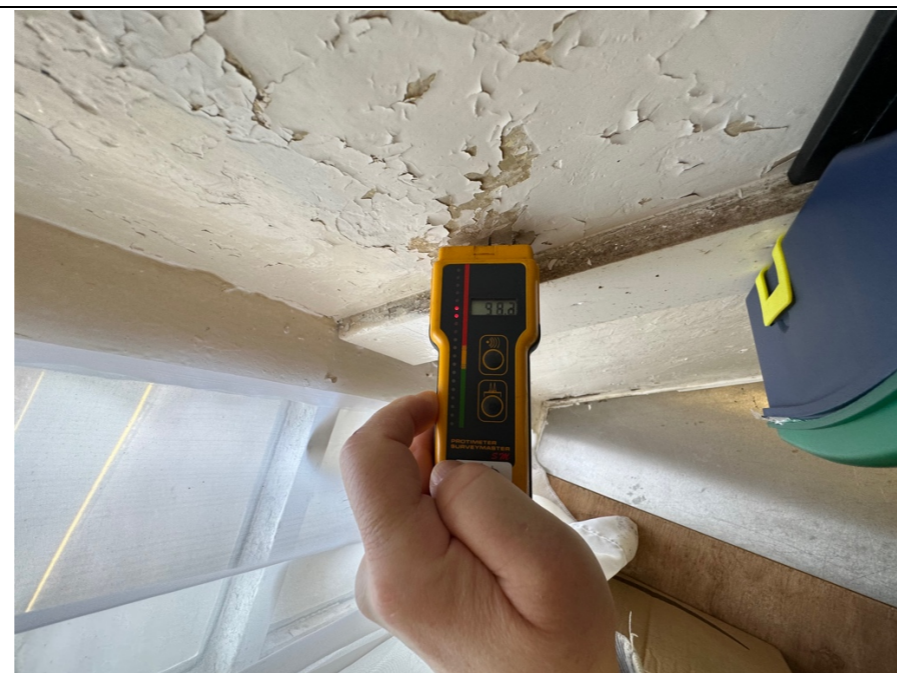
041 – Right hand internal wall reveal to the kitchen window, deteriorating condition of the decorated finishes, evidenced by the flaking paint finish.

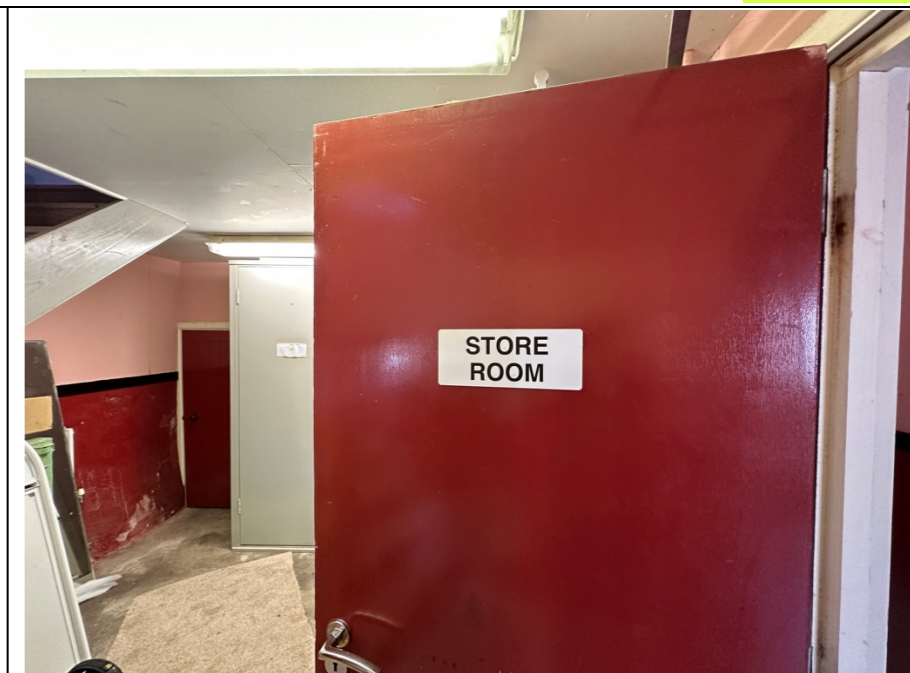
042 – General view of the ground floor store room area within the traditionally constructed Listed structure. For purposes of orientation the ground floor kitchen is to the left of this room, when viewed from this position.
