## Client Details

Gosforth Parish Council  
c/o Jacqueline Williams  
Clerk to Gosforth Parish Council  
2 Wells Cottages  
Ravenglass  
Cumbria CA18 1SP

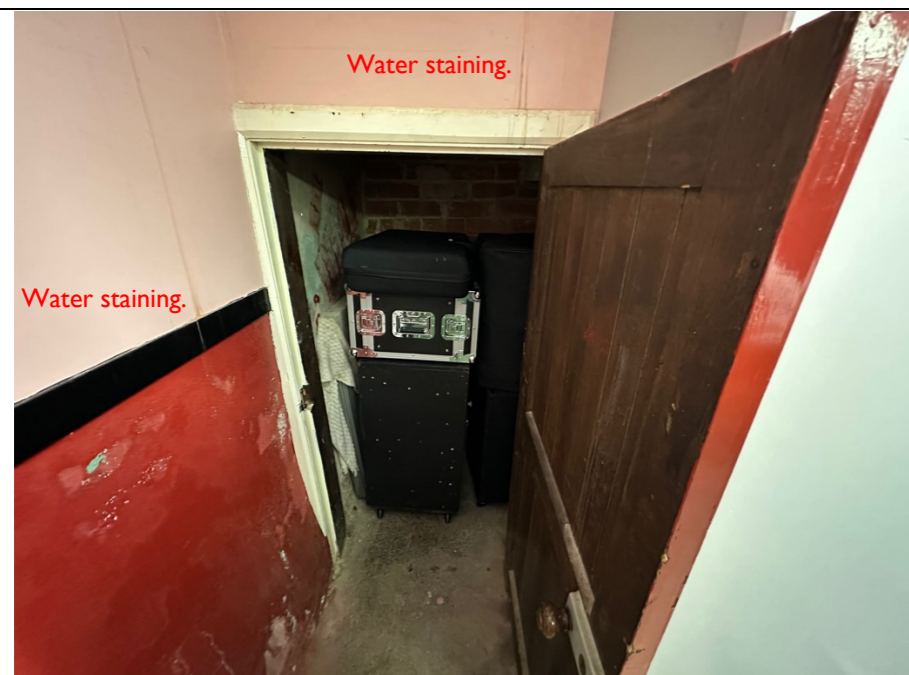
043 – Deteriorating and defective internal finishes to the internal partition walls, also presenting clear evidence of water ingress from higher levels as denoted by the water staining to the walls.

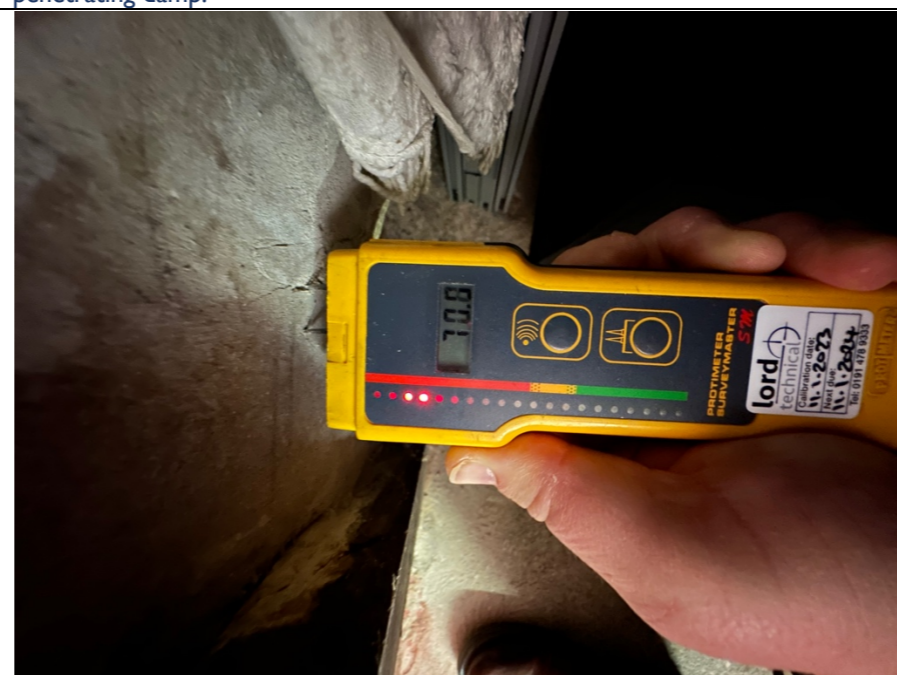
044- Protimeter reading taken within the internal store cupboard.

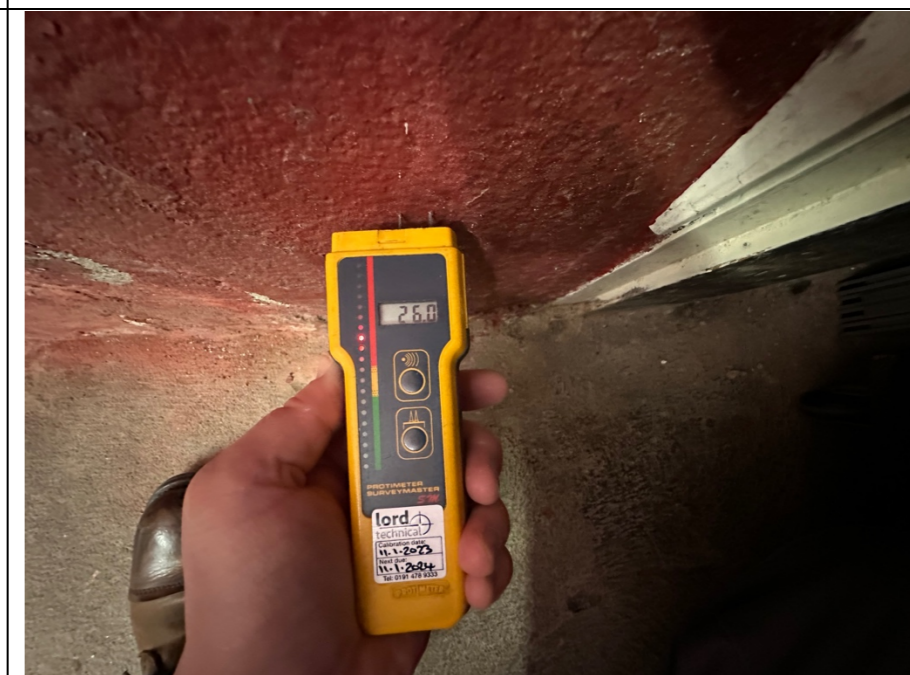
045 – Protimeter reading taken outside the internal store cupboard.

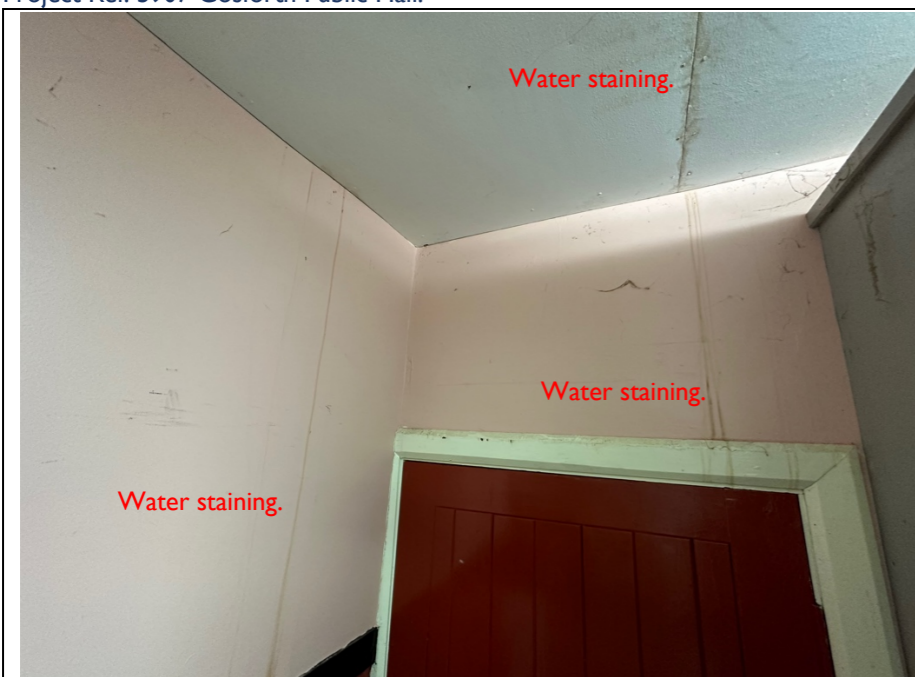
046 – View at a higher level of the door and associated walling / ceiling to the internal store cupboard ( refer to photo 043) with clearer evidence of the water staining and its affects on the wall and ceiling finishes. The unprepared finishes of the ceiling suggests that a repair has occurred in recent times, however the presence of the water staining would suggest that any repairs to resolve the issue with water leaks has been unsuccessful.

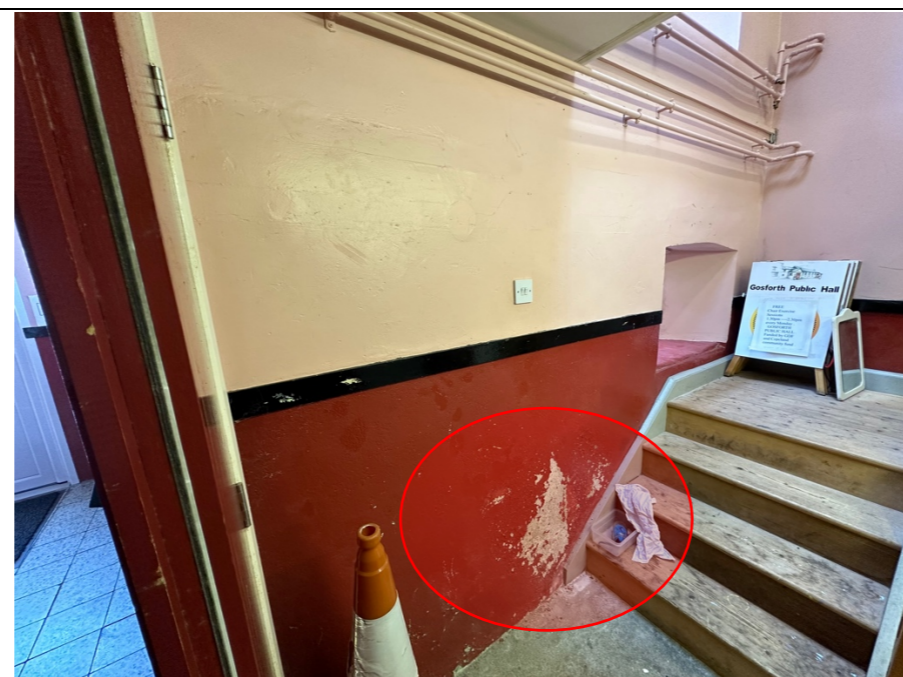
047 – Principal front wall of the traditional structure.  
Note: The deteriorating finishes at the base of the front wall.

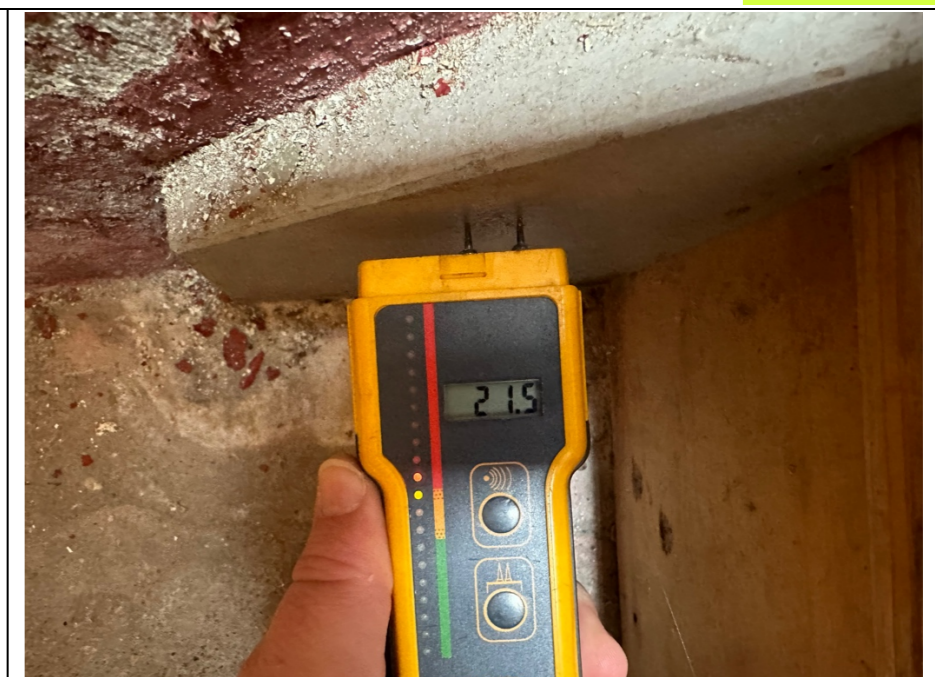
048 – Timber string of the internal staircase providing access to the first floor storage area (Refer to photo 047).  
In this location (timber staircase stringer) the Protimeter presented moisture levels of 21.5%. As this reading was taken directly from a timber element of the building, the 21.5% moisture level is a matter for concern in respect of issues with rot.

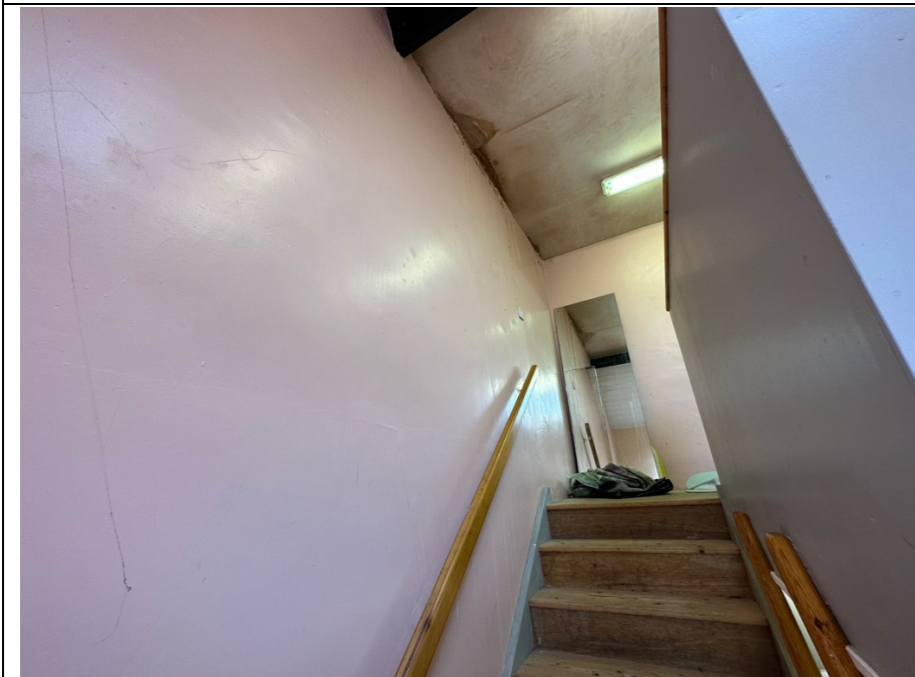
049 – View from the ground floor of the store room looking up to the upper first floor level.  
Note: the heavy water staining and discolouration of the ceiling at first floor level.

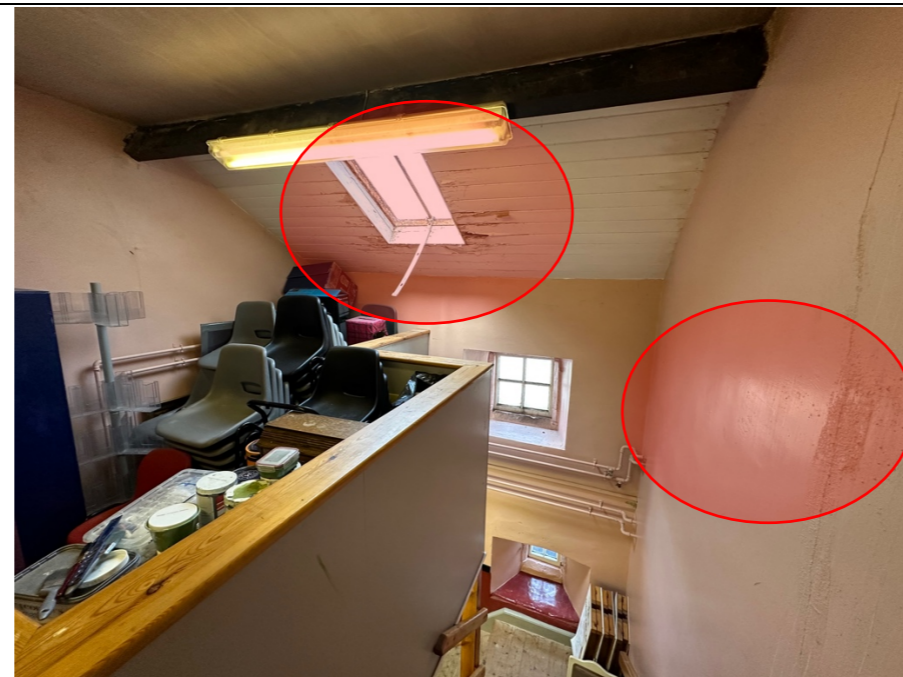
050 – General view of the first floor storage level, looking toward the front principal elevation.  
Note: Signs of water damage and deterioration of the panelled sloping ceiling area around the rooflight. Signs of water damage and surface disruption to the internal wall finishes, associated with water ingress (RHS of photo).

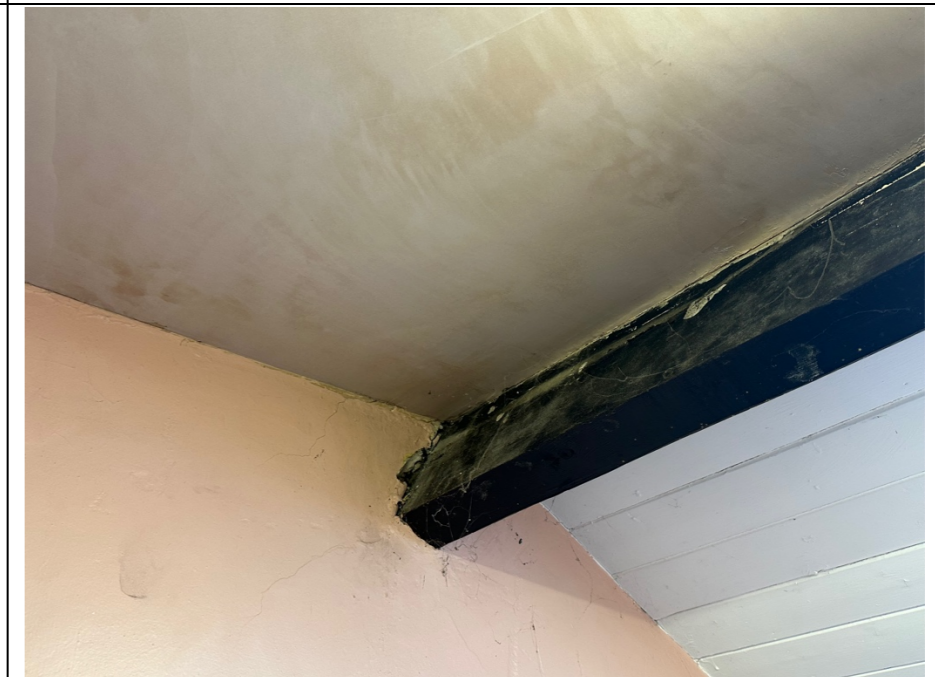
051 – Image of the recently plastered ceiling area to the left hand side of the rooflight.  
Note: There is a discolouration and unevenness to the new plaster, indicative of the area retaining moisture and suggesting any repairs undertaken to resolve water ingressions have not been entirely successful.

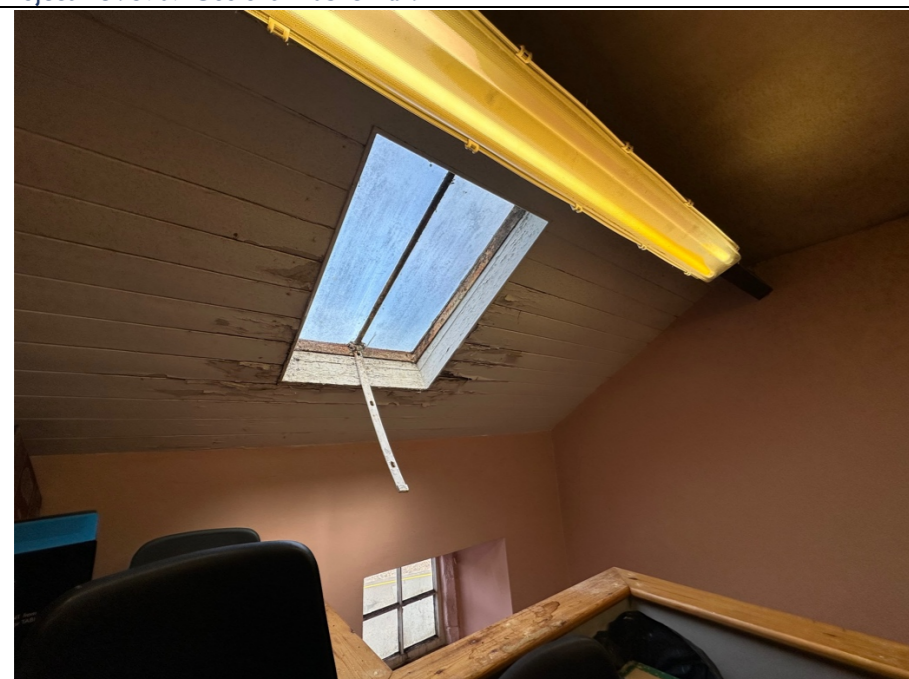
052 – General distortion in the alignment of the panel boarding to the sloping ceiling and a deterioration in the decorative finishes. Corrosion of the rooflight may be historical, but indicative that internal maintenance of this area has not been a priority. It is believed that issues with water ingress connected to the defective slate roof covering and also potentially the rooflight are contributing to the general deterioration of this area.

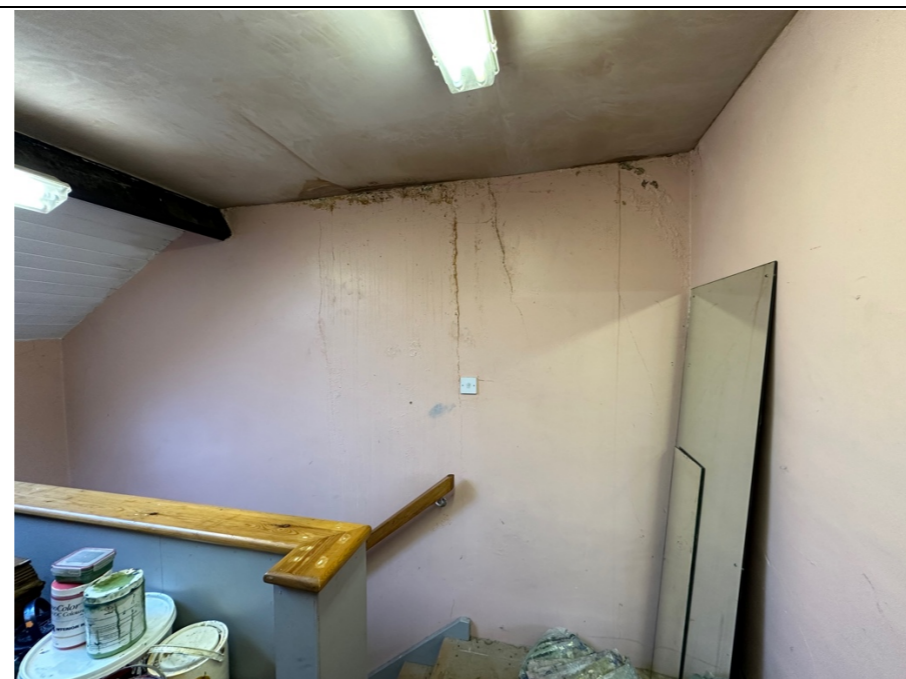
053 - Image of the recently plastered ceiling area above the staircase.  
 Note: There is a discolouration and unevenness to the new plaster, indicative of the area retaining moisture and suggesting any repairs undertaken to resolve water ingressions have not been entirely successful.  
 The tracking of running water down the internal face of the wall is also connected to the water ingression issues identified in photo's 043 – 046.

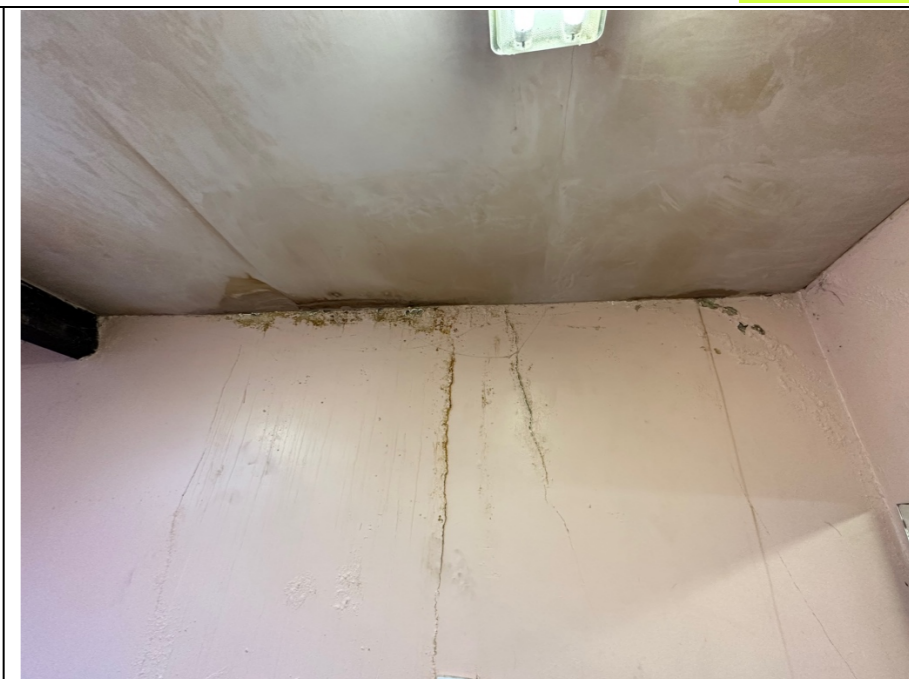
054 - Image of the recently plastered ceiling area above the staircase.  
 Note: There is a discolouration and unevenness to the new plaster, indicative of the area retaining moisture and suggesting any repairs undertaken to resolve water ingressions have not been entirely successful.  
 The tracking of running water down the internal face of the wall is also connected to the water ingression issues identified in photo's 043 – 046.

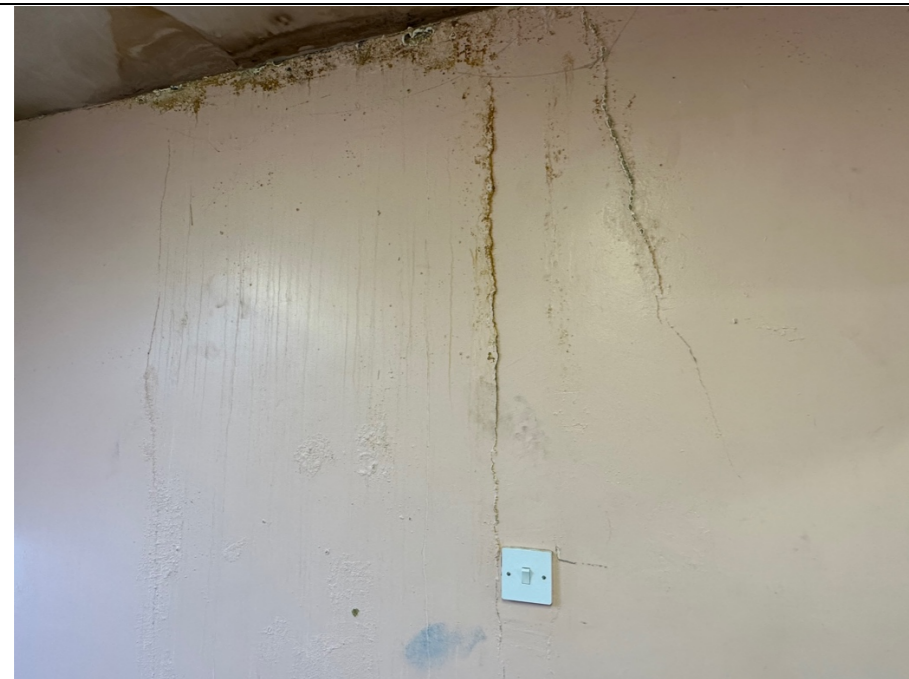
055 - Image of the recently plastered ceiling area above the staircase.  
 Note: Further investigation required, which may entail destructive works to expose the potential ingress point and to also inform on the condition of the timber roof structure, which will have been exposed to penetrating water for some time.

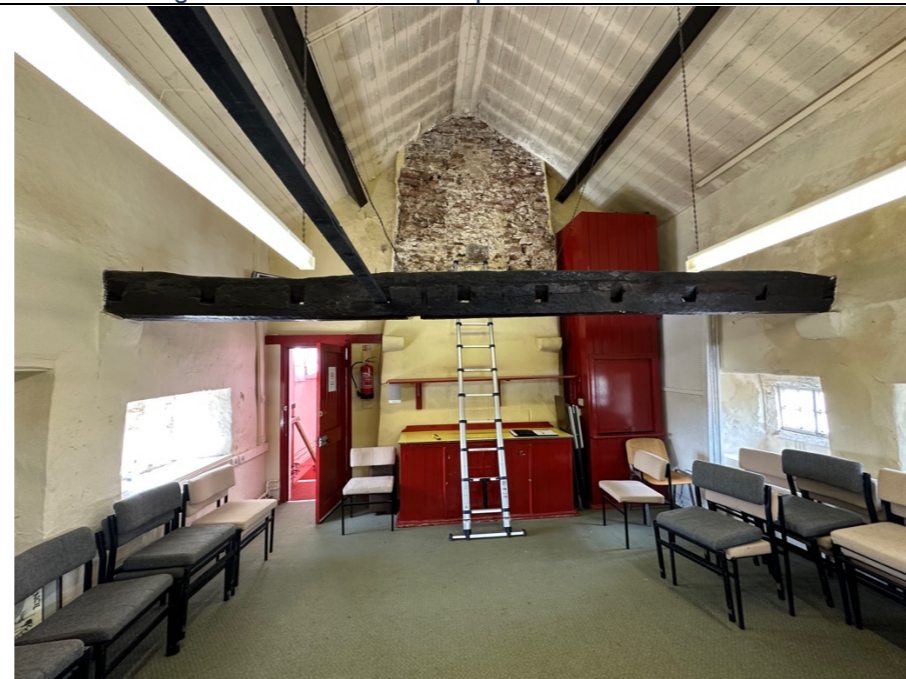
056 – General view of the first floor meeting room within the traditional constructed Listed building. Looking toward the South West gable end wall and the chimney stack identified in photo's 004 – 006. Evidence of recent work to dry out the chimney breast by way of removing the internal plaster finishes.

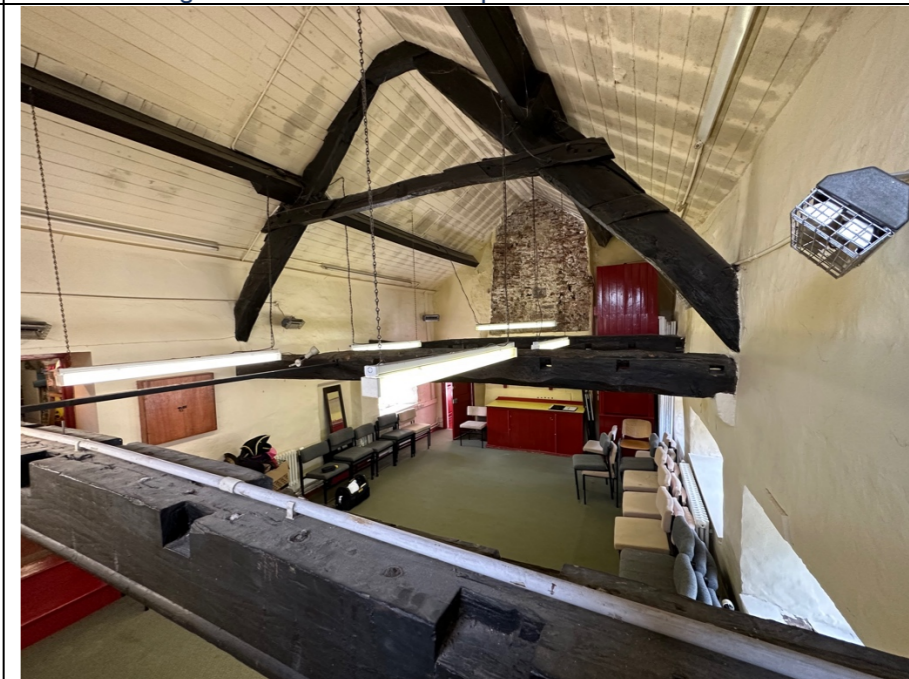
057 – General view of the first floor meeting room within the traditional constructed Listed building. Note the extensive discolouration to the timber panelling under-drawing the vaulted ceiling to the meeting room. This discolouration and marking is associated with the failing condition of the external slate roof covering and also indicates (as would be expected) a lack of insulation within the roof structure itself.

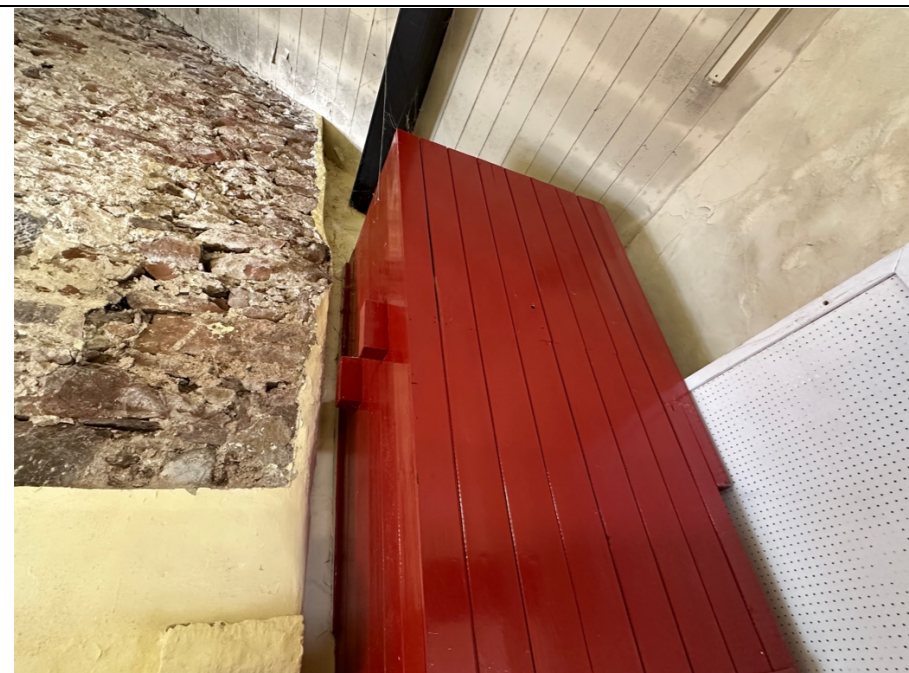
058 – Right hand side of exposed masonry to the chimney breast structure identified in photo 056.  
 Note: Evidence of structural movement and bowing to the right hand side reveal of the structure.  
**Recommend** services of a structural engineer to inspect and report on any necessary remedial structural repairs required to stabilise structure.

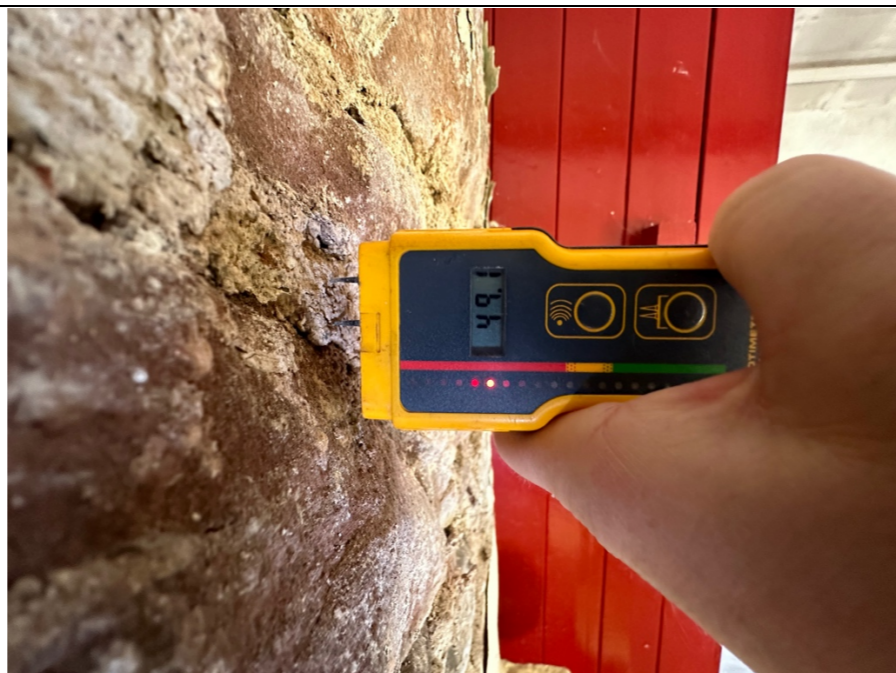
059 - Exposed masonry to the chimney breast structure identified in photo 056.  
 In this location (chimney breast) the Protimeter presented moisture levels of 49.1%.

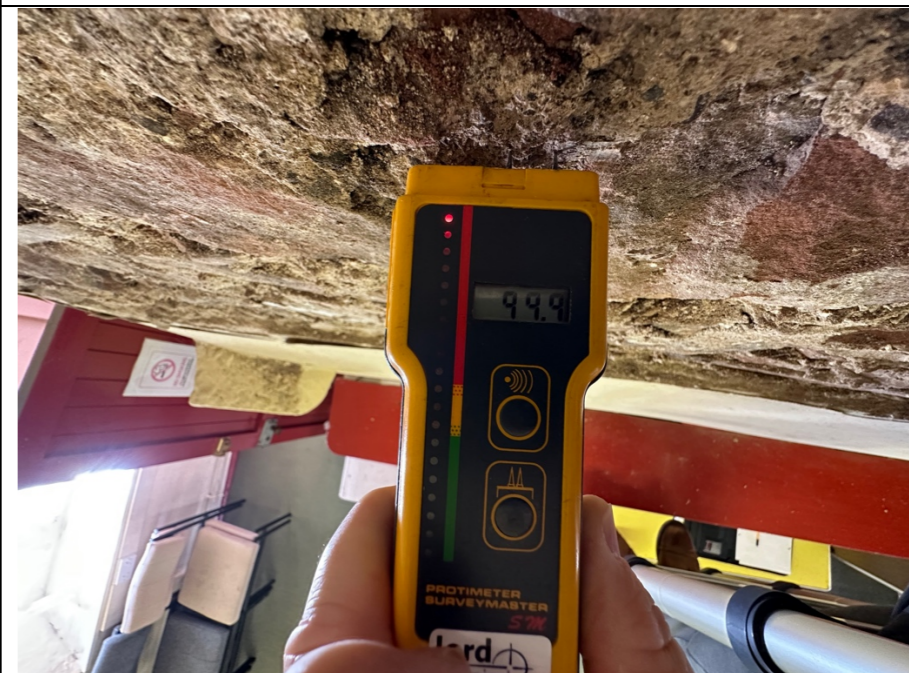
060 - Exposed masonry to the chimney breast structure identified in photo 056.  
 In this location (chimney breast) the Protimeter presented moisture levels of 99.9%. Indicating almost full saturation of the structure.

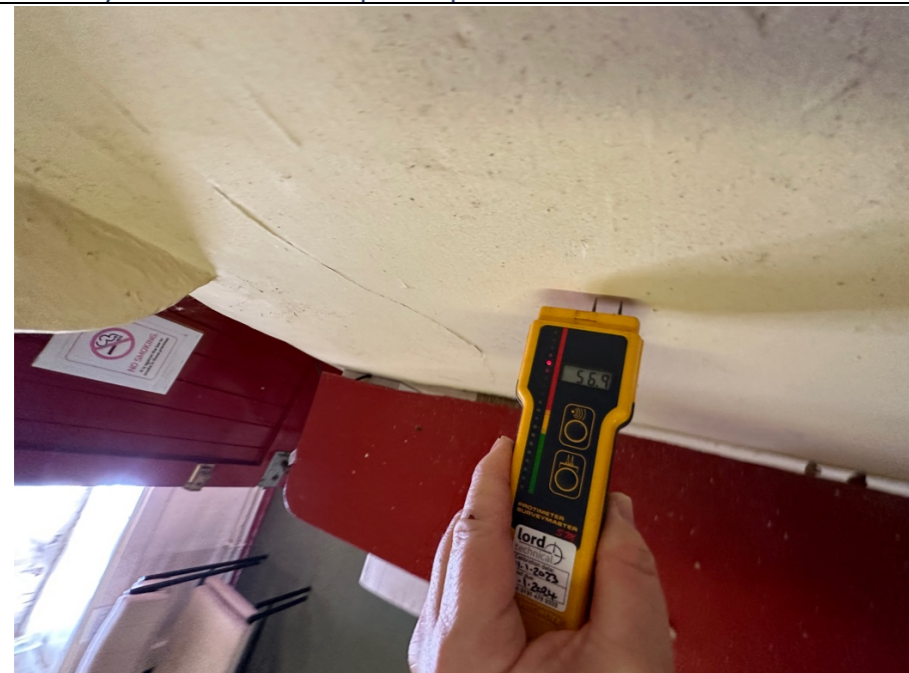
061 - Plastered masonry to the chimney breast structure identified in photo 056.  
 In this location (chimney breast) the Protimeter presented moisture levels of 56.9%.

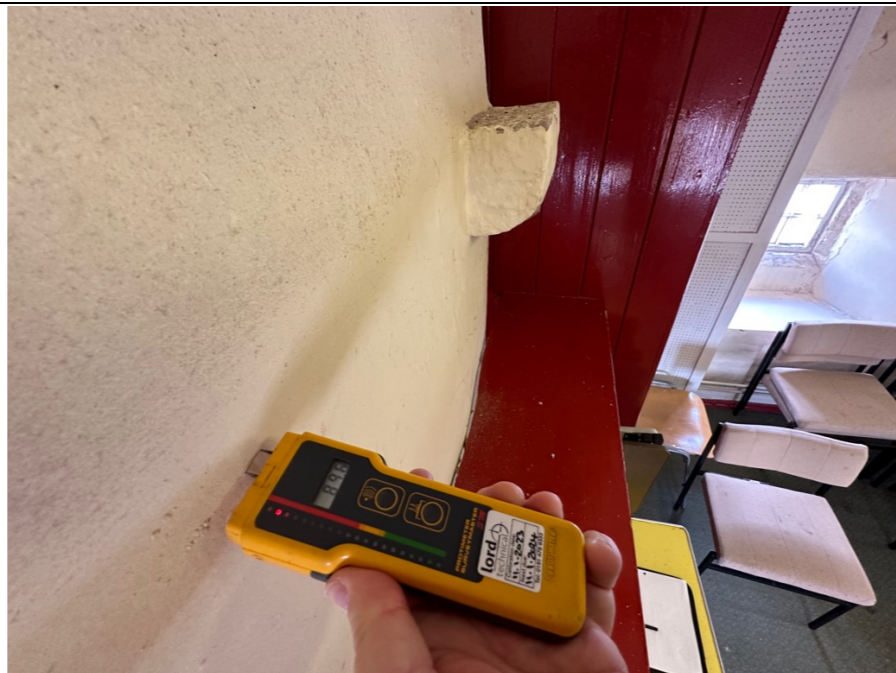
062 - In this location (chimney breast) the Protimeter presented moisture levels of 89.6%. Indicating almost full saturation of the structure.

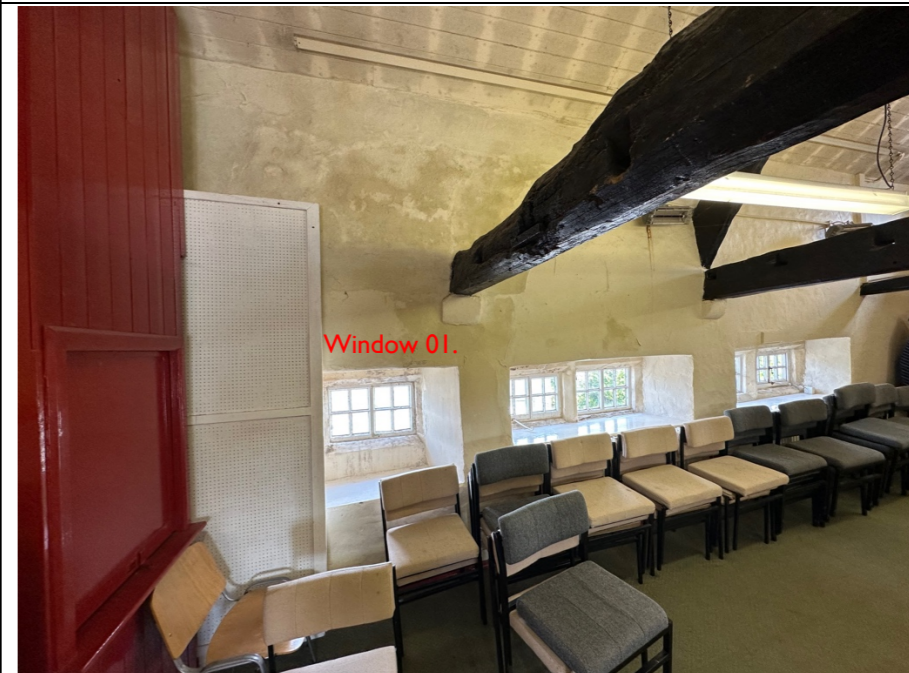
063 – View of the principal front elevation to the traditionally constructed Listed building. There is extensive discolouration and staining to the internal plastered wall finishes.

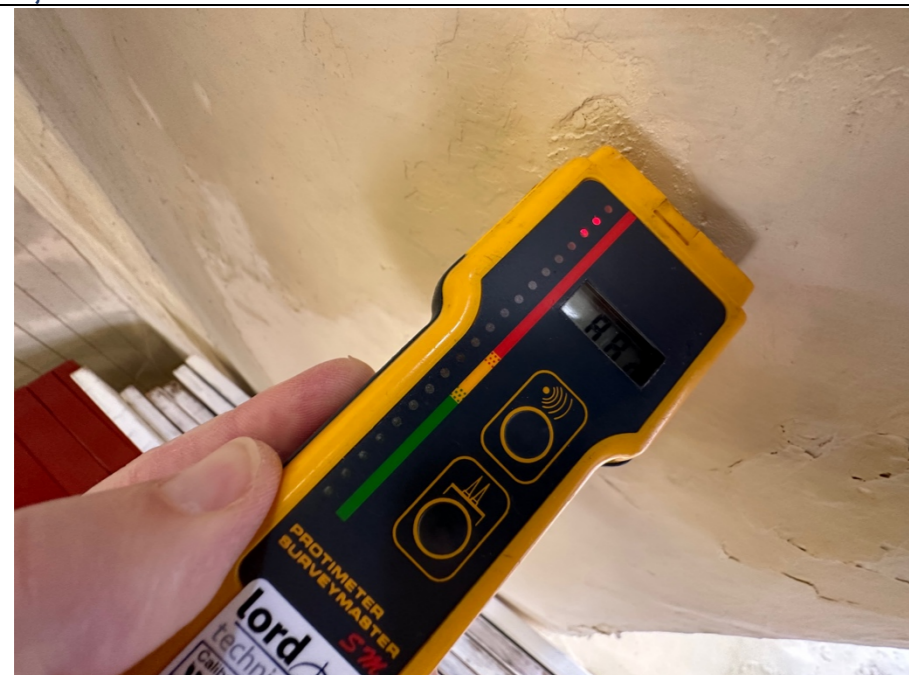
064 – Image of the principal front elevation to the left hand side of window 01 along the elevation (LHS) Extensive discolouration and staining to the internal plastered wall finishes.  
In this location (front wall panel) the Protimeter presented moisture levels of 88.2%.

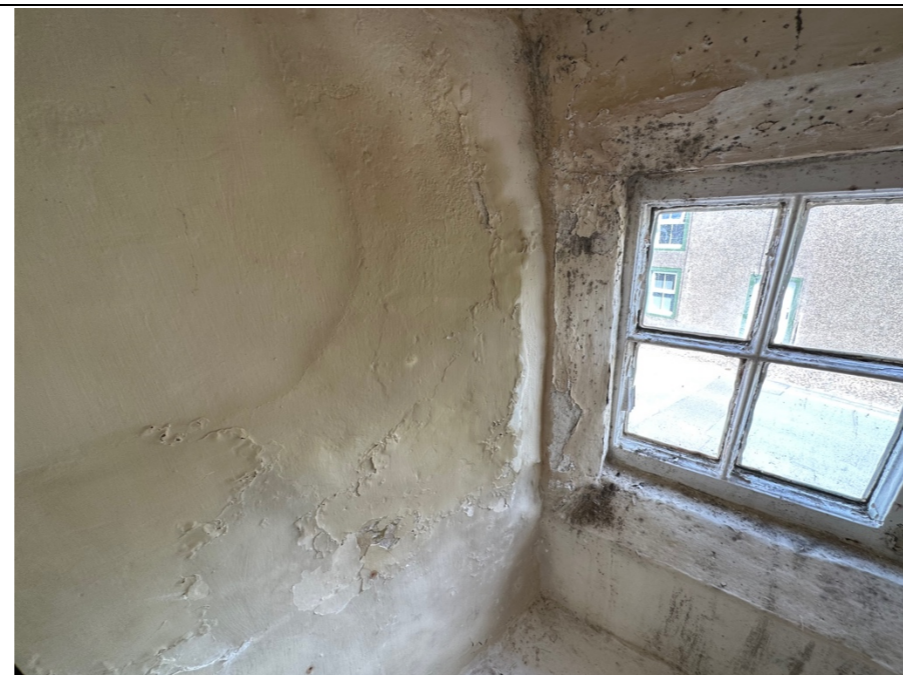
065 – Internal reveal of the window 01, extensive deterioration to both the internal wall finishes and the timber framed window joinery.

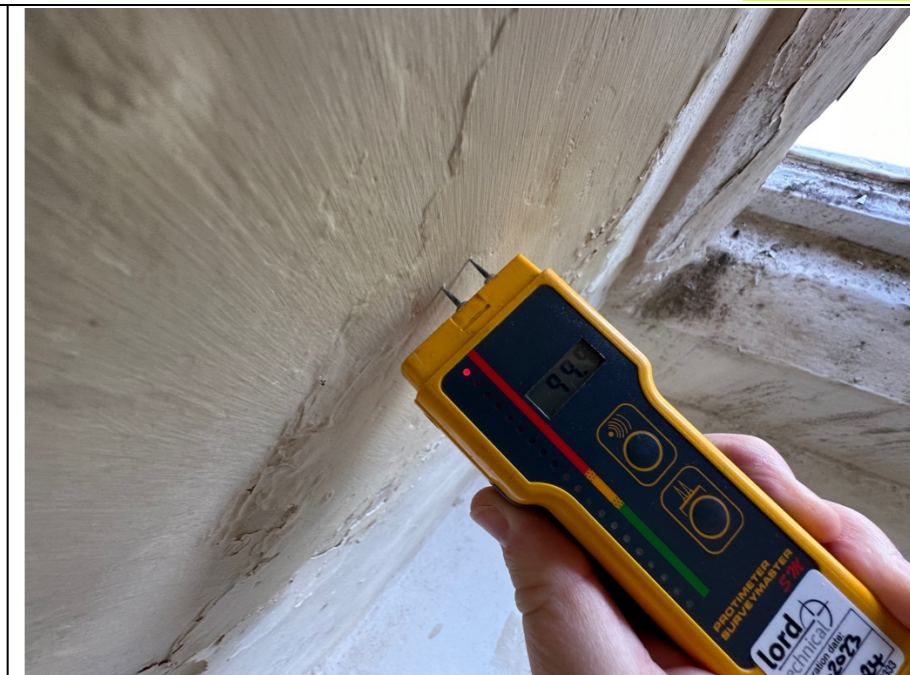
066 – Internal reveal of the window 01.  
In this location (window reveal) the Protimeter presented moisture levels of 99.9%.

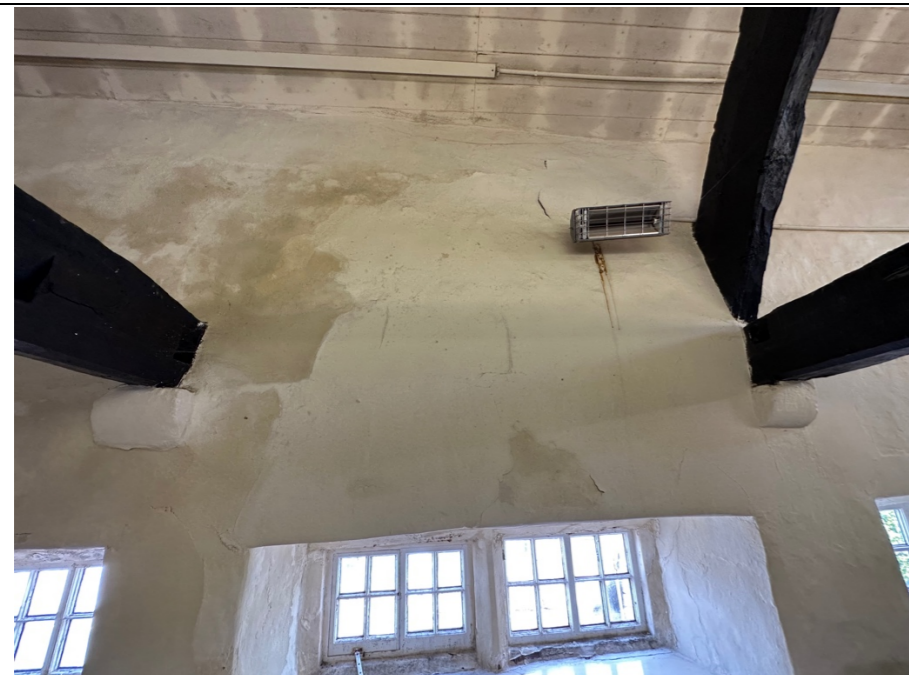
067 - View of the principal front elevation to the traditionally constructed Listed building. There is extensive discolouration and staining to the internal plastered wall finishes, across the face of the wall.

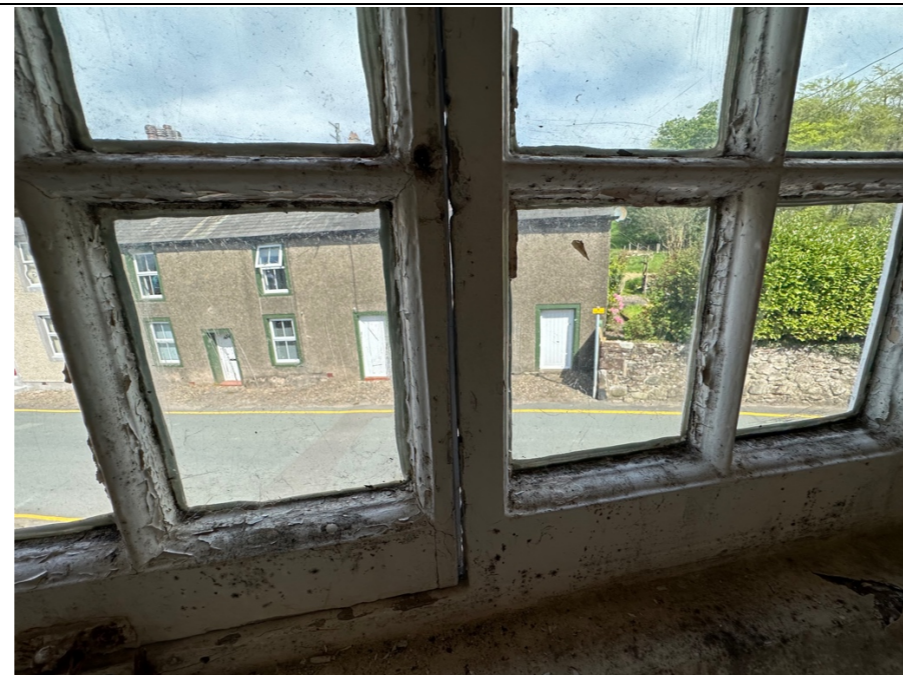
068 – Timber framed window in a poor decorative condition, evidencing of gapping between window components.  
All window joinery to this elevation is in need of an extensive overhaul and repairs.

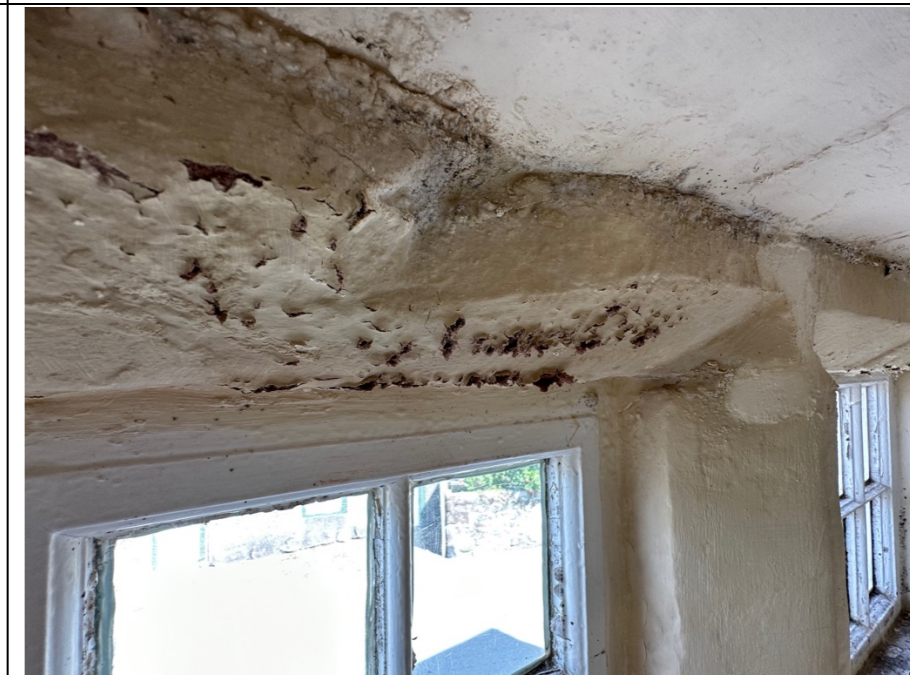
069 – Sandstone lintel above a meeting room timber framed window on principal elevation. Extensive flaking and general deterioration in the painted surface of the natural stone lintel. Evidence of water staining to surrounding finishes, related to the trapped moisture behind the external rendered wall finishes.

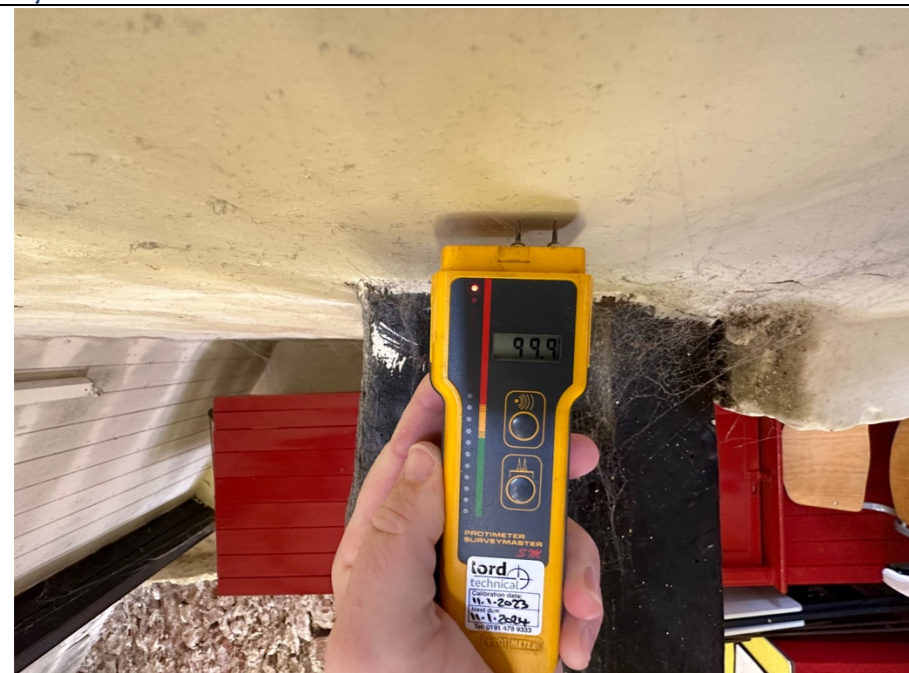
070 – Intermediate principal timber roof truss to the roof structure above the meeting hall. Truss is bearing into the principal front elevation wall.

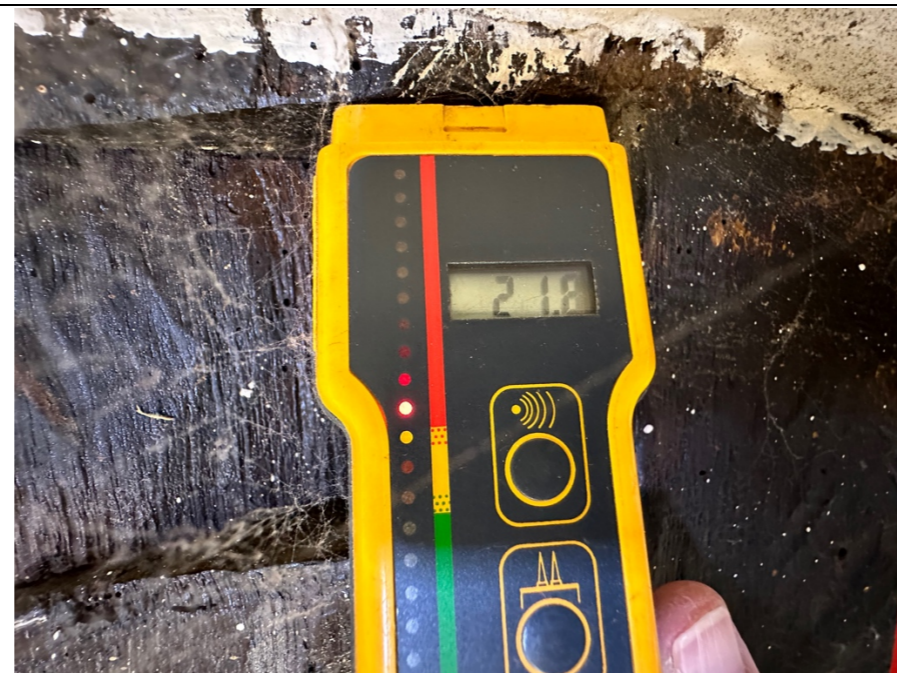
071 – Principal truss section identified in photo 070, protimeter recording the moisture level to the truss section itself within the meeting room.

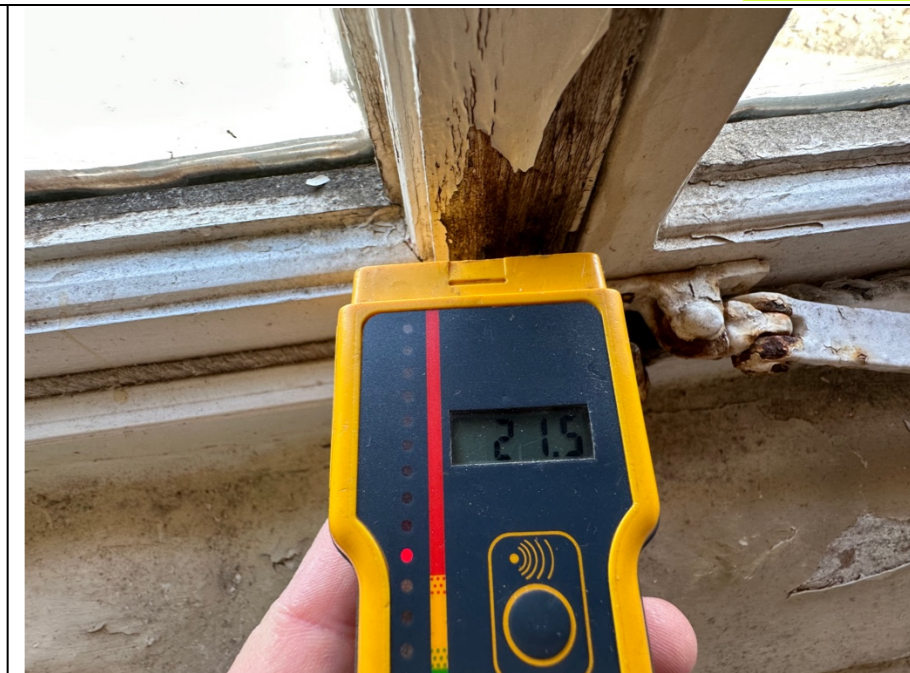
072 – Timber framing to principal elevation window. Complete breakdown and failure of the painted finishes to the framing.

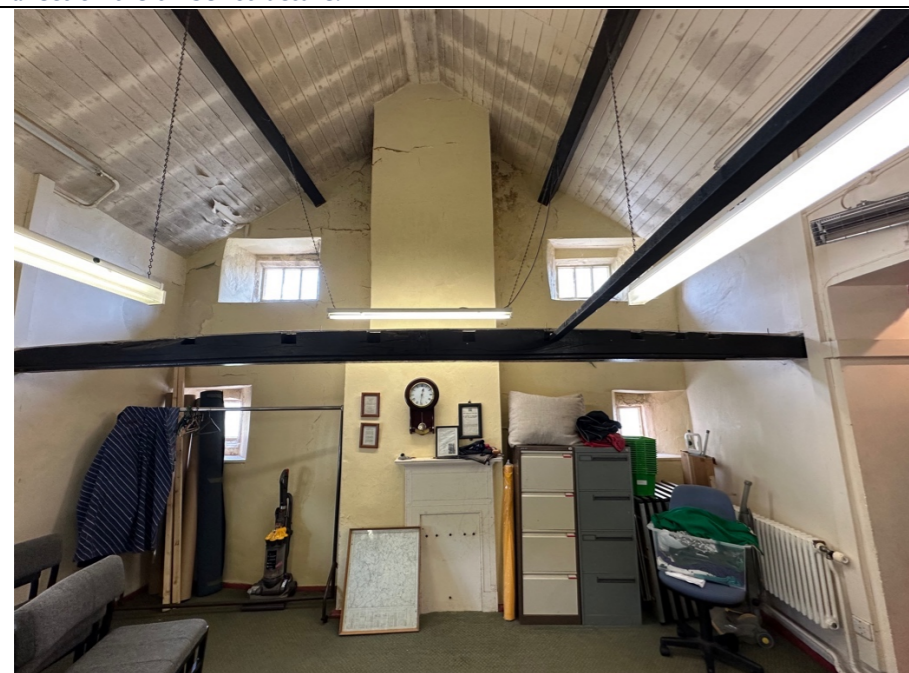
073 – General of the first floor meeting room looking toward the North East gable end wall.

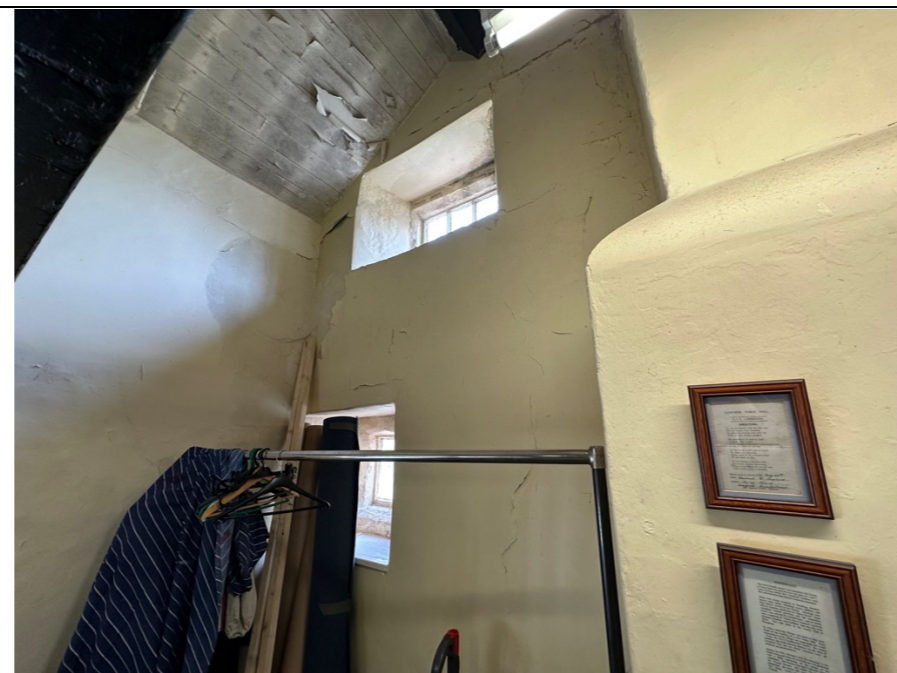
074 – General deterioration of wall finishes and boarded ceiling finishes to the left hand side of the chimney structure, spreading across to the principal front elevation.

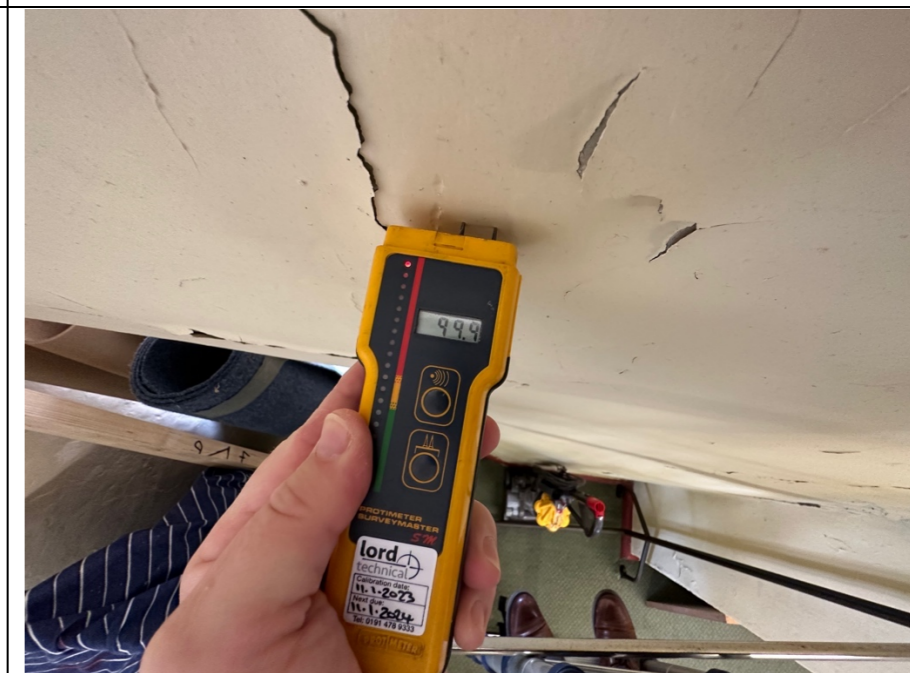
075 – Mid-level wall panel between the two windows identified in photo 074.

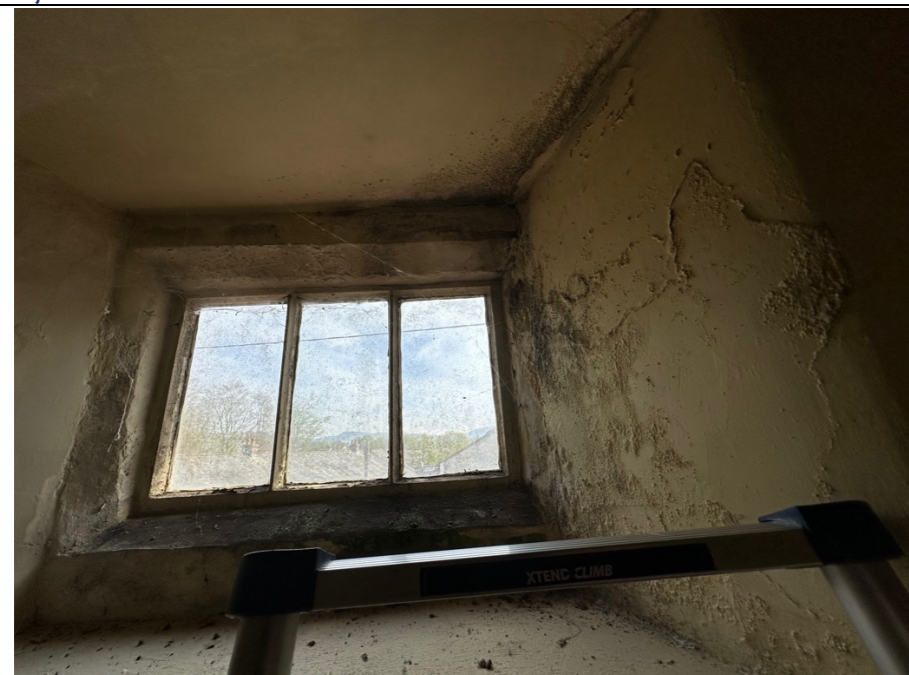
076 – High level window identified in photo 074. Extensive disruption of the painted and plastered wall surfaces as well as to the sandstone window surround. Evidence of algae growth to sandstone and mould growth.
