## Client Details

Gosforth Parish Council  
c/o Jacqueline Williams  
Clerk to Gosforth Parish Council  
2 Wells Cottages  
Ravenglass  
Cumbria CA18 1SP

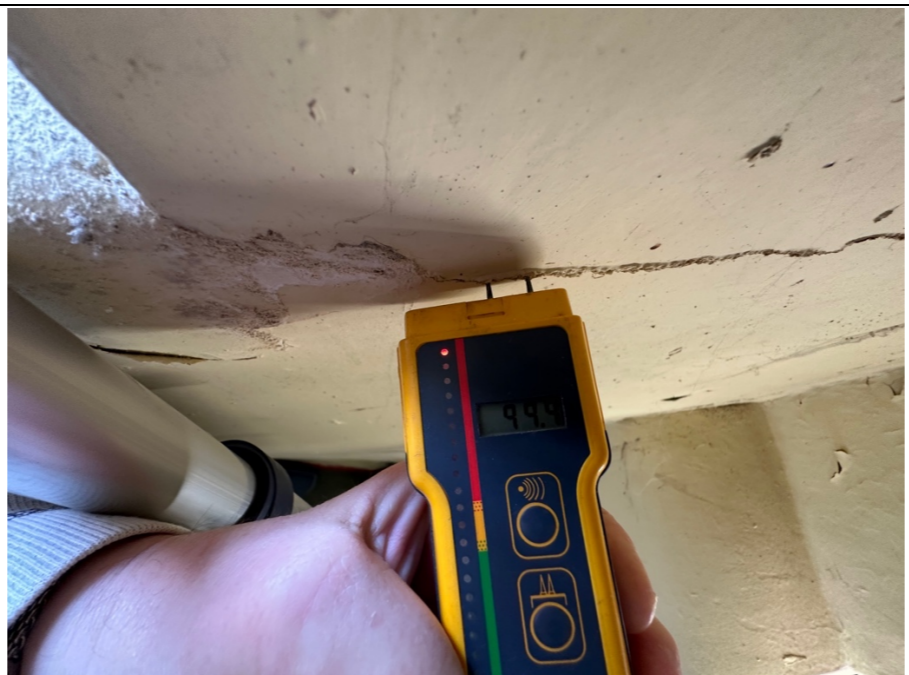
077 - Mid-level wall panel between at the sill level of the higher window. Evidence of localised movement and cracking in the gable wall at this location.

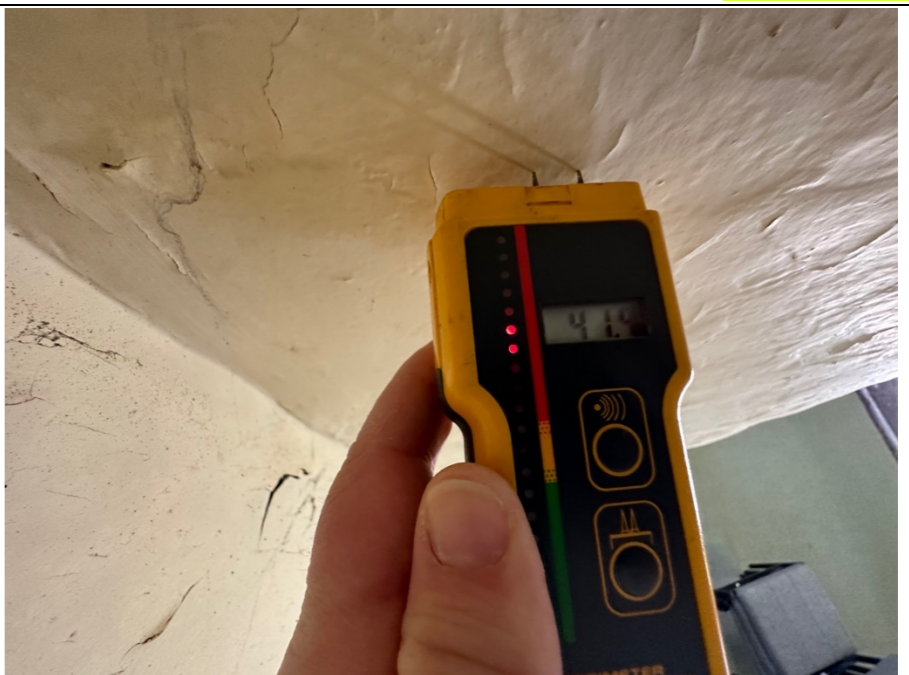
078 – Left hand reveal to the chimney breast structure identified in photo 073.

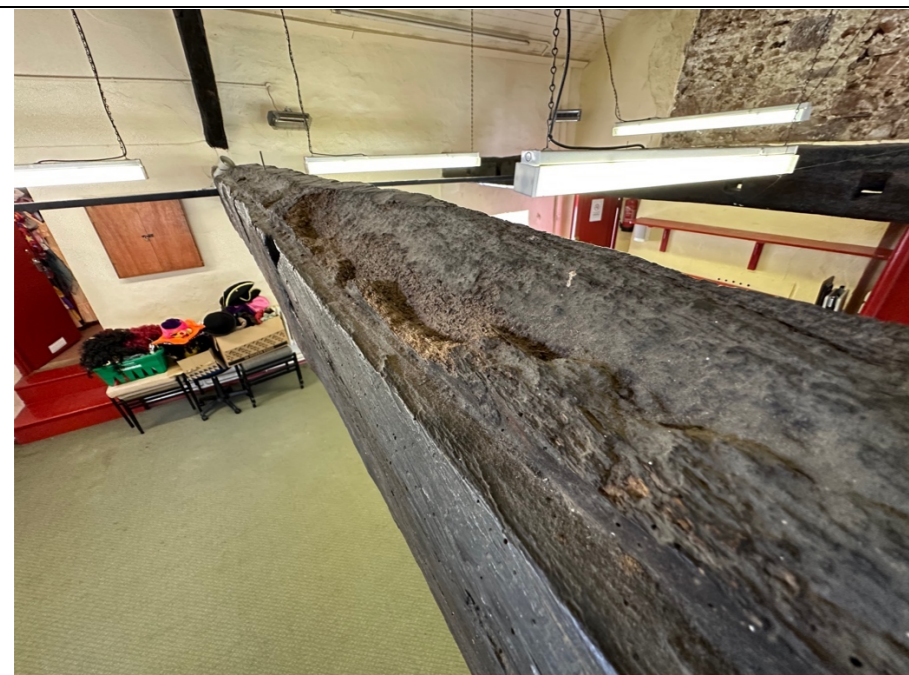
079 – Typical view across the upper surface of the bottom chord of a principal roof truss. Evidence of older wood boring insect activity.

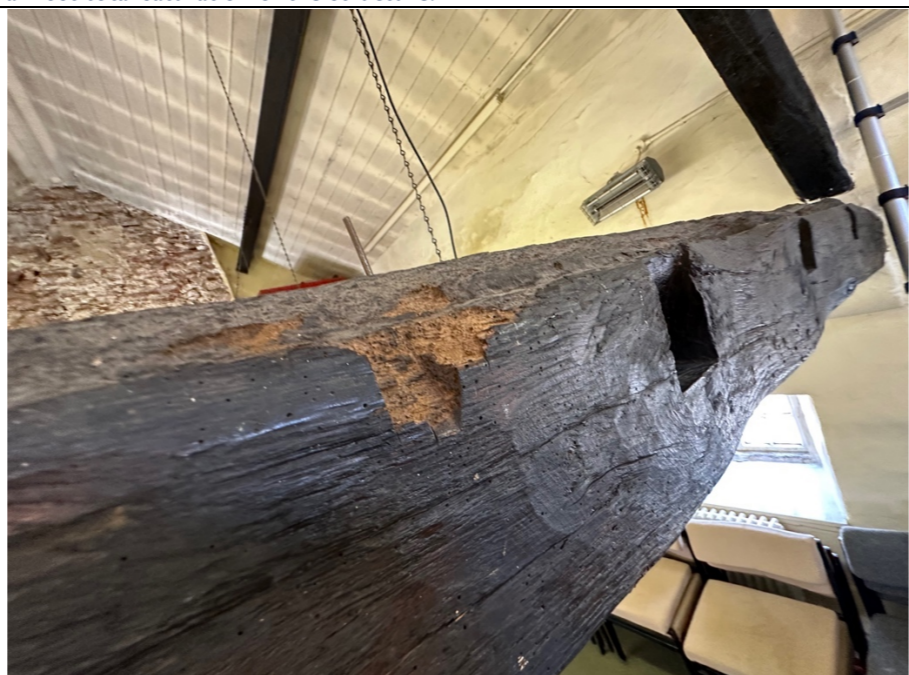
080 – Potential ongoing wood boring insect activity to principal roof trusses.

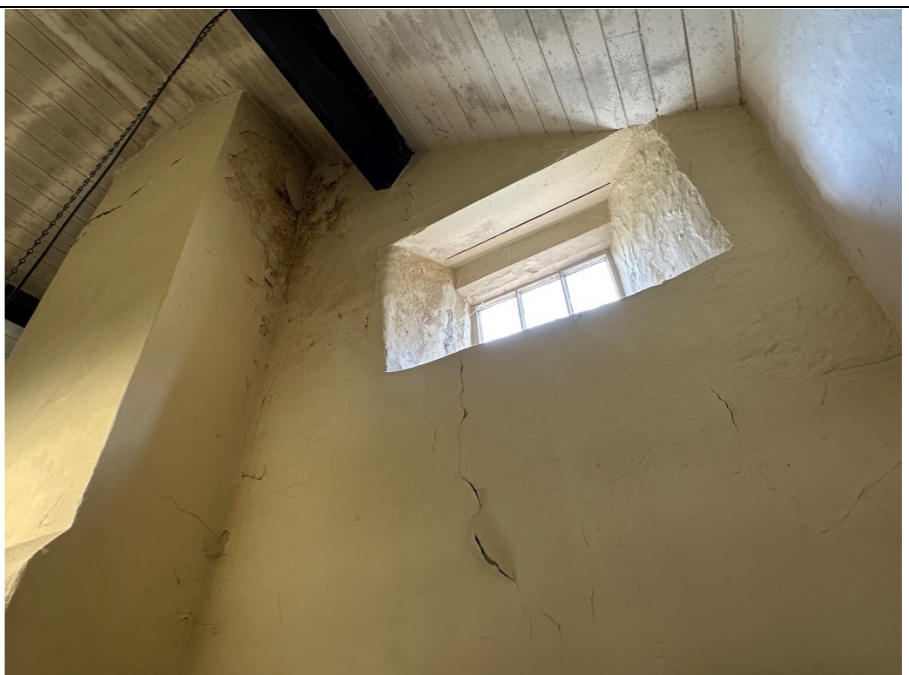
081 - General deterioration of wall finishes and boarded ceiling finishes to the right hand side of the chimney structure.

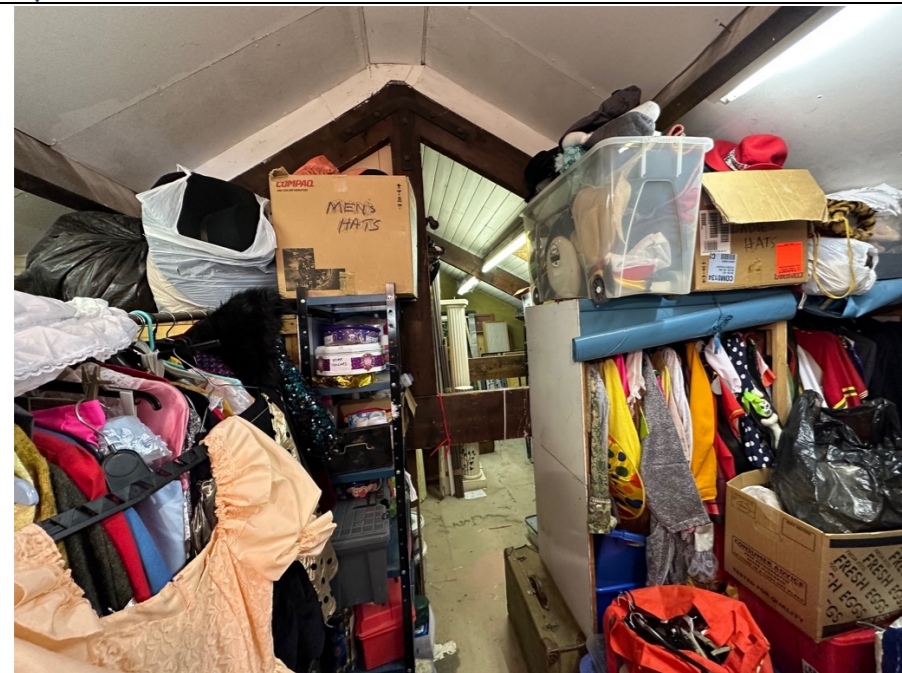
082 – General view of the store area above the Library within the two storey rear addition to the traditional building. Note the extensive loading up of the floor structure.

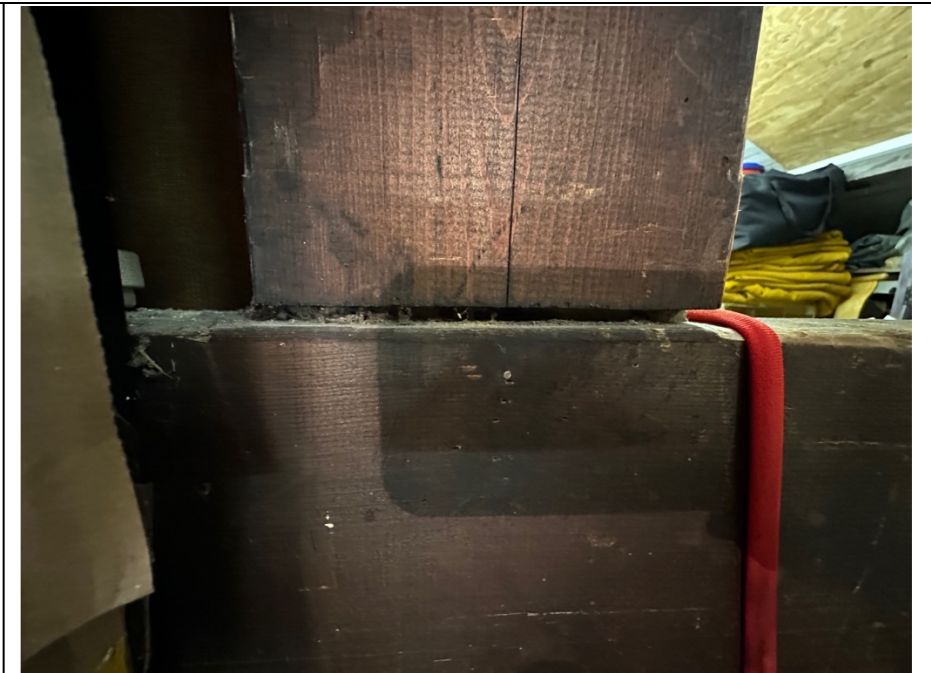
084 – A consequence of the additional loads imposed on the timber truss sections is that the joints between the truss members are being forced to part.

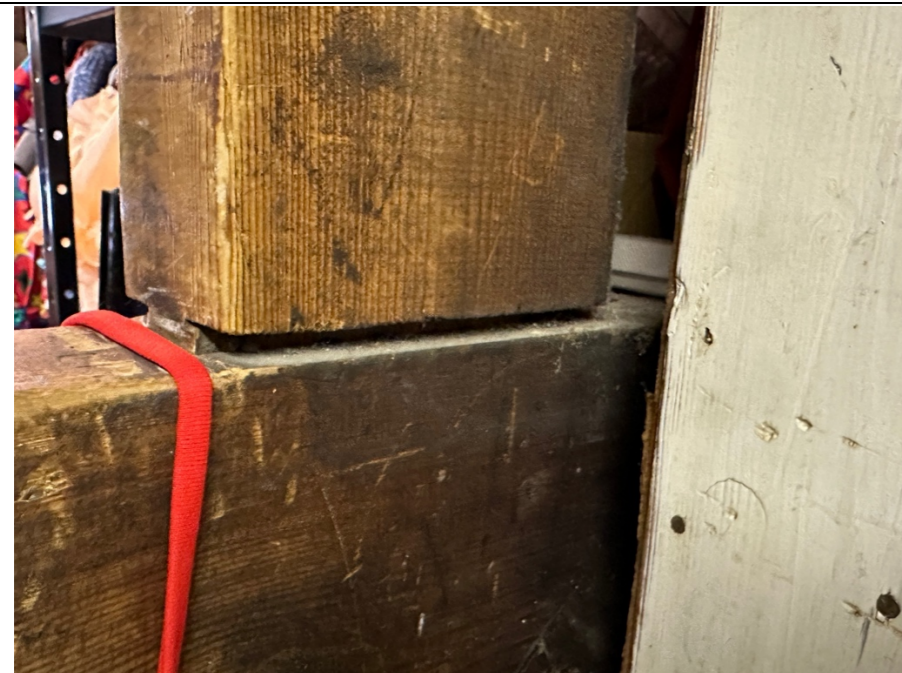
085 – A consequence of the additional loads imposed on the timber truss sections is that the joints between the truss members are being forced to part.

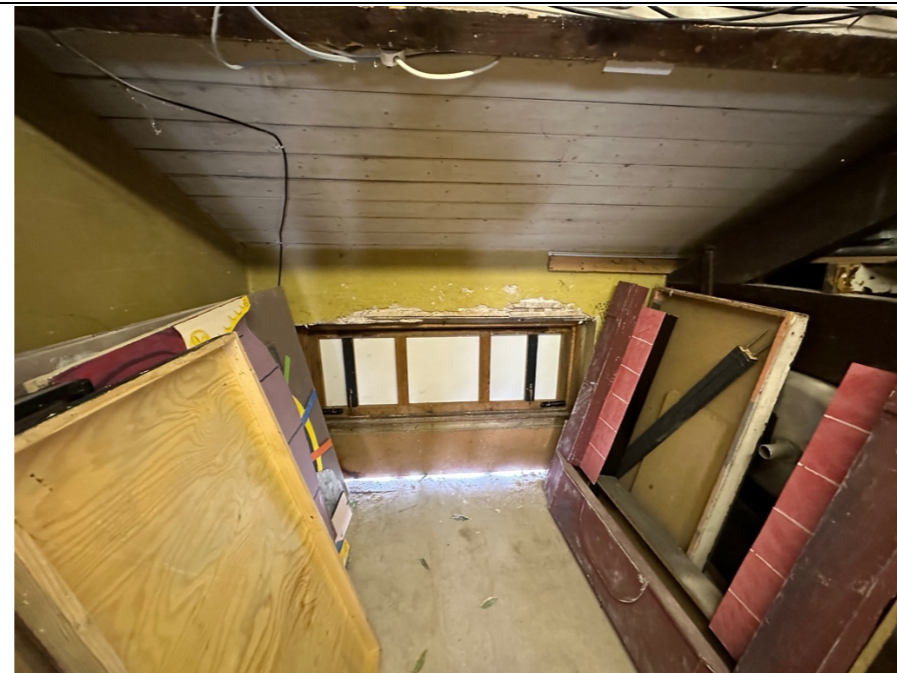
086 – View of the South West facing external opening within the store room that looks over the rear car park area. Note: Daylight is visible at the base of the opening, suggesting that this opening is not 100% watertight.

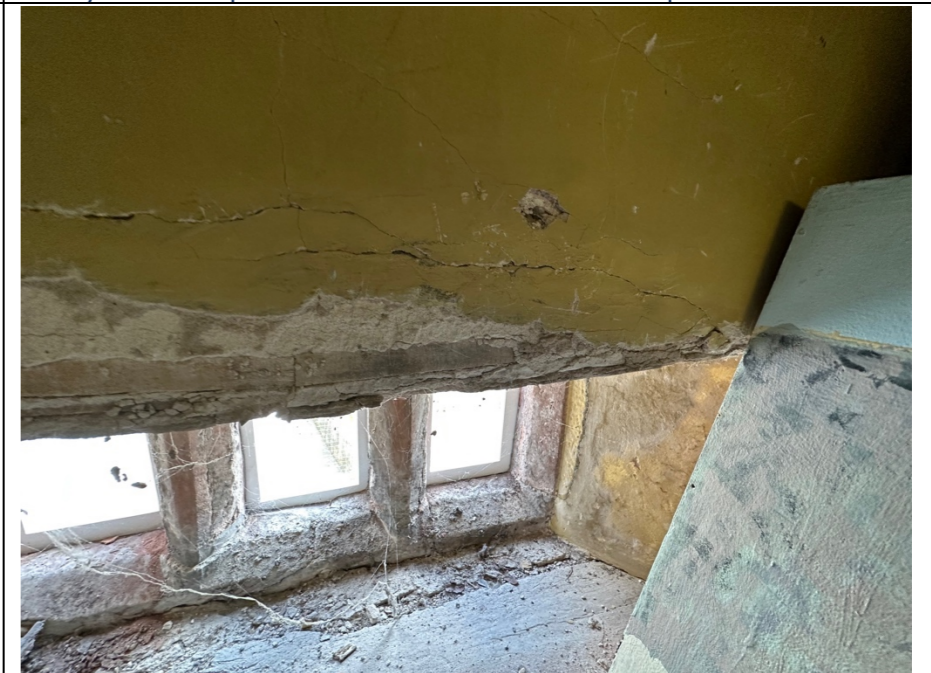
087 – Sandstone framed external window opening to the North East facing elevation. General deterioration of the lime plaster finishes, degradation to the sandstone framing.

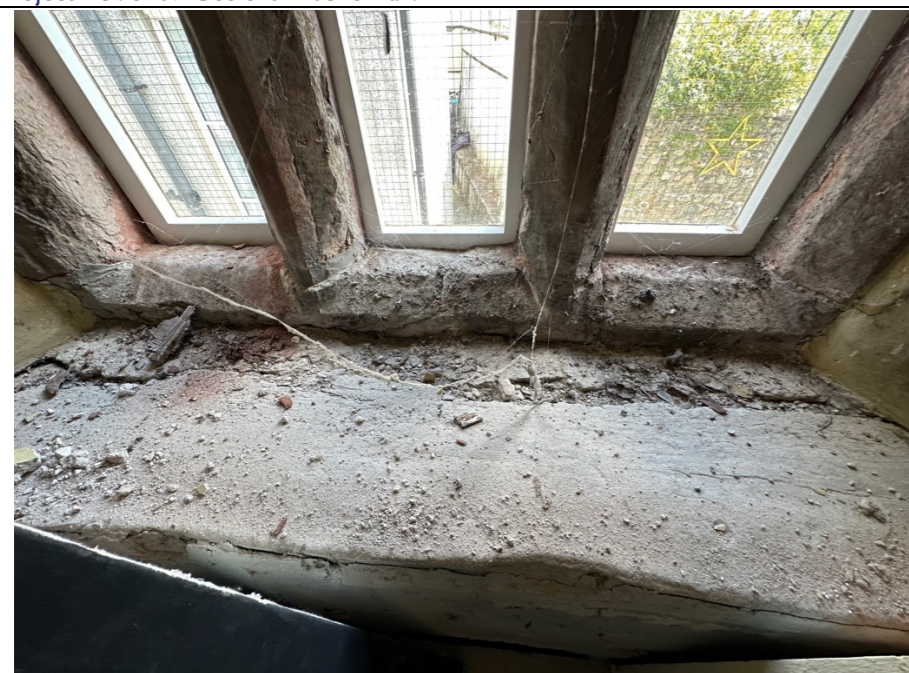
088 – Significant deterioration and degradation to the sandstone framing to the external window opening. Mullion sections are fractured and split.

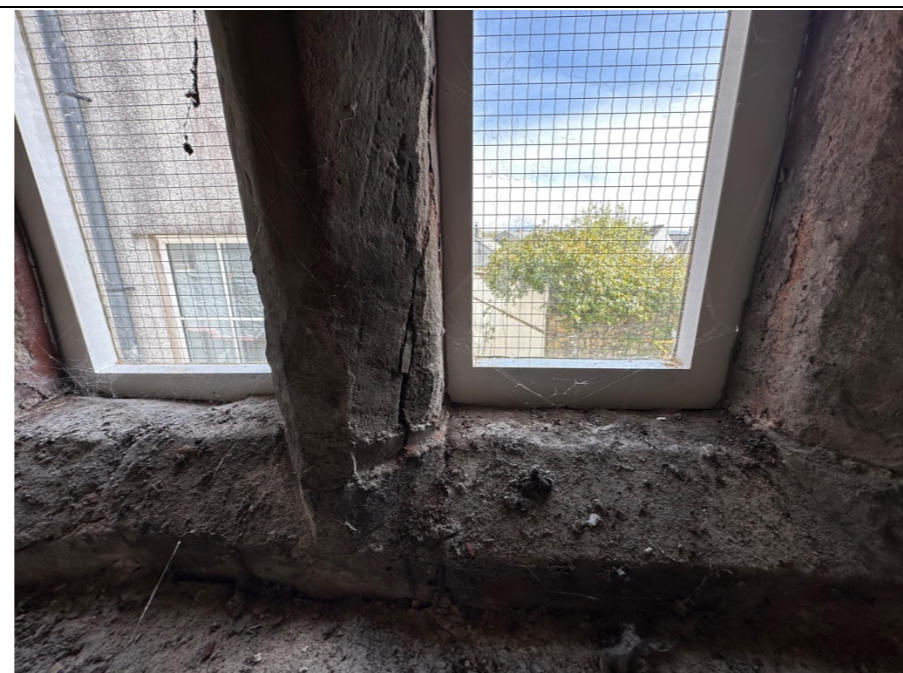
089 – Significant deterioration and degradation to the sandstone framing to the external window opening. Mullion sections are fractured and split.

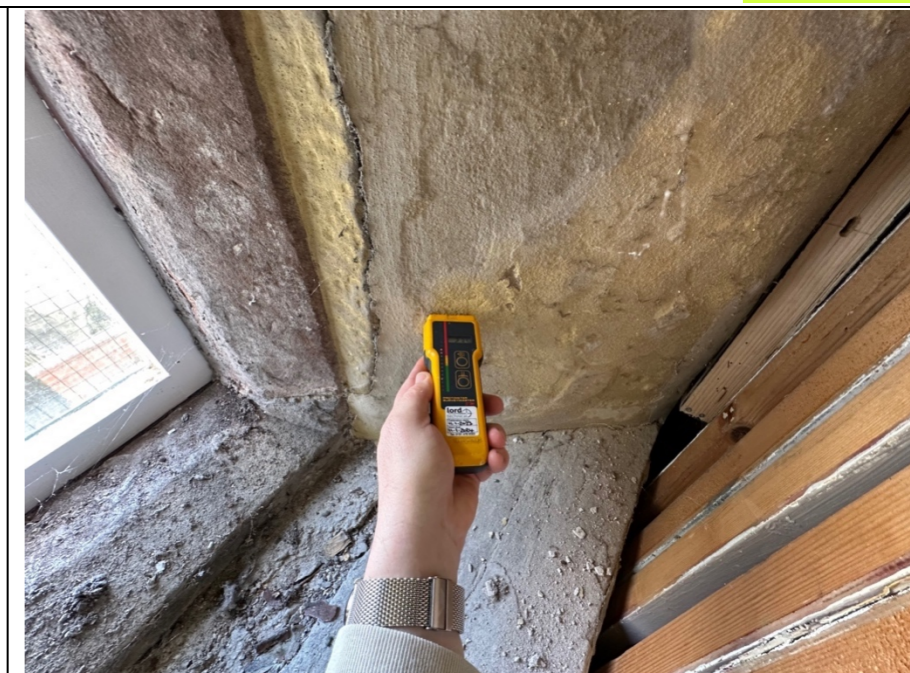
090 – Internal window reveal to the window opening identified in photo's 087 – 089.

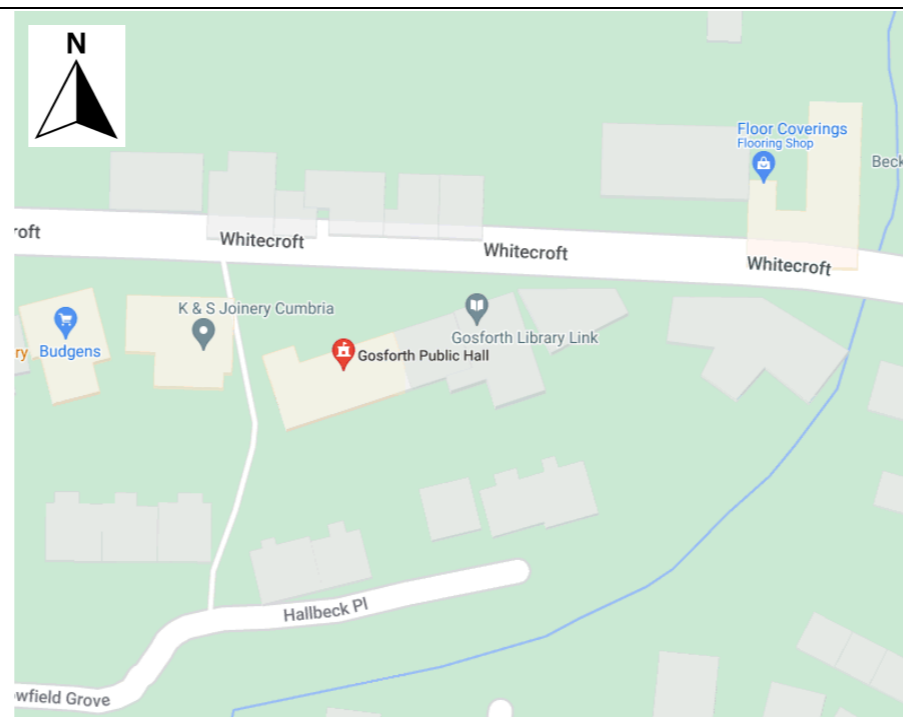
**Recommended remedial and repair works include:**
