## Client Details

Gosforth Parish Council  
c/o Jacqueline Williams  
Clerk to Gosforth Parish Council  
2 Wells Cottages  
Ravenglass  
Cumbria CA18 1SP

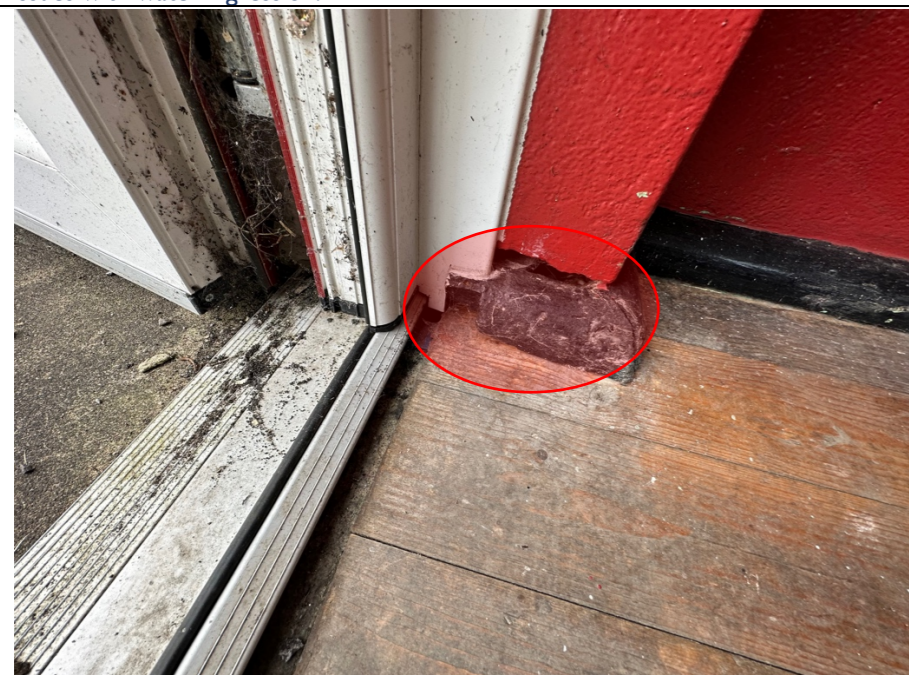
100 – Close up image of the issue noted in photo's 098 & 099.  
 Note: the change in level and the evidence of the timber perimeter section parting company from the wall.

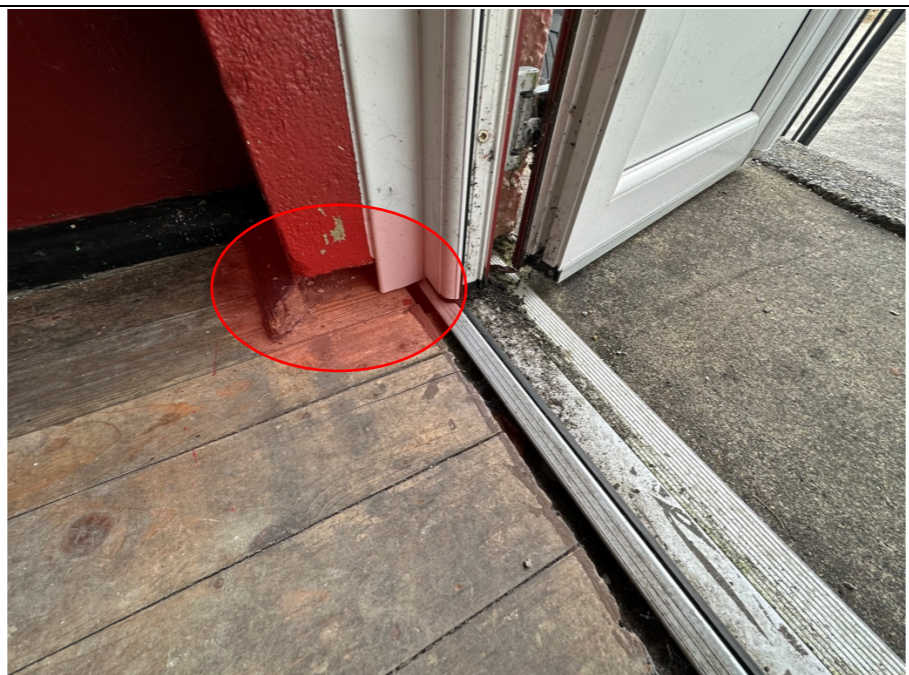
101 - Close up image of the issue noted in photo's 098 & 099.  
 Note: the change in level and the evidence of the timber perimeter section parting company from the wall.

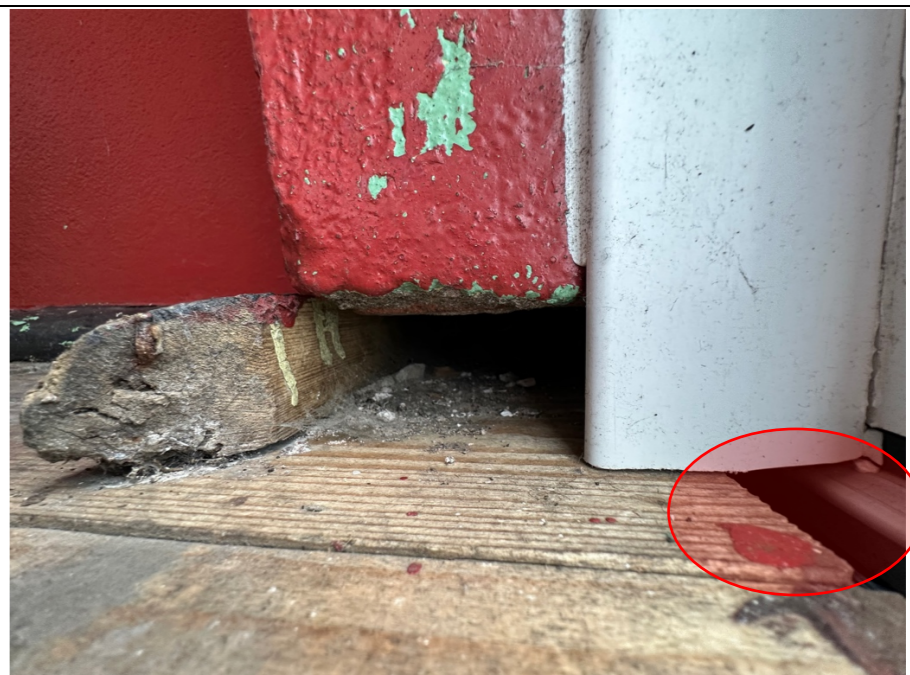
102 – Close up image of defective floor structure in the threshold area of the lobby entrance doors.  
 Note: The timber flooring is not only dropping in level but pulling away from the aluminium threshold. Likely cause to be localised subsidence of the supporting sub-structure beneath the suspended floor or issues with water ingress and the rotting of the floor joist ends bearing into the masonry structure. Further destructive investigation recommended.

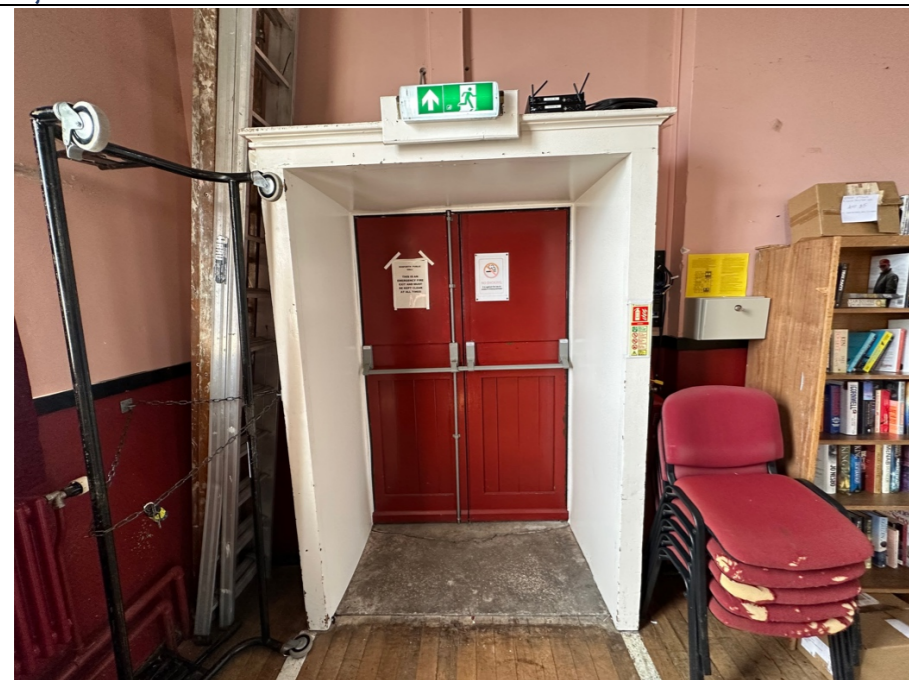
103 – Main Hall rear entrance / exit lobby. Cast concrete floor extending from suspended timber floor of the main hall.

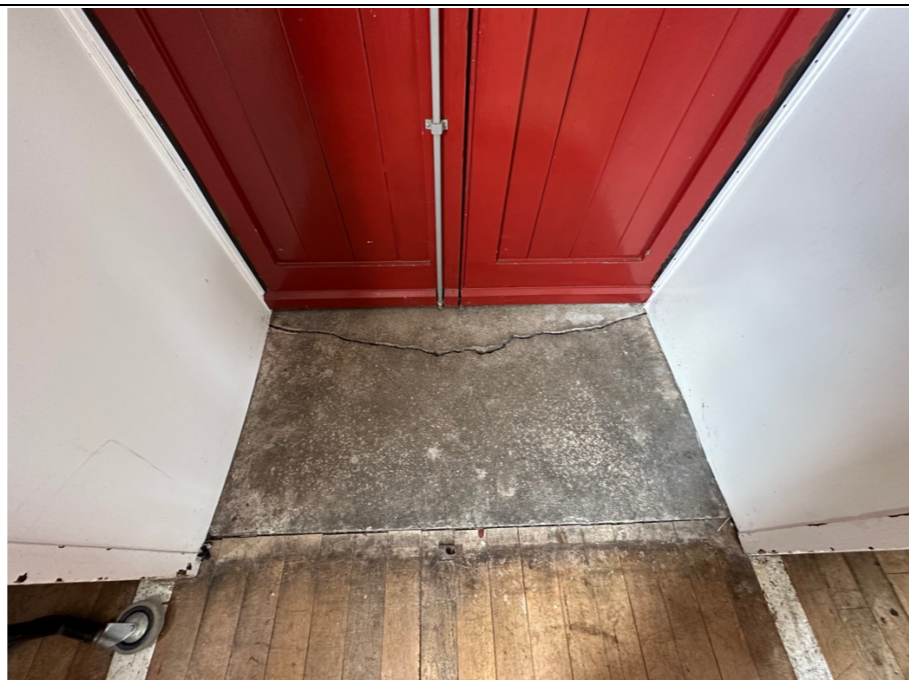
104 – Full width 'open' structural crack in the concrete floor structure to the entrance / exit lobby. Indicative of structural movement having occurred in this location.

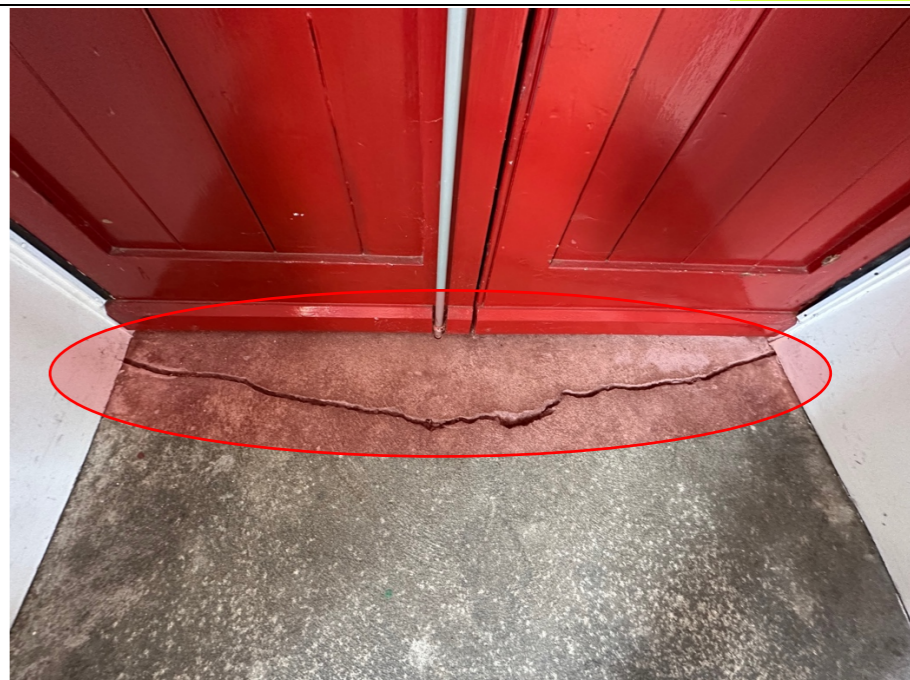
105 – Close up image of the defective floor structure identified in previous photos.

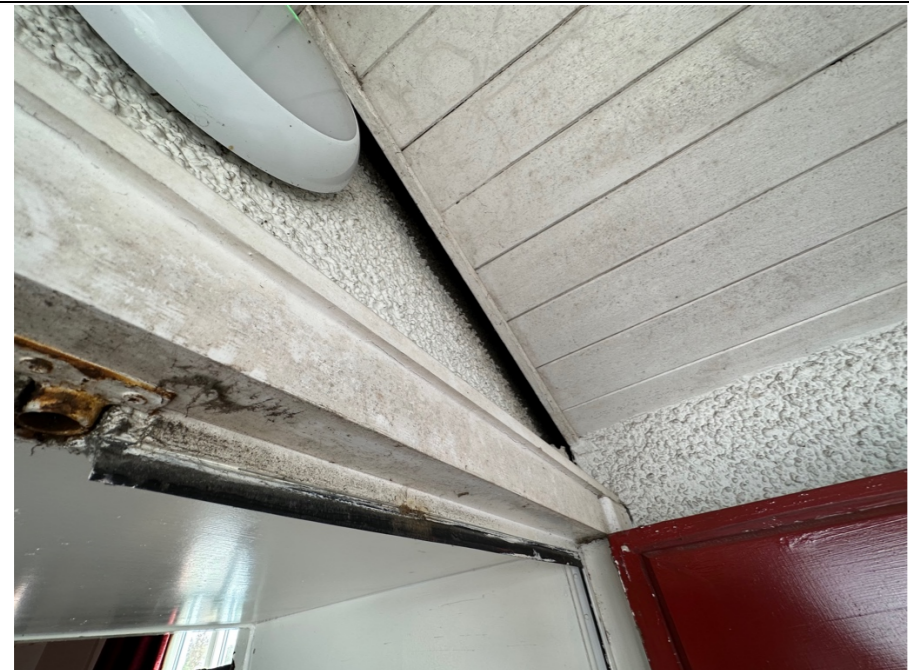
106 – View of the panelled ceiling structure within the lobby entrance (external).  
Note: Large void between the timber edge section to the ceiling panels and the rendered masonry wall.

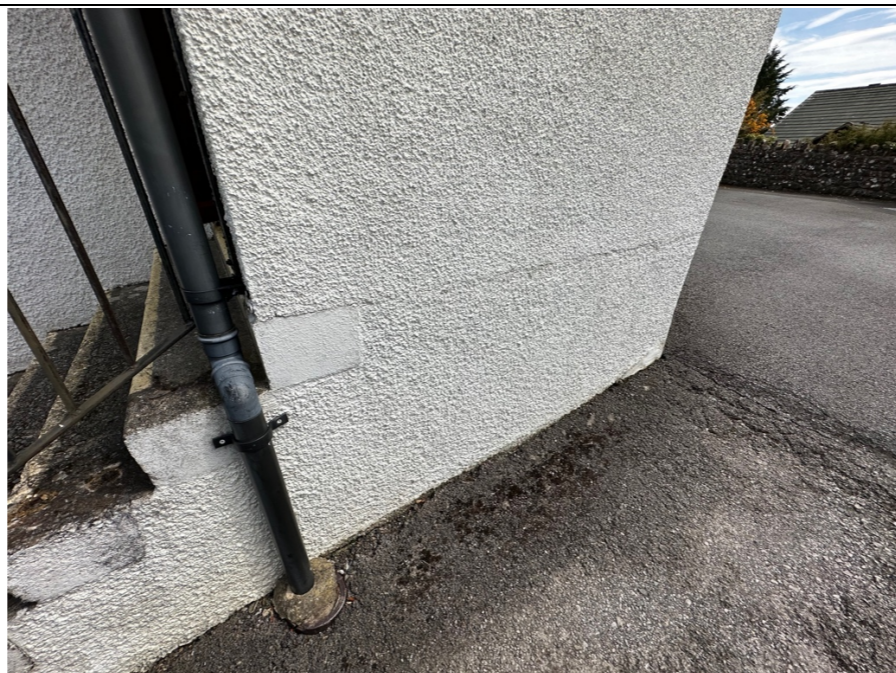
110 – Potential contributing cause for the noted movement in the lobby structure.  
 Note: Horizontal line level with the top step of the structure and slight shift in the alignment of the structure external corner, alongside presence of a surface water downpipe discharging to gully.

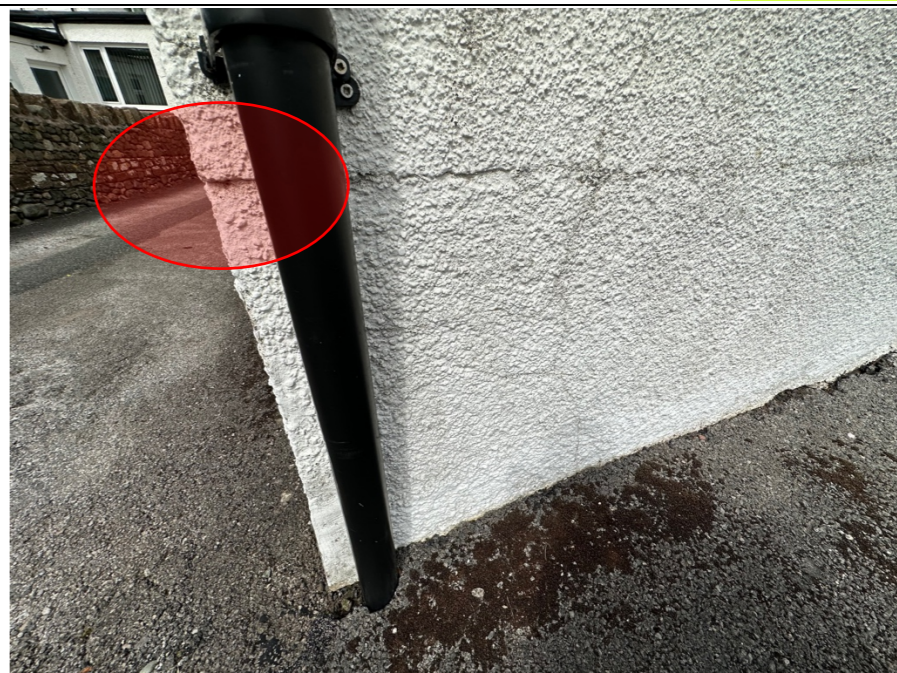
111 - Potential contributing cause for the noted movement in the lobby structure.  
 Note: Horizontal line level with the top step of the structure and slight shift in the alignment of the structure external corner, alongside presence of a surface water downpipe discharging to gully.

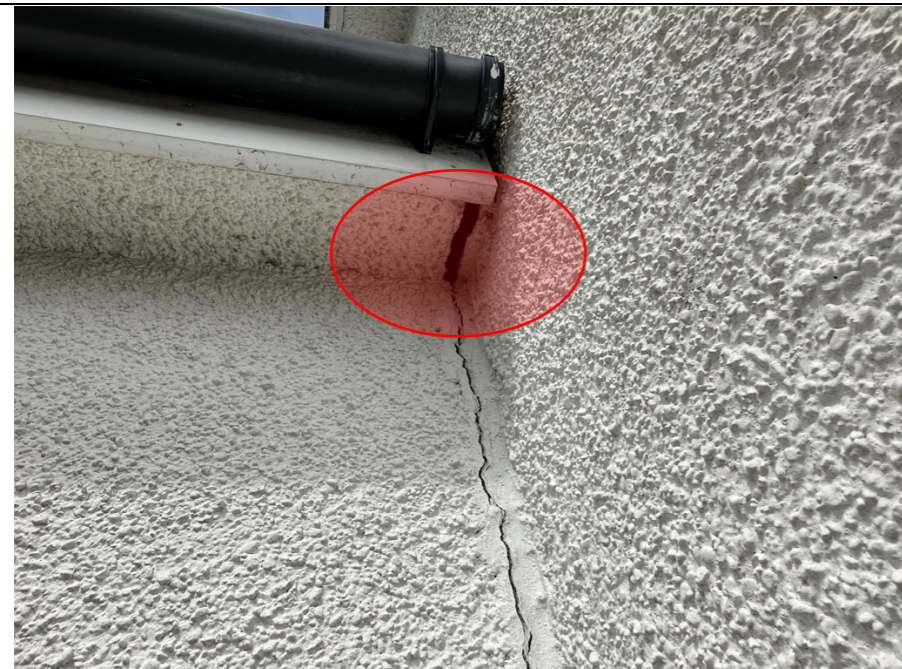
112 – View of the rear car park elevation of the lobby structure. Note evidence of previous attempts to fill void / gap between the two structures. Presence of open crack suggests movement of the lobby structure is ongoing and should be monitored.

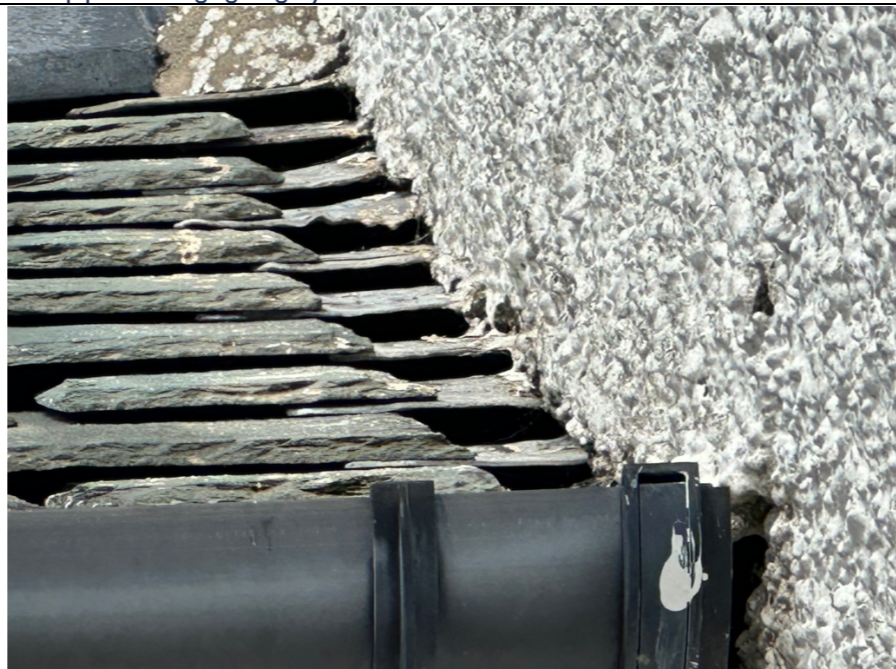
113 – Roof level view of the abutment between the lobby roof covering and the masonry wall to the Hall.  
 Note: Gap of approximately 50mm between the slate edges and the rendered wall, exposing the lead soakers placed to help with weathering the junction at roof level between the two structures. At apex of the roof a cement fillet has previously been added to bridge the void created by the movement in the structures.

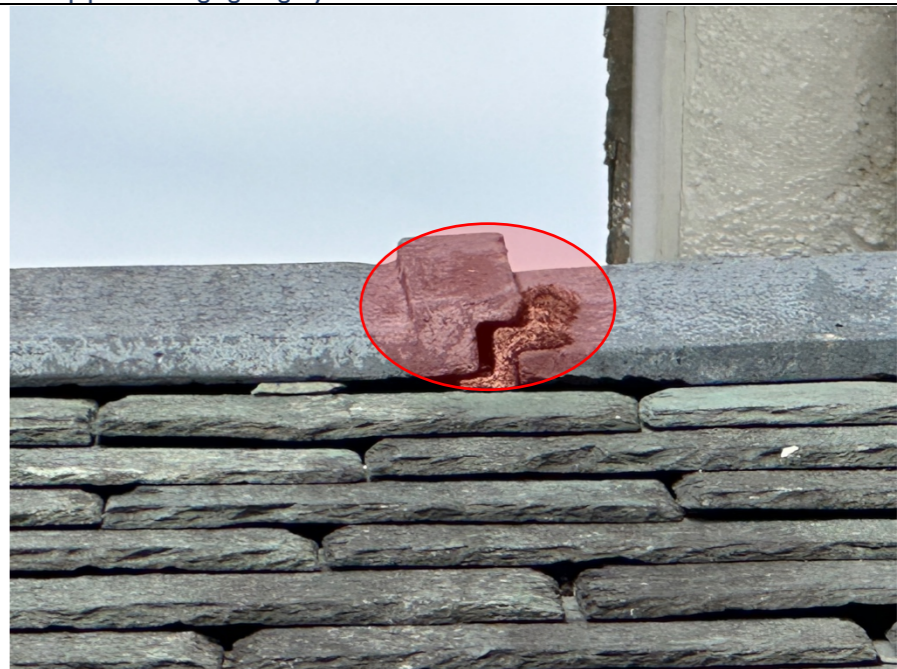
114 – Mis-aligned and disconnected ridge tile to the lobby structure, providing additional evidence that the lobby structure is moving away from the main Hall building.
