M&E CONDITION REPORT
AT
GOSFOTH COMMUNITY HALL
GOSFORTH
CUMBRIA

DATE: MAY 2023
REF: 8749

Pettit Singleton Associates have been employed by Day Cummins to review the condition of the existing Mechanical and Electrical building services at Gosforth Community Hall, Gosforth, Cumbria.

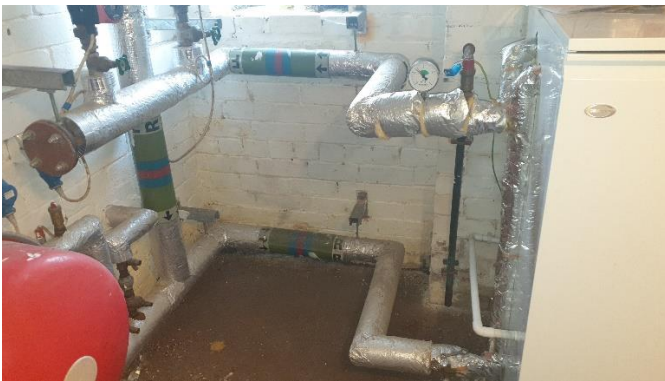
The heating is provided a single Grant Vortex Utility 58-70 oil boiler, this was fitted in 2019, the boiler is fitted with a balanced flue this exhaust at low level through the wall. The oil storage tank is also located internally within the plantroom, this a non-bunded 1,250 litre plastic tank, the tank sits within a brick bund, the tank also appears not to be fire rated. In line with OFTEC regulations only fire rated should be fitted internally, ideally this tank needs to either replaced with a fire rated bunded unit or placed externally.

Oil Boiler & Header

The heating system appears to have no form weather compensation or frost protection, at the time of survey, the oil-fired boiler was not operational however it appeared to be in good condition.

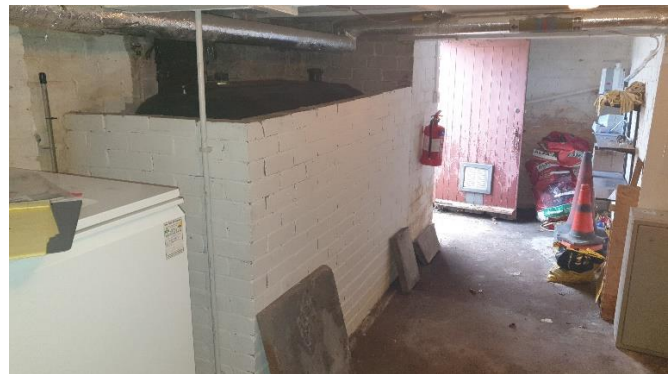
Oil Tank

Mechanical Works Description	Cost
Preliminaries	£5,000.00
Relocate oil tank	£8,750.00
New incoming cold-water supply	£5,500.00
Heating distribution system, inc library	£48,500.00
Hot and cold-water distribution system	£22,370.00
Kitchen extract canopy and fan	£6,500.00
Testing and commissioning	£3,015.00
As fitted documentation	£475.00
Totals	£100,110.00

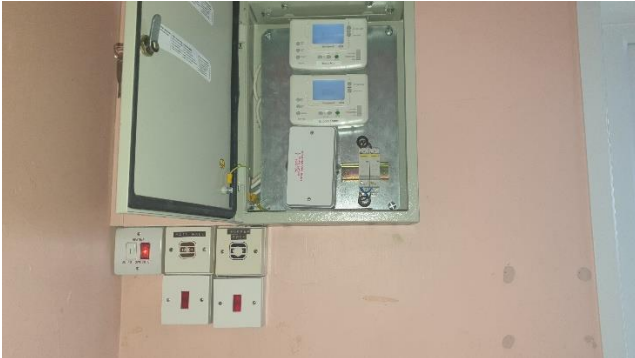
Heating controls and time extension switches

The heating zones are controlled by a two basic time clocks, each zone also has a heating time extension function

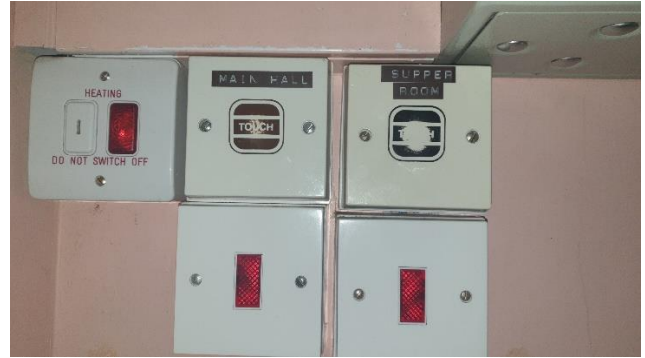
Heating extension timers

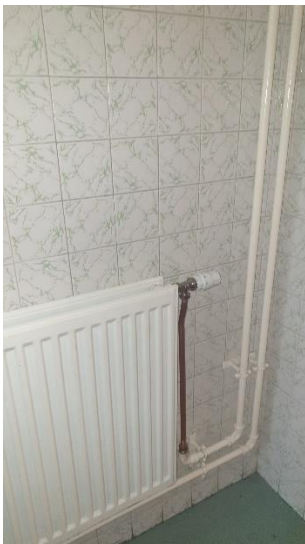
With the exception of the Library the majority of the main building is heated using the wet heating system, this works in conjunction with a combination of press steel iron column radiators and panel radiators, these are all fitted with TRVs, in some cases the TRVs have been retro fitted. The pipework and radiators appear to be around 25-30 years old; the heating system is coming towards the end of its economic life; however, it appears to be in reasonable condition and there were no obvious signs of water leaks.

Typical Retro fit

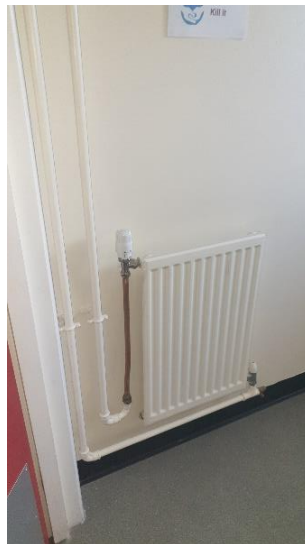
In the disable WC it was noted that a standard radiator has been installed, to avoid the risk on burns in these types of rooms it is good practice to fitted low surface temperature (LST) radiator.

Standard rad in disable WC

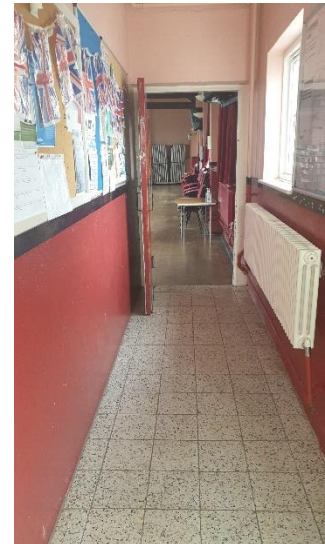
Column radiator

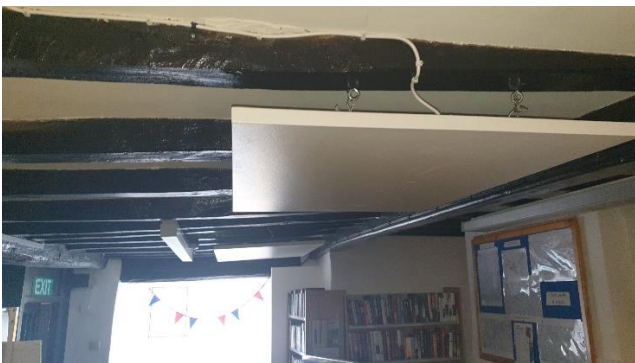
Electric radiant panel heater

The electric storage heater and panel heater appear to be around 20 years old; these are at the end of their economic life and are due for replacement. The radiant panel heaters appear to be relatively new probably around 5-10 years old, these appear to be in reasonable condition. The infrared heaters appear to be around 20 years old; these are in poor condition and at the end of their economic life, these are due for replacement

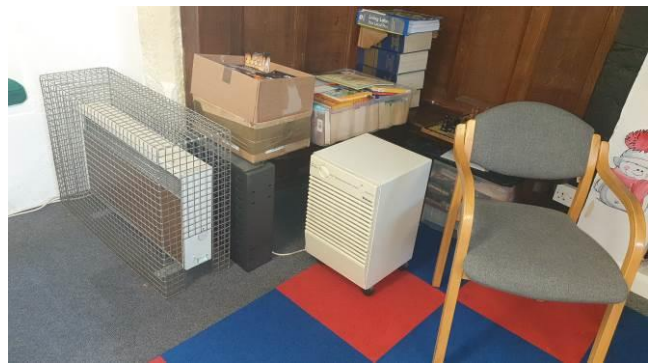
Electric storage heater

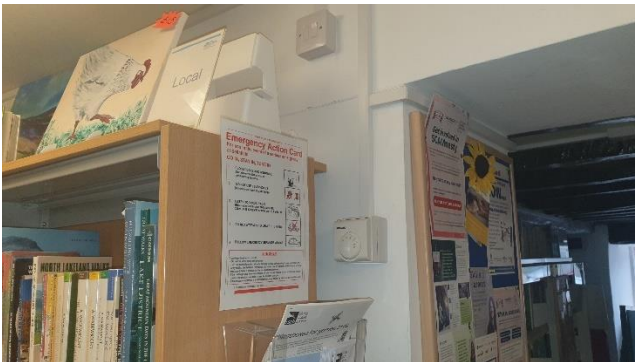
Radiant panel heater thermostat

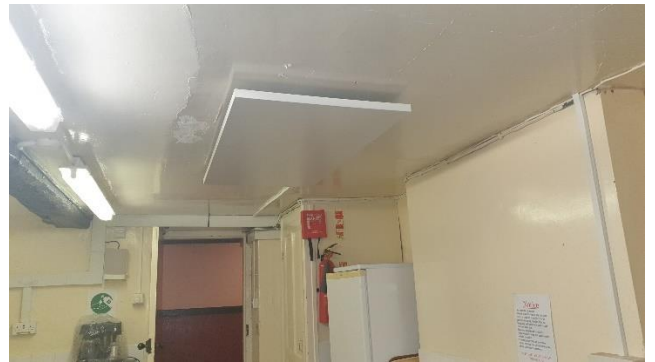
The main kitchen also has a ceiling mounted radiant panel heater fitted, the room is also fitted with a radiator of the wet heating system, it is assumed that the radiant panel this used to supplement heating in this space.

Radiant panel heater – kitchen

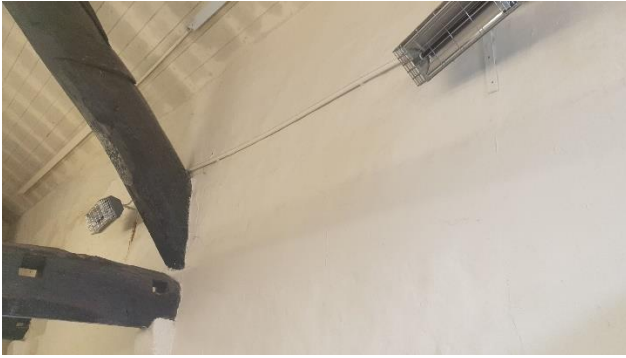
The supper room on the first floor with a combination of radiators and wall mounted infrared heaters, out of five infrared heaters only one appeared to be operational.

Infrared heater – Supper room

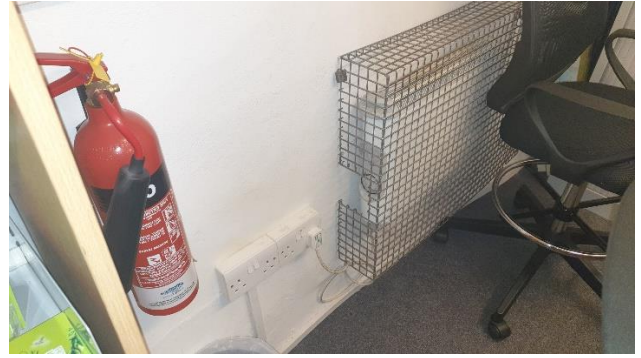
Electric panel heater

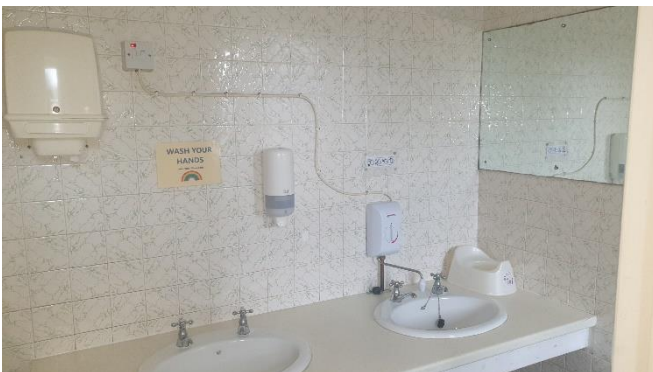
Instantaneous water heater - Female WC

Each of the WC blocks is fitted with two wash hand basins (WHB), however the instantaneous heater only supplies hot water to one WHB, ideally both WHB should have hot water.

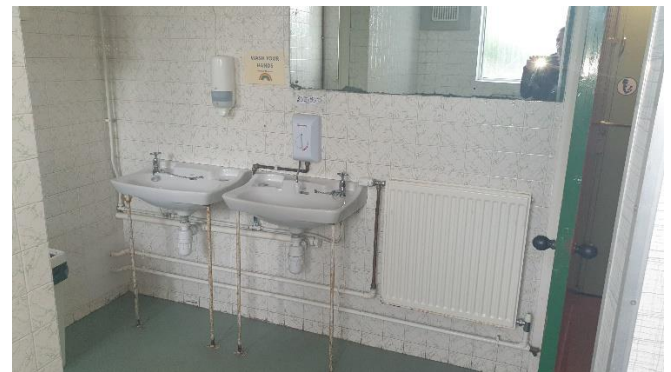
Instantaneous water heater - Male WC

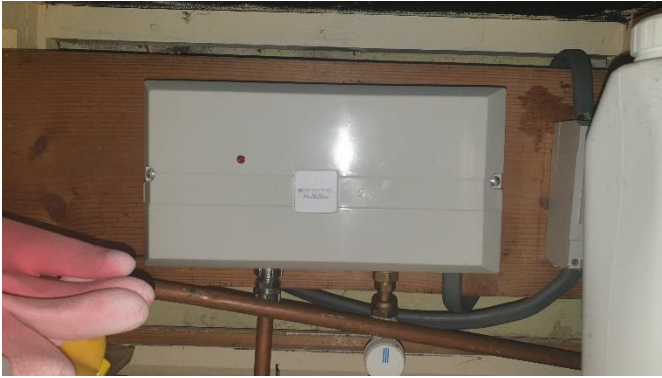
Instantaneous water heater – Kitchen

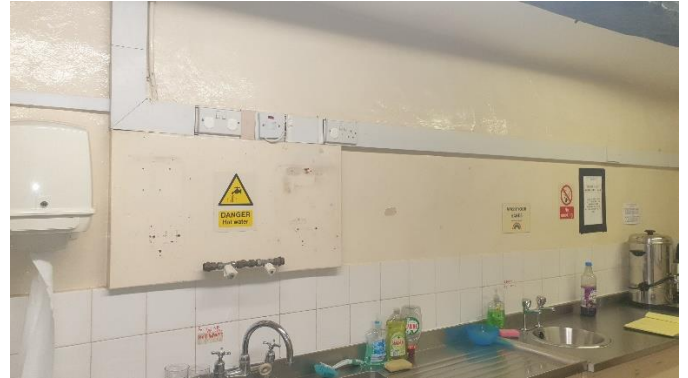
Location of old kitchen water heaters

It appears that the hot water for the kitchen had previously been generated by two wall mounted electric heaters, these have been stripped out, however the pipework connections remain in place, these are not capped off. This pipework is both a flooding and legionella risk, ideally all redundant pipework should be stripped out leaving no dead legs.

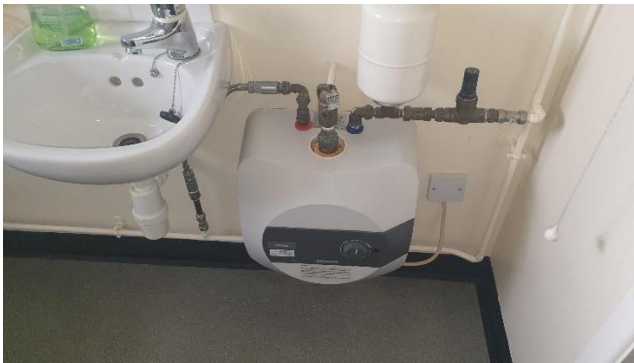
10 litre water heater – Disable WC

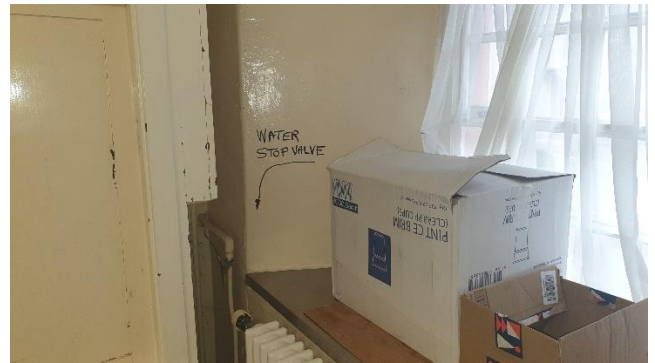
The building has a single 15mm copper unmetered cold-water supply, this is located in the kitchen, the water distributes round the building at mains pressure, there are no cold-water storage tanks.

Incoming water supply - kitchen

The building only has a 15mm incoming water supply, this is usually only considered to be suitable for a domestic property with low water use, if the building is to be used for commercial operation with higher occupancy number a larger water supply will be required.

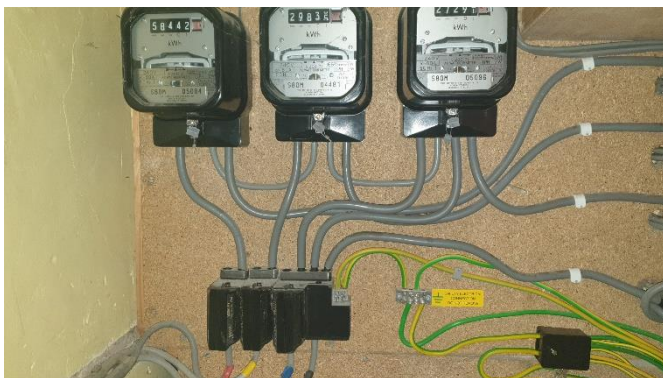
Incoming Main Cut out

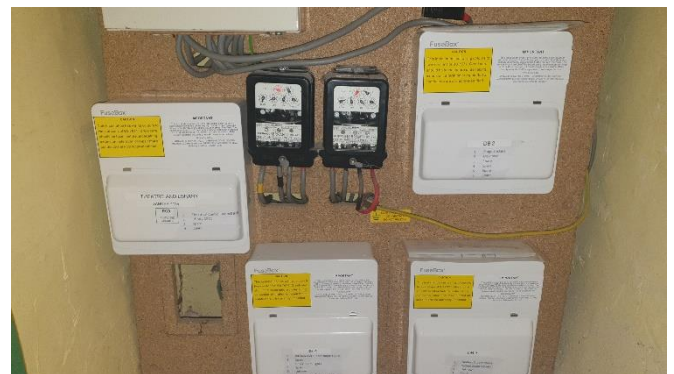
All but the Stage Consumer units have recently been replaced (March 2023) providing RCBO and surge protection throughout, all Consumer units are of single-phase configuration.

Recently replace Consumer units

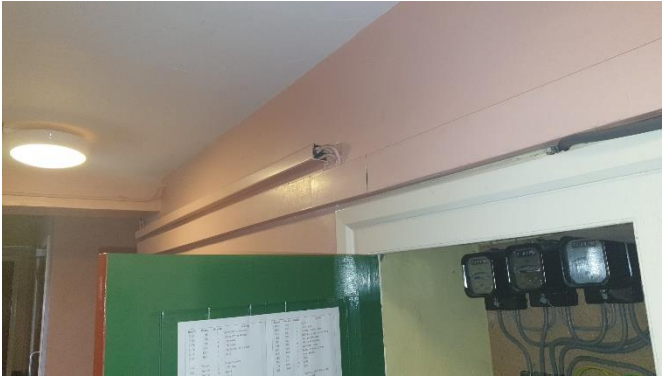
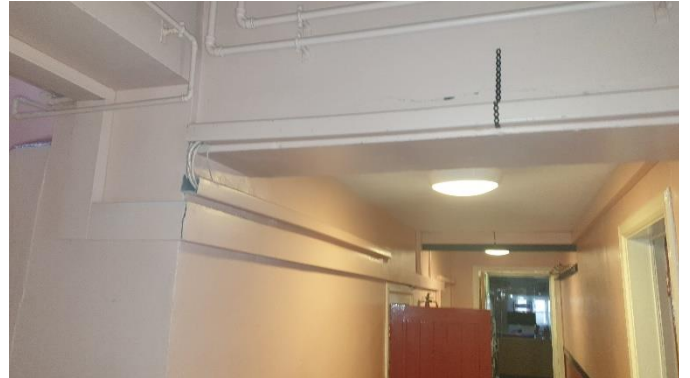
The existing Mains supply tails length appears to be excessive and the route taken exposes the cabling to damage as it passes unprotected, in areas, through the building to the supply cut out; as a minimum the supply tails should be better protected or the incoming supply relocated during the course of major works.

Expose Tails

Exposed Tails

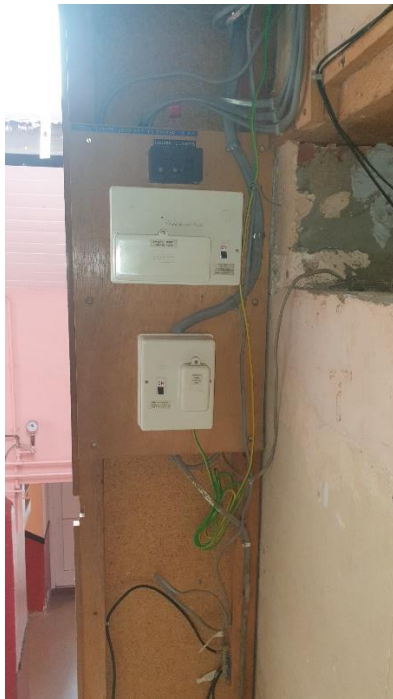
The Stage Consumer units are at the end of their expected life span, consideration should therefore be given to upgrading the switchgear that has not already been replaced.

Stage Consumer Units

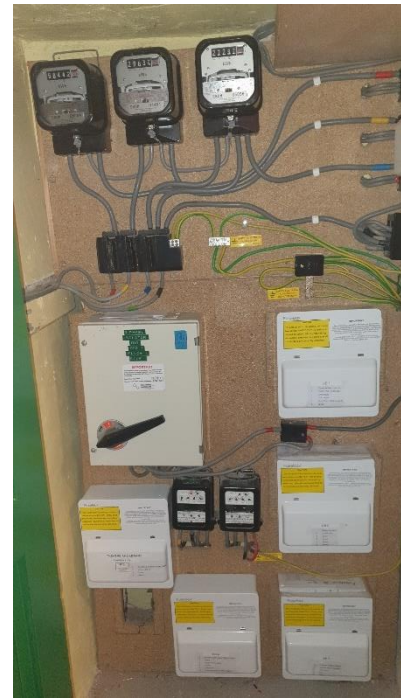
Switchgear Layout

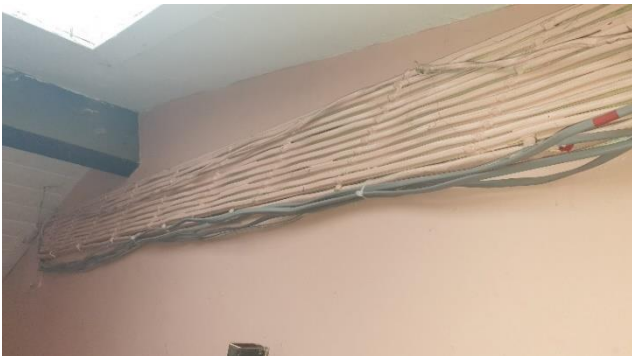
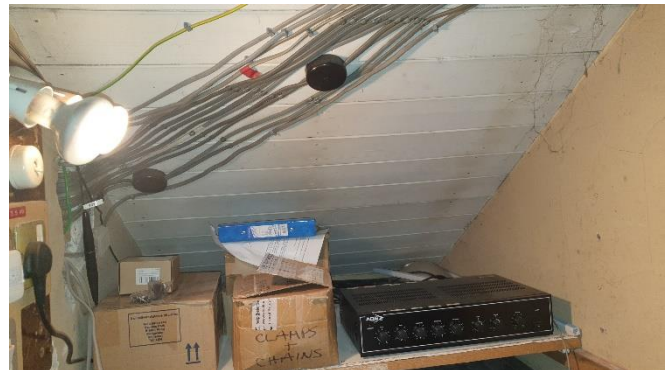
Generally cable fixing and containment requires improvement.

Poorly fixed and protected cabling

It is estimated that the existing cabling is of an age where rewiring would be considered, this would in turn better support the needs of the current building use.

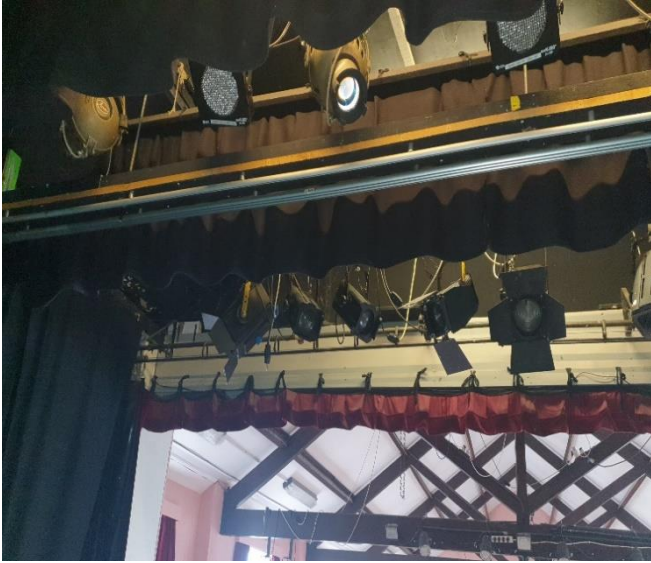
The Building has a Stage area and Hall with Adhoc performance equipment having been installed – the cabling to the equipment would appear to consist of a mix of hard wired and flexible cabling with multiple extension leads in use to provide the required number of connection points; exposed live cable joints were identified during the inspection – the Stage Lighting installation should be reviewed as a separate specialist item and deficiencies found made safe for further use.

Stage lighting

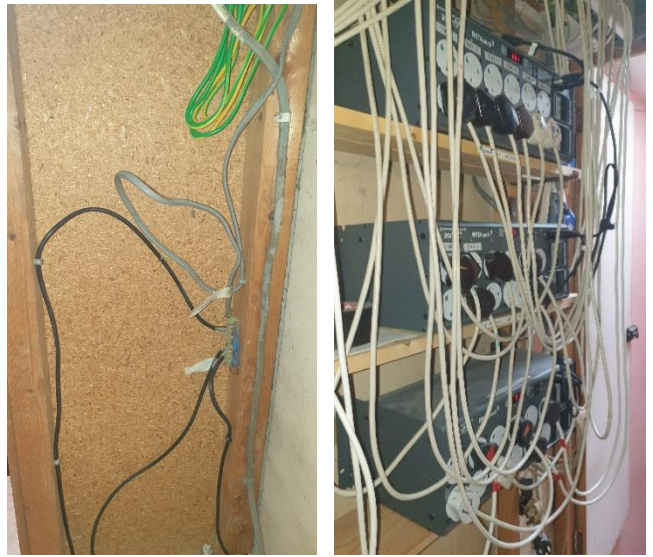
Stage Equipment and Exposed Cable Joints

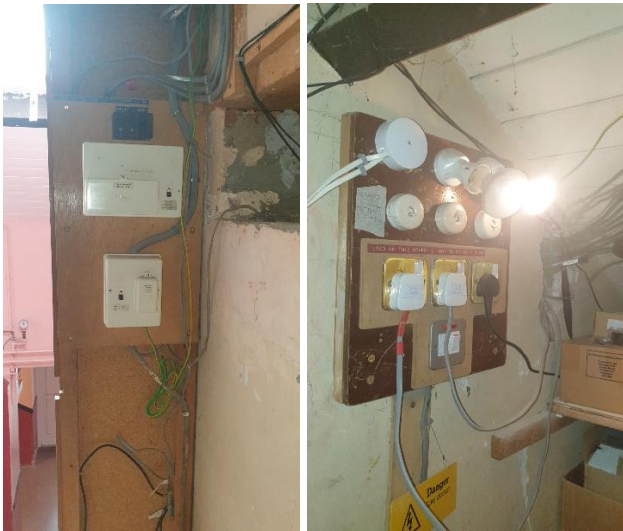
Older style rewirable fuses and Twin cable into plug tops

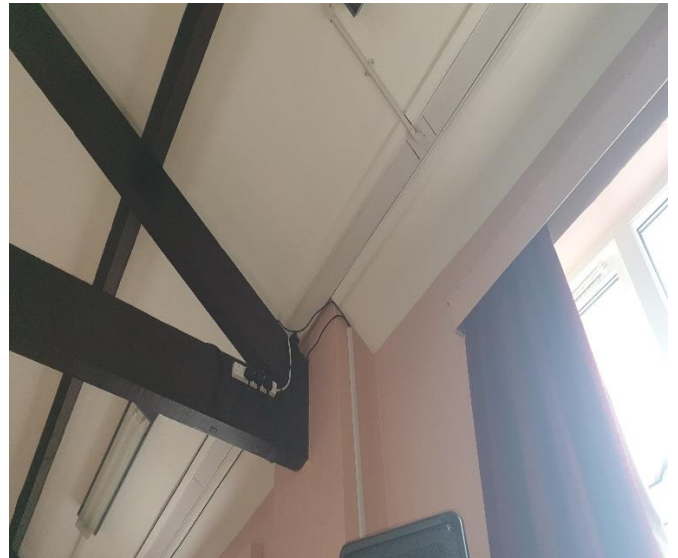
Extensions used in place of fixed wiring

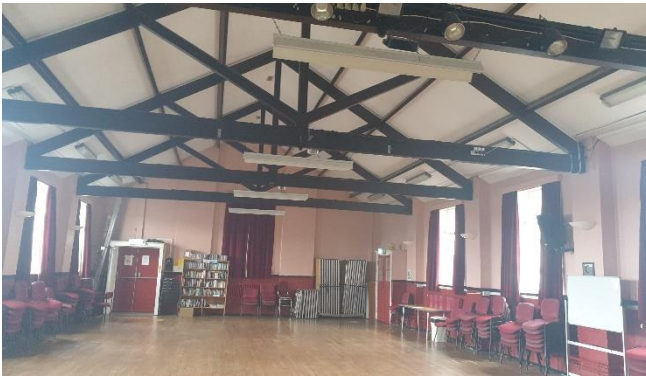
Lighting throughout the building is poor and of an age where replacement would be considered, consisting of a mix of fittings with exposed lamps, bulkheads fitted with Incandescent lamps and fluorescent tube lighting. Switching is manual in nature throughout.

Hall Lighting

The lighting installation is at the end of its economic life and complete replacement of the installation, both internally and externally should be considered utilising LED technology with appropriate controls to minimise energy consumption.

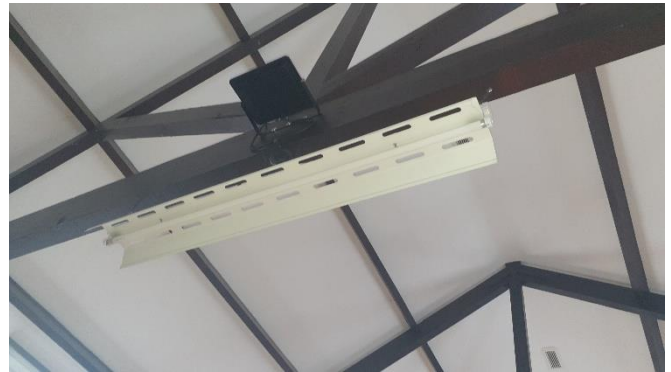
Exposed lamp fluorescent

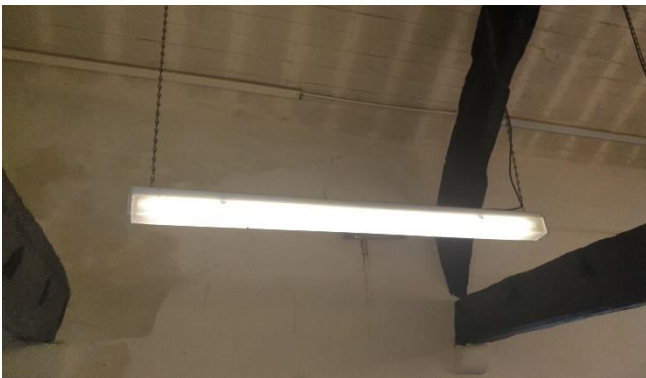
Suspended Luminaire

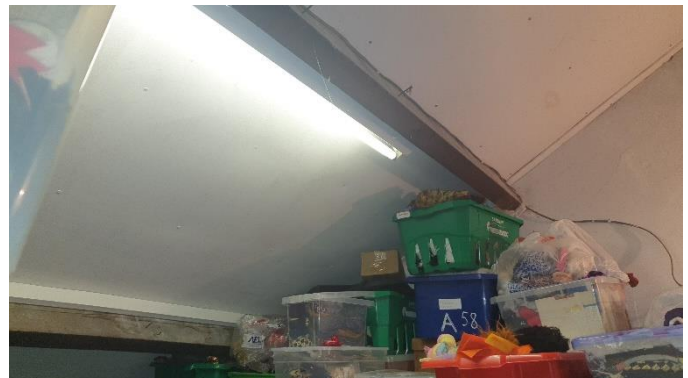
Exposed lamp fitting in store room

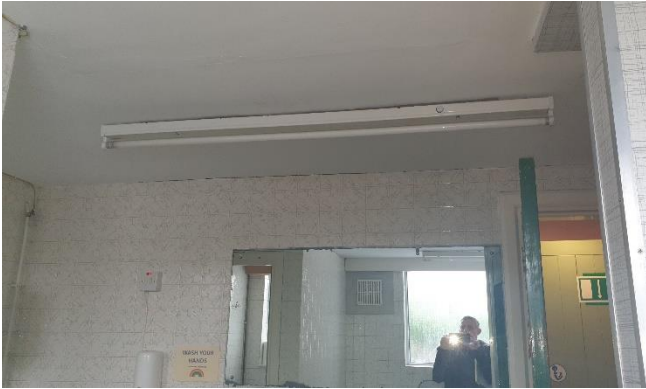
Exposed fitting in WC.

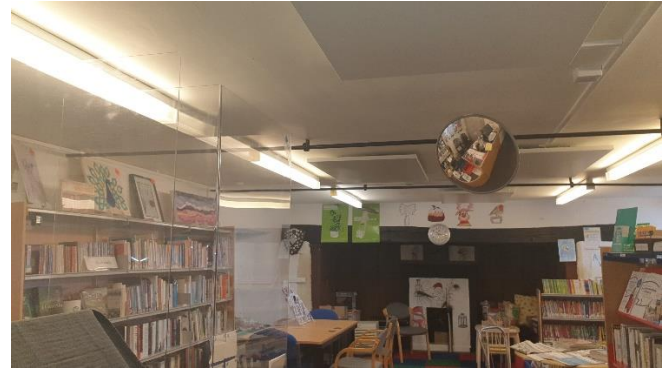
Library Luminaires

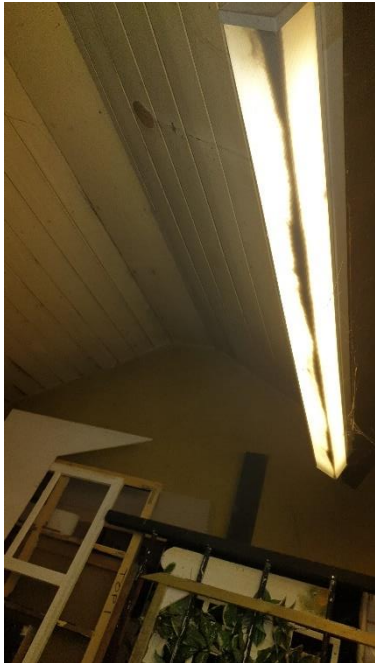
Luminaire in need of cleaning / replacement diffuser

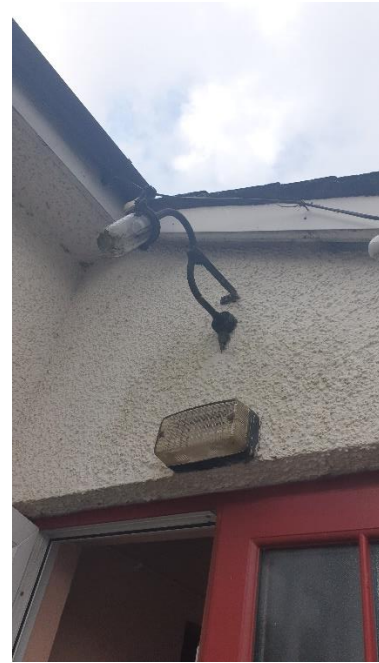
Basic External lighting.

Externally lighting is minimal, this should be reviewed and upgraded to allow safe passage to emergency assemble points and to provide better access and security during the hours of darkness.

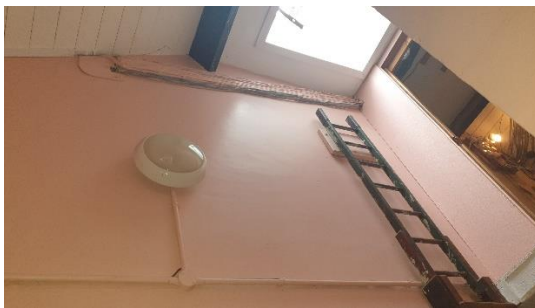
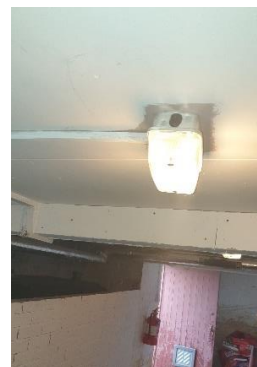
Bulkhead Luminaire

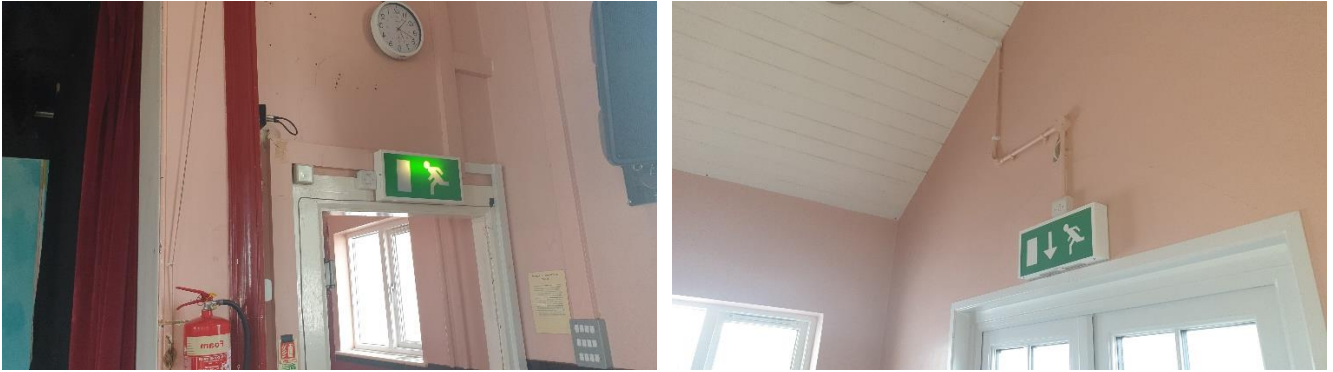
Only illuminated emergency signage was identified at Exit points; As this is a Public Use building a risk assessment should be carried out to determine a suitable level of emergency lighting for current use – both Escape and Anti Panic lighting should be considered both internally and externally to Assembly Points.

Existing Emergency Lighting

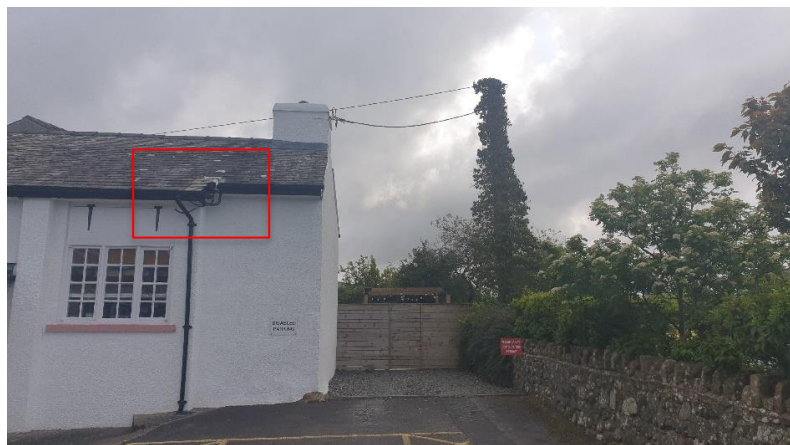
It was reported that the site does not have CCTV provision; it was noted however that there is a camera to the rear of the building, it was not possible to determine the operation of this camera at time of visit and it may well be a dummy camera – The Client should consult with their insurers to determine the building need.

Location of existing camera

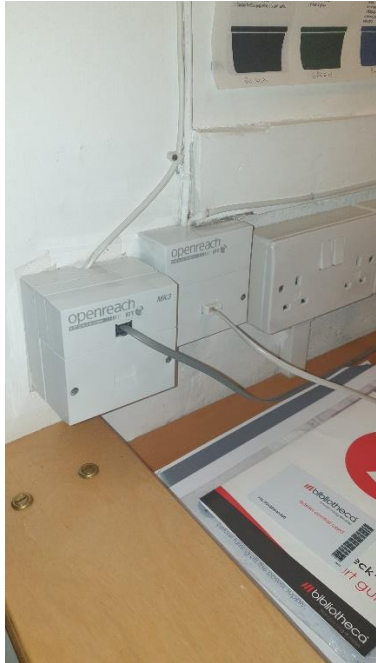
Data and Telephone provision within the building is minimal in nature with two BT points being identified within the Library area; The main data “Hub” is housed within a data cabinet which is laid on the floor under a desk within the Library. The Building Occupiers should be consulted to determine the building need and enhancements required.

Incoming BT Provision

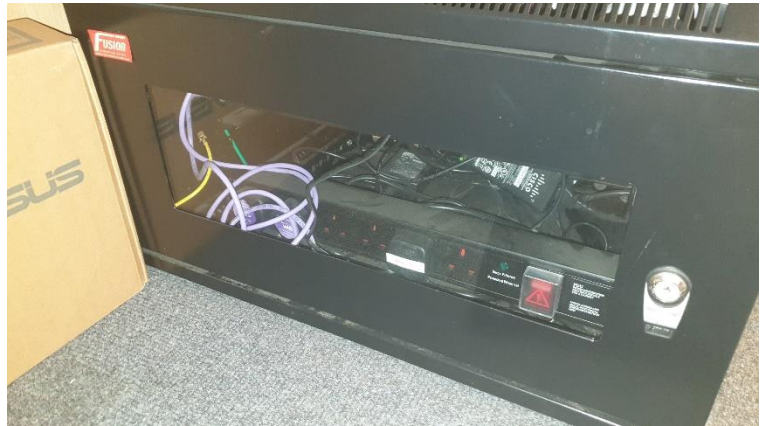
Data Hub located on floor
