M&E CONDITION REPORT
AT
GOSFOTH COMMUNITY HALL
GOSFORTH
CUMBRIA

DATE: MAY 2023
REF: 8749

Pettit Singleton Associates have been employed by Day Cummins to review the condition of the existing Mechanical and Electrical building services at Gosforth Community Hall, Gosforth, Cumbria.

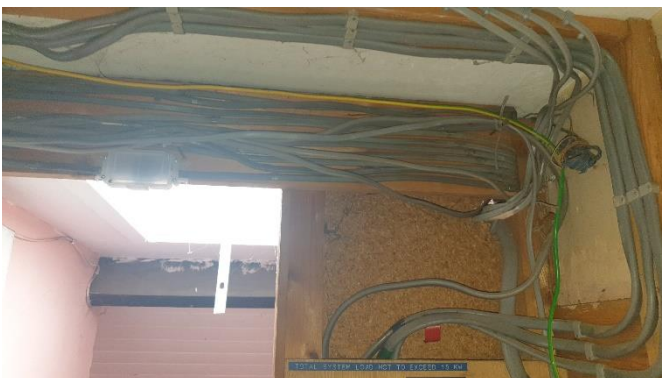
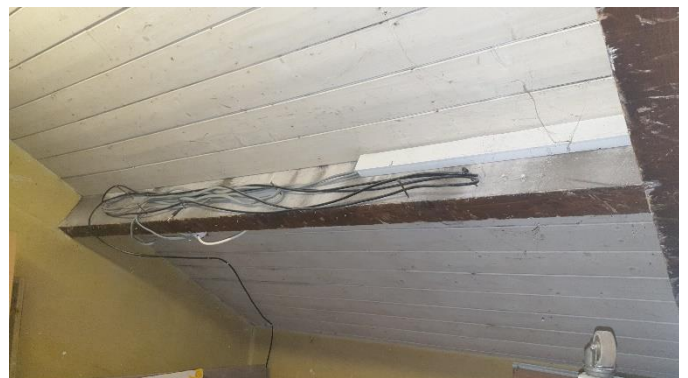
The Building has a Stage area and Hall with Adhoc performance equipment having been installed – the cabling to the equipment would appear to consist of a mix of hard wired and flexible cabling with multiple extension leads in use to provide the required number of connection points; exposed live cable joints were identified during the inspection – the Stage Lighting installation should be reviewed as a separate specialist item and deficiencies found made safe for further use.

Poorly fixed and protected cabling
