OPTION AND COSTINGS APPRAISALS

GOSFORTH PUBLIC HALL REFURBISHMENT PROJECT

WHITECROFT, GOSFORTH, SEASCALE, CUMBRIA CA20 IAS

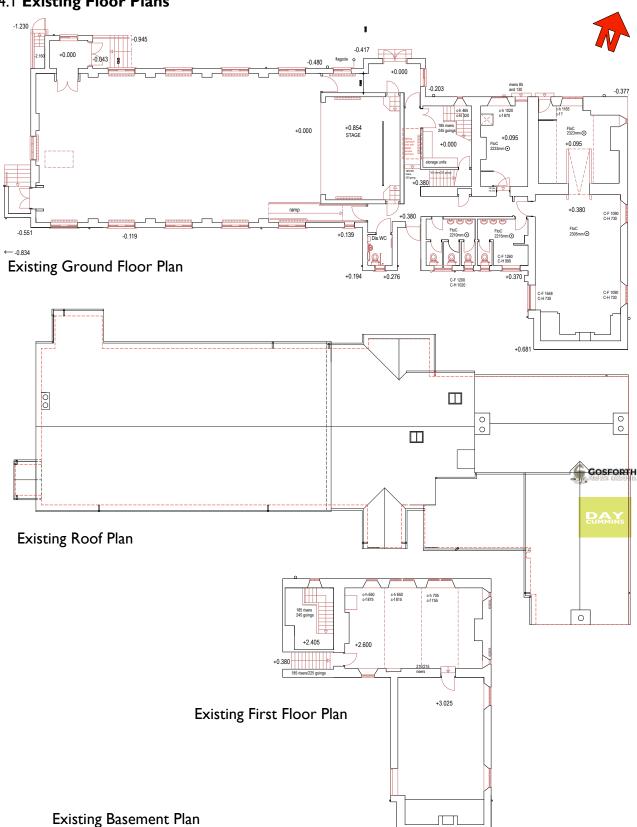
4. | Existing Floor Plans

In order to provide an accurate record of the existing building DCL carried out a measured survey, copies of which are included below. These drawings are for information only, they are not to scale and larger format drawings are available on request.

The existing building, although functional, was found to present several issues in terms of level access, open space, layout and storage. The route between the kitchen and the hall can be hazardous and makes catering for events difficult and even unsafe at times. The kitchen is also quite small and cramped.

There is an area that provides access to the first floor that has two staircases in very close proximity to each other. This appears to be poor utilisation of space when storage is of a premium.

Level ingress and egress is limited and the existing steps at the fire escapes are neither deep enough or level enough to provide the preferred safe escape.

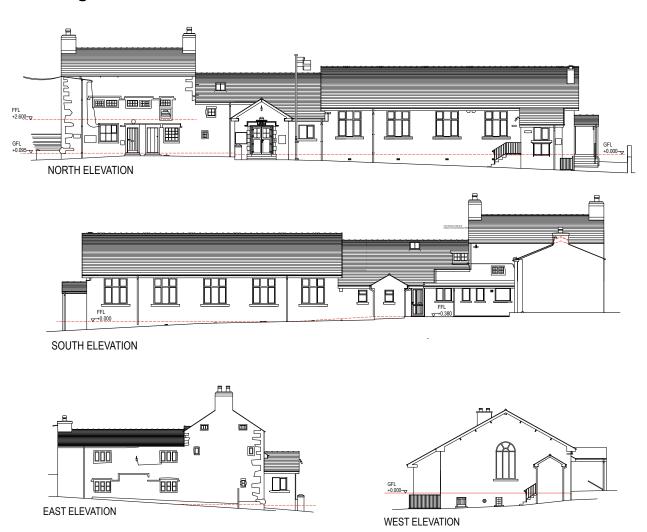
4.2 Existing Elevations

The building is generally of traditional construction, with rendered stone walls and a combination of slate and felted roofs. The building is clearly from the as a public hall and reflects the style of many similar buildings throughout the Country

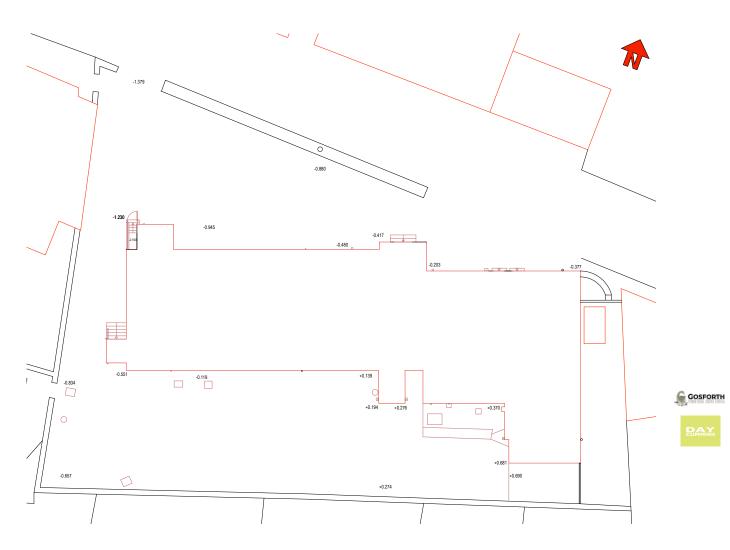
The existing site plan provides several constraints to the possibility of development that need to be carefully evaluated. The lack of available space has been a consideration throughout these works, the committee and wider user groups have all been aware that any form of extension will impact upon the existing parking arrangements and that a compromise will need to be made for the benefit of the sustainability of the facility.

Existing Access – The site is accessed directly off Whitecroft, there are two vehicular access points, which are both narrow and have poor visibility. There is no dedicated pedestrian access or path, which, when combined with the lack of line markings in the carparks, can cause conflicts between pedestrians and vehicles, especially with users who are unfamiliar with the building.

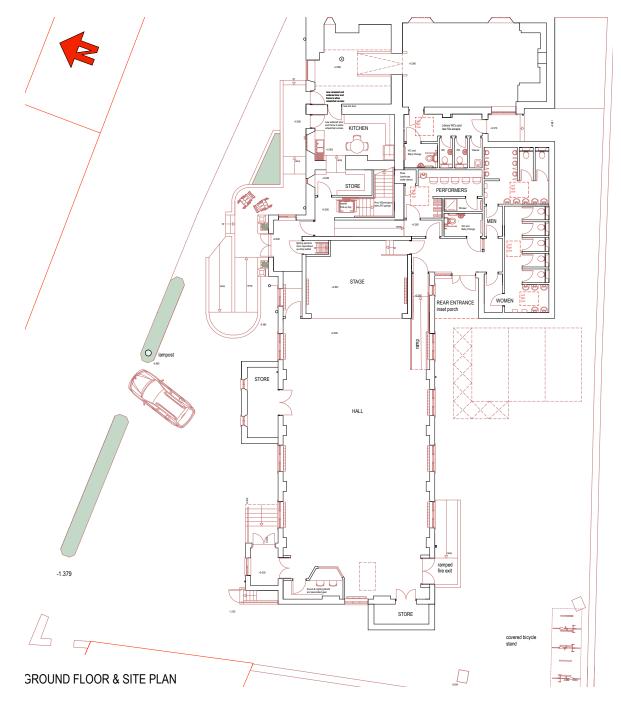
This option retained the main entrance in its existing location and provides a single ramp for use by the public hall and the library.

There is a single stair to the first floor areas, affording additional storage on both floors. The stair has a chair lift, to allow disabled access to the supper room.

A store has been added to the front of the building, for use in the hall. The rear link building has been removed and replaced with additional toilets and a dressing area. The library has a dedicated rear exit and a separate set of toilets.

The benefits of this option were noted as improved level and first floor access, additional toilets and improved storage areas.

The drawbacks were noted as considerable loss of parking due to the large rear extension, the ramp and the hall store. The stairlift was envisaged to be prohibitive and the kitchens location and access points were not thought to be an improvement on existing. Also, the loss of the direct internal link between the library and the hall facilities was thought too detrimental.

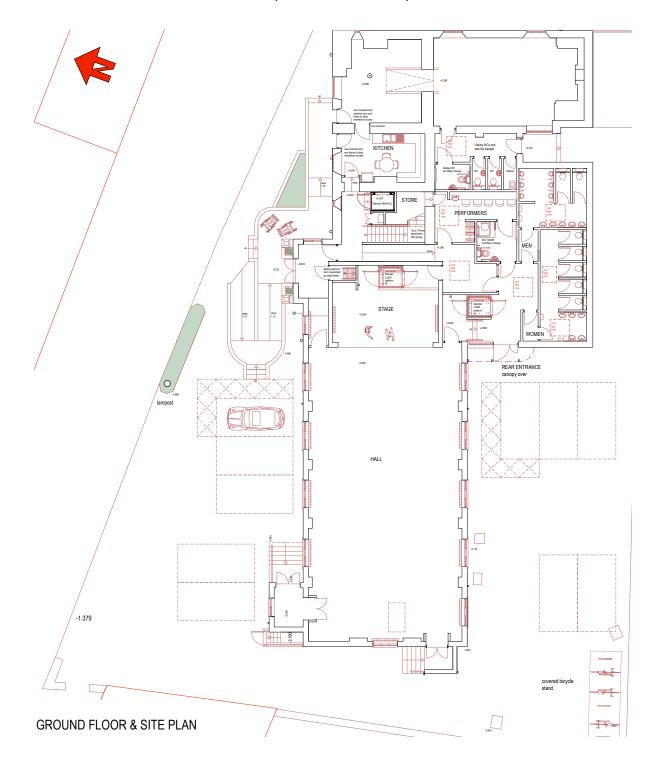
A single stair is implemented once again, however the chair lift has been replaced with an adjacent platform lift. In general, platform lifts have been used to replace chair lifts and ramps throughout the building in this proposal. The ramp in the main hall has been removed and the change in level has been relocated to the extension

The benefits of this option were noted as improved level and first floor access, additional toilets, improved kitchen and greater vehicle access with additional parking. The relocation of the ramp from the main hall

was seen as a vast improvement, as there would be less of an impact on the space in this room, allowing greater usage.

The drawbacks were noted as lack of storage, especially in the hall, loss of the direct internal link between the two facilities, excessive use of platform lifts, which will require ongoing maintenance and a lack of suitable ramped fire exits directly off the main hall.

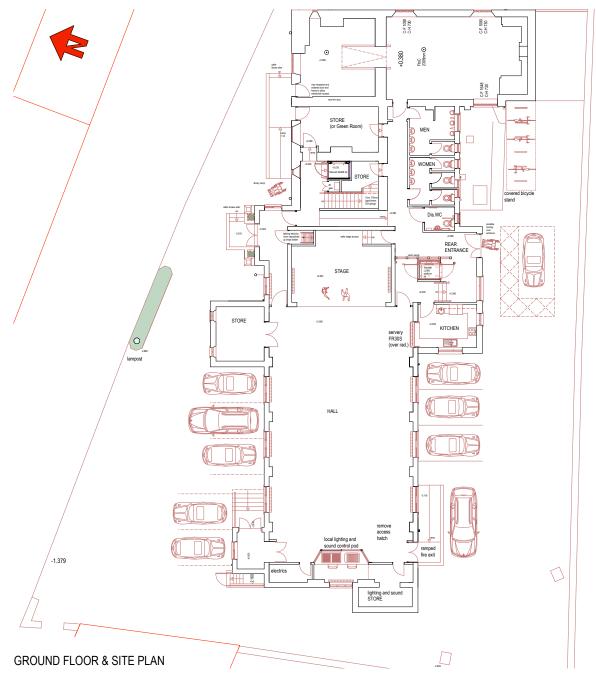
5.3 Option Three

The final option presented to the committee allowed for the relocation of the main entrance to one of the existing fire escapes at the rear of the main hall. The current entrance becomes a dedicated fire exit and a landing with improved steps is added to it, to assist in safe escape.

A dedicated ramp has been provided to the library, the entrance door widened and an internal lobby removed to improve access

The benefits of this option were noted as improved kitchen and storage, the maintenance of the link between the two areas, improved vehicular access and parking.

The drawbacks were noted as the use of platform lifts, which will require ongoing maintenance and the loss of level access for users at the front of the building.

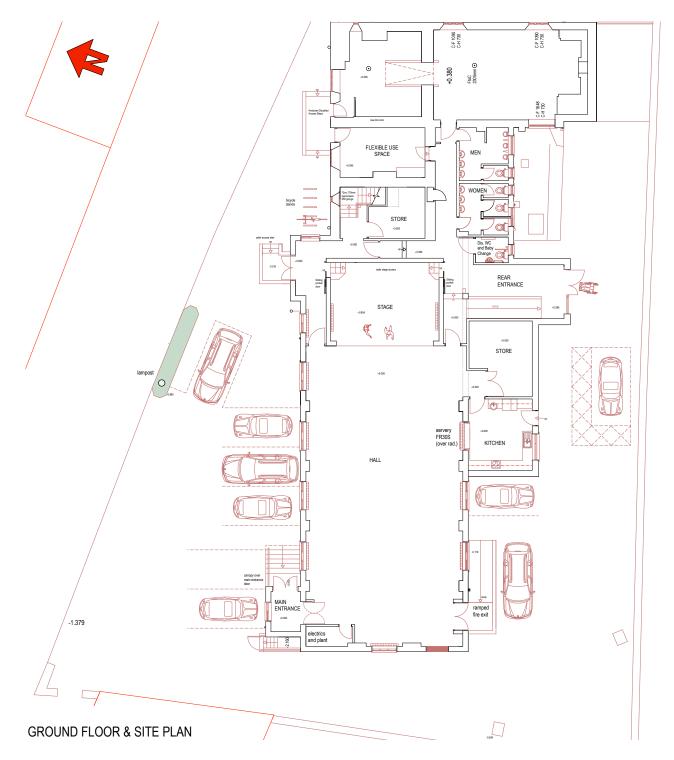
This information was taken forward, integrated into the design by DCL and the various consultants and the following plan now forms the basis of the costings included in this report.

The kitchen has been relocated and enlarged, the relocation to avoid a conflict between the hatch and the front of the stage or access to the toilets.

An external door has been added to the kitchen to improve access for deliveries.

The platform lifts have been removed. This does mean an acceptance that first floor access for those in wheelchairs is prohibited, however an increase to the usable space on the ground floor, improved level access generally through the building and the introduction of the kitchen in the main hall provide improved facilities for wheelchair users on the ground floor.
